NOAA FORM 76-35A	
U.S. DEPARTMENT OF COMMERCE NATIONAL OCEANIC AND ATMOSPHERIC ADMINISTRATION NATIONAL OCEAN SURVEY	
DESCRIPTIVE REPORT	
Type of Survey	Chart Evaluation
Field No.	
Office No.	17435 (D-61)
LOCALITY	
State	Alaska
General Locality	Gastineau Channel
Locality	Juneau Harbor
1983	
CHIEF OF PARTY	
Cdr. Walter E. Forster	
LIBRARY & ARCHIVES	
DATE

SUBJECT: Chart Inspection, Chart 17315 (D-61), Juneau Harbor, Gastineau Channel, Alaska

JUNEAU HARBOR, ALASKA
INVESTIGATION OF REPORTED SHOALING
SOUNDINGS IN FATHOMS SCALE = 1:10000

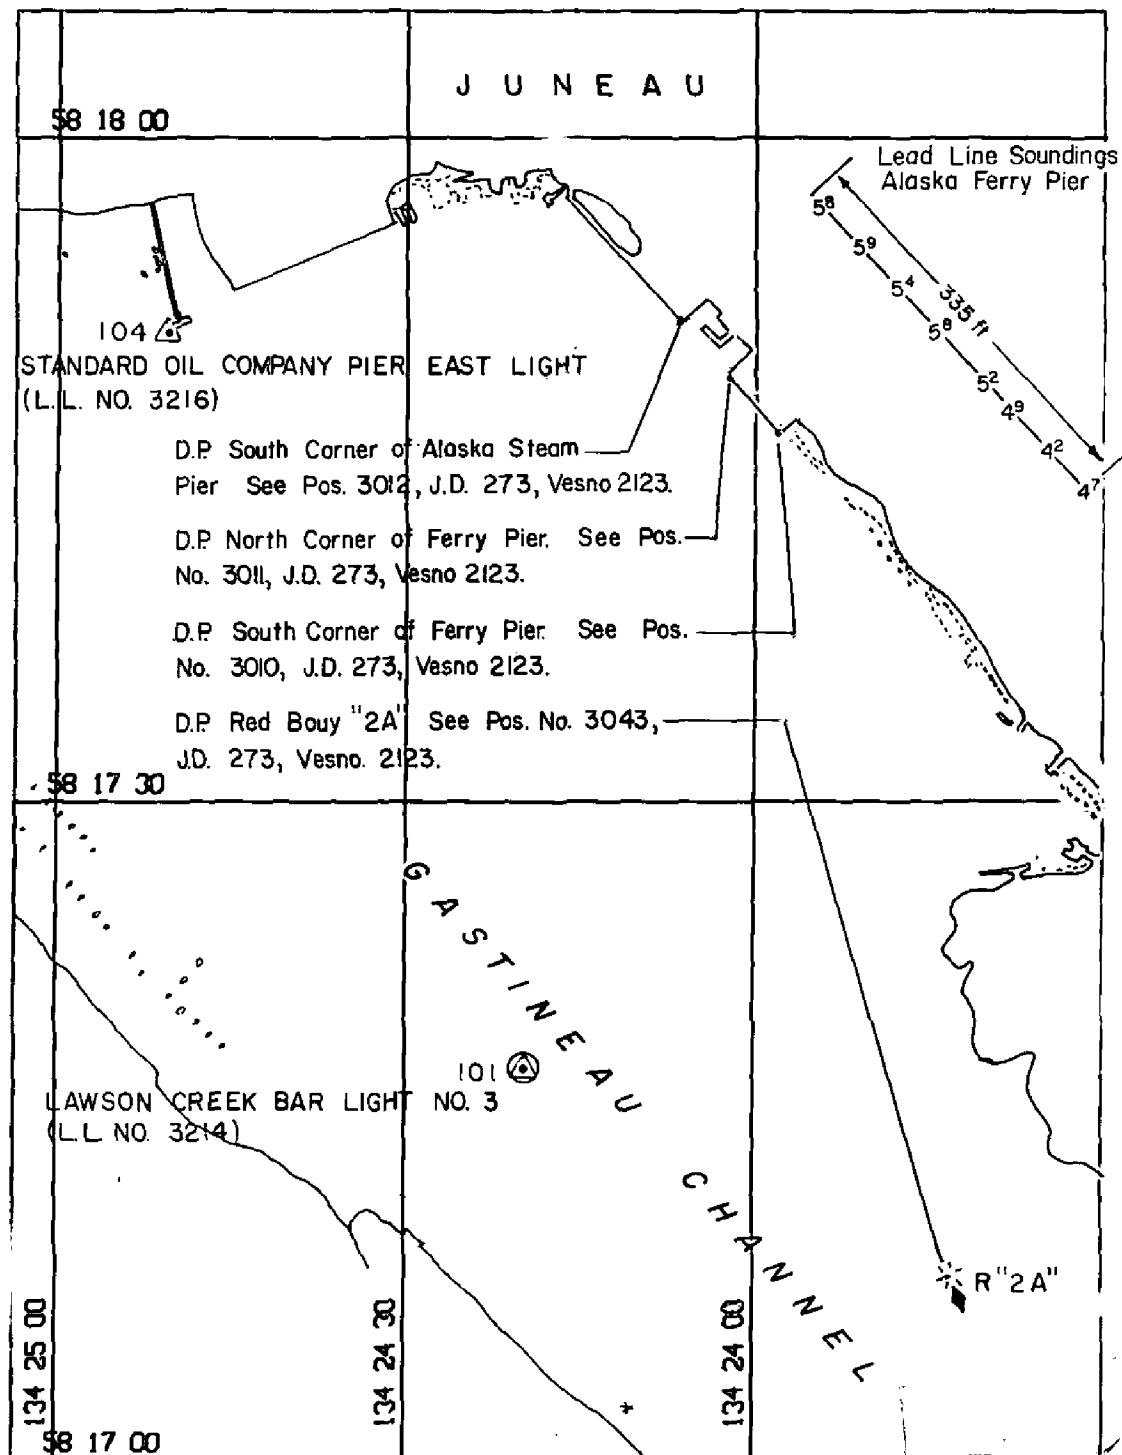
Field data was verified and is adequate to determine that shoaling has not occurred in the areas investigated except for a 5-fathom shoal at latitude 58°17'45"N, longitude 134°23'56"W, located in proximity to an 8-fathom charted sounding.

Comparison between the survey soundings and those on Chart No. 17315, 18th edition, July 10, 1982, generally show the survey soundings to be greater, by 1 to 2 fathoms, where discrepancies occur, with the exception of the charted 8 fathom sounding at $58^{\circ}17'45''$ N Latitude, $134^{\circ}23'56''$ W Longitude. The investigative survey showed a 5 fathom sounding at the location of the charted 8 fathom sounding. No indication of shoaling was found in the vicinity of $58^{\circ}17'23''$ N Latitude, $134^{\circ}23'56''$ W Longitude. ✓
44 CONCUR

This survey is found to be adequate for its intended purpose. Except for the addition of the 5-fathom sounding mentioned earlier, it is recommended that no change to the chart be made.

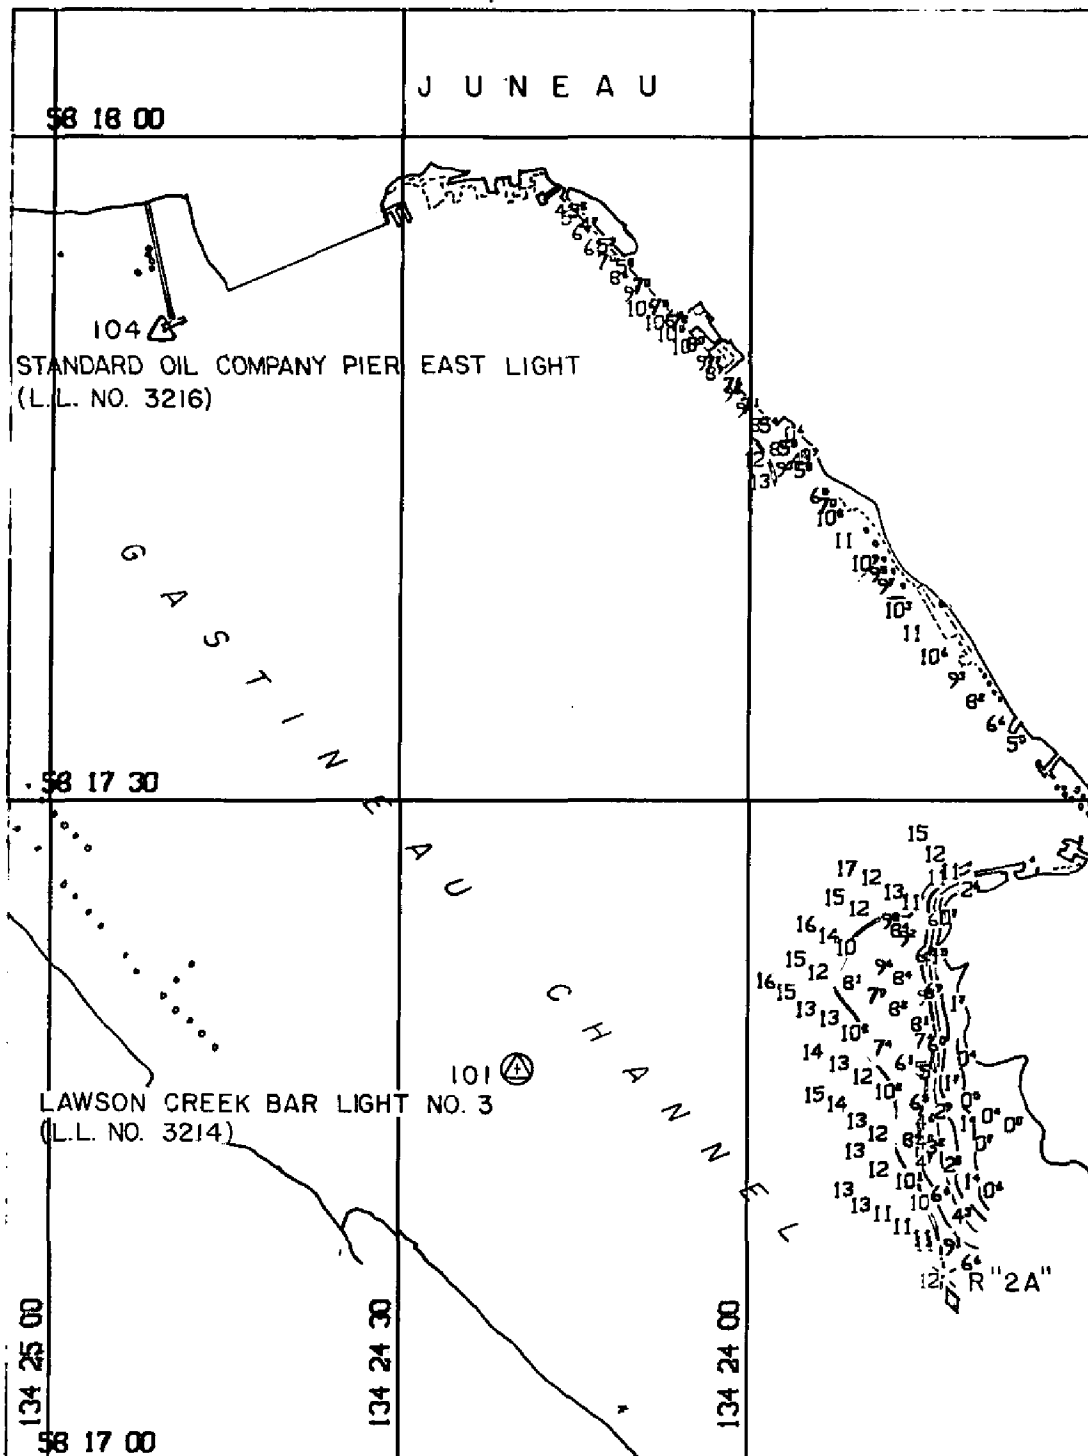
JUNEAU HARBOR, ALASKA
 INVESTIGATION OF REPORTED SHOALING
 SOUNDINGS IN FATHOMS SCALE = 10000

Leadline soundings taken at approximately 50 foot intervals along the face of the City Wharf and Ferry Terminal Pier ranged from 25 to 35 feet, 4 to 5 feet shoaler than the Coast Pilot No. 8, June 1982, reported alongside depths of 29 to 40 feet. *Coast Pilot depths may be Keel-line depths* ✓
11/11/86
11/16/86
12/18/86
