Form 504	
U. S. DEPARTMENT OF COMMERCE	
COAST AND GEODETIC SURVEY	
DESCRIPTIVE REPORT	
Type of Survey	Chart Topography
Field No.	Office No. T-13213
LOCALITY	
State	Oregon-Washington
General locality	Columbia River
Locality	Arlington
19 68 1967-69	
CHIEF OF PARTY	
V. Ralph Sobieralski, Chief	
Photogrammetry Division	
LIBRARY & ARCHIVES	
DATE

T - 13213

Summary to Accompany Descriptive Report T-13213

T-13213 is one of seven 1:20,000 scale chart topography maps covering Lake Umatilla (John Day Pool) a part of the Columbia River. John Day Pool was formed by impounding the water behind John Day Dam east to McNary Dam. The seven maps will provide the base for two small craft charts (673 SC and 674 SC).

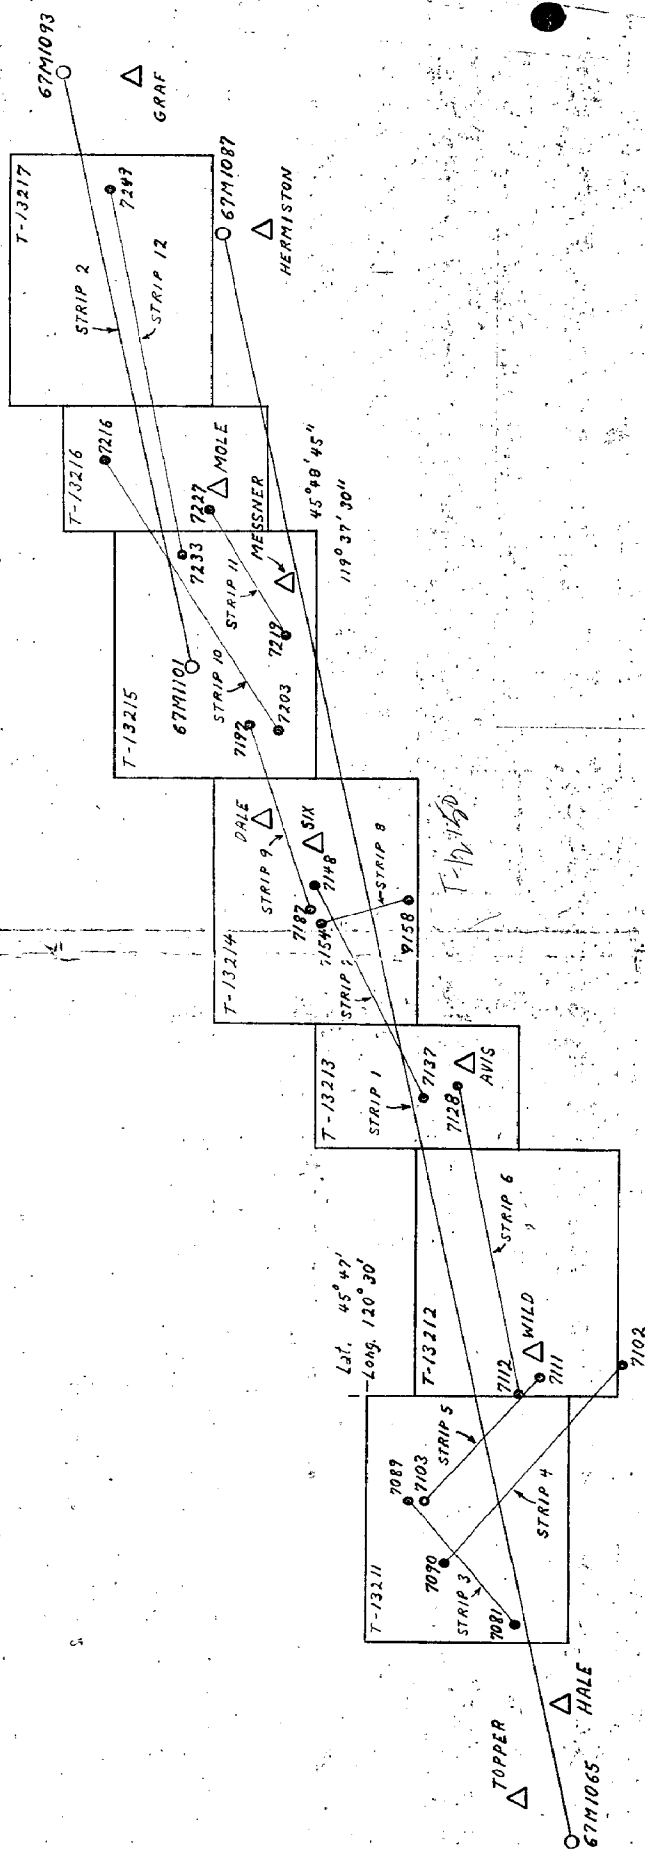
AEROTRIANGULATION SKETCH

The attached sketch of the strips bridged shows the placement of triangulation used in the final strip adjustments. Closures to both horizontal and vertical control are shown for each strip on the IBM readouts along with all bridge points on Oregon Zone 1 plane coordinates. All points have been converted to Mercator values.
