Form 504 U. S. DEPARTMENT OF COMMERCE COAST AND GEODETIC SURVEY DESCRIPTIVE REPORT	
Type of Survey	SHORELINE
Field No.	Office No. T-10544
LOCALITY	
State	FLORIDA
General locality	OLD TAMPA BAY
Locality	ROCKY POINT TO CABBAGEHEAD BAYOU
<u>19 58</u> CHIEF OF PARTY Arthur L. Wardwell, Tampa Photo Office	
LIBRARY & ARCHIVES MAY 25 1960 DATE

T-10544

SUMMARY
TO ACCOMPANY SHORELINE MANUSCRIPTS
T-10544 and T-10545

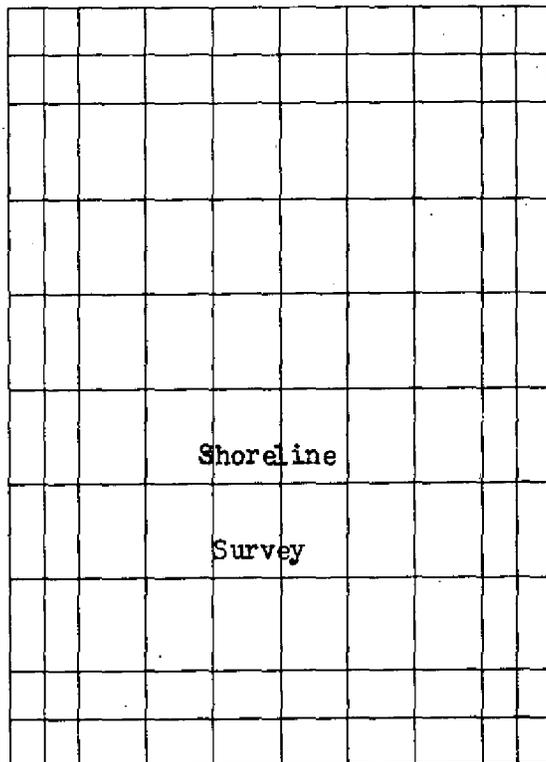
Areas contoured by various personnel
(Show name within area)
(II) (III)
