DESCRIPTIVE REPORT

| Type of Survey Shoreline(Photogrammetric) |
| Field NoOffice No. T-10576 |
| Locality Head of Tonowek Bay |

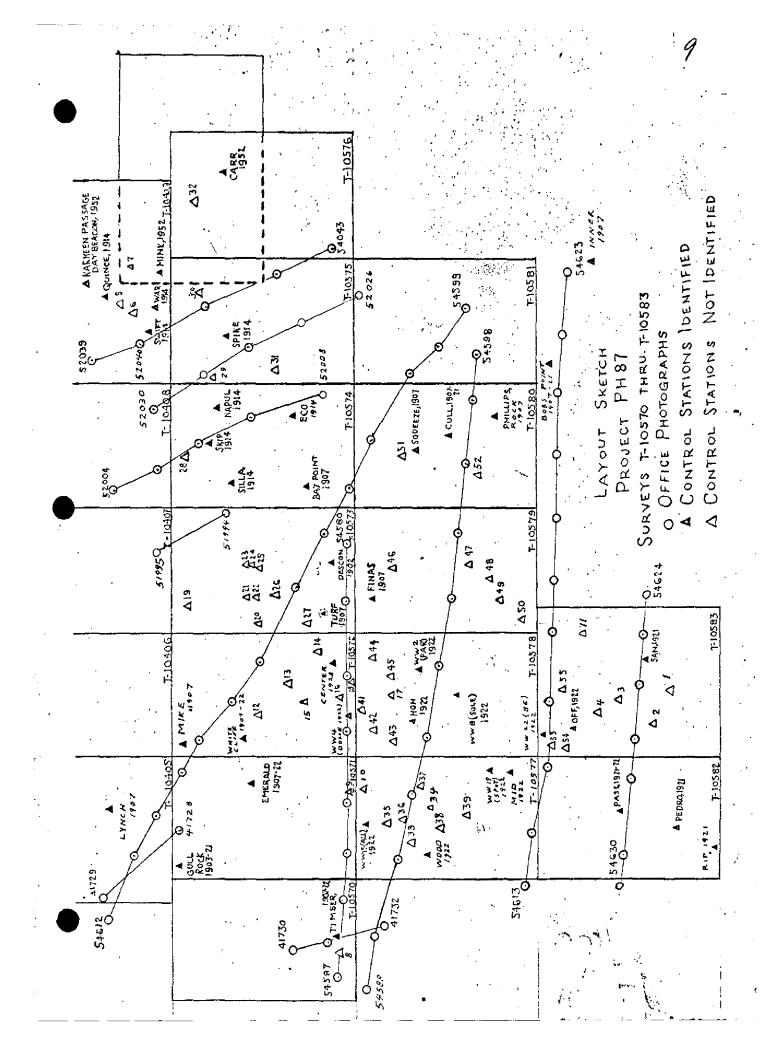
A sketch showing a layout of surveys and the distribution of control and photograph centers is attached to this report.
