DESCRIPTIVE REPORT

Y Shoreline(Photogrammetric)
Field No. Office No. T-10580
LOCALITY
StateAlaska
General locality Gulf of Esquibel
Locality Culebra and St. Philip Islands
1956
CHIEF OF PARTY
W.F. Deane, Baltimore District Office
LIBRARY & ARCHIVES
DATE

SUMMARY TO ACCOMPANY DESCRIPTIVE REPORT T-10580

PHOTOGRAMMETRIC PLOT REPORT Project Ph-87 Surveys T-10570 through T-10583

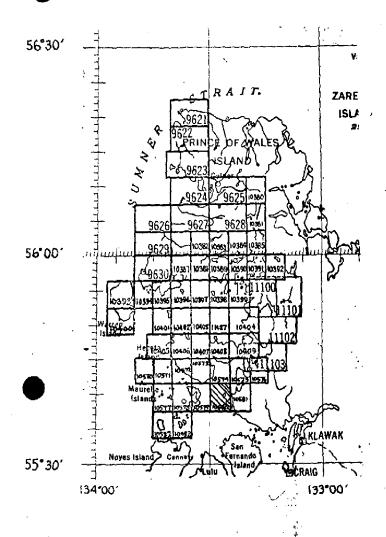
Prince of Wales Island, Alaska

Shoreline survey T-10580 is one of 58 similar surveys in project PH-87. It covers the Culebra Islands and part of St. Philip Island in the Gulf of Esquibel. See page 5 for the area of the survey within the project.

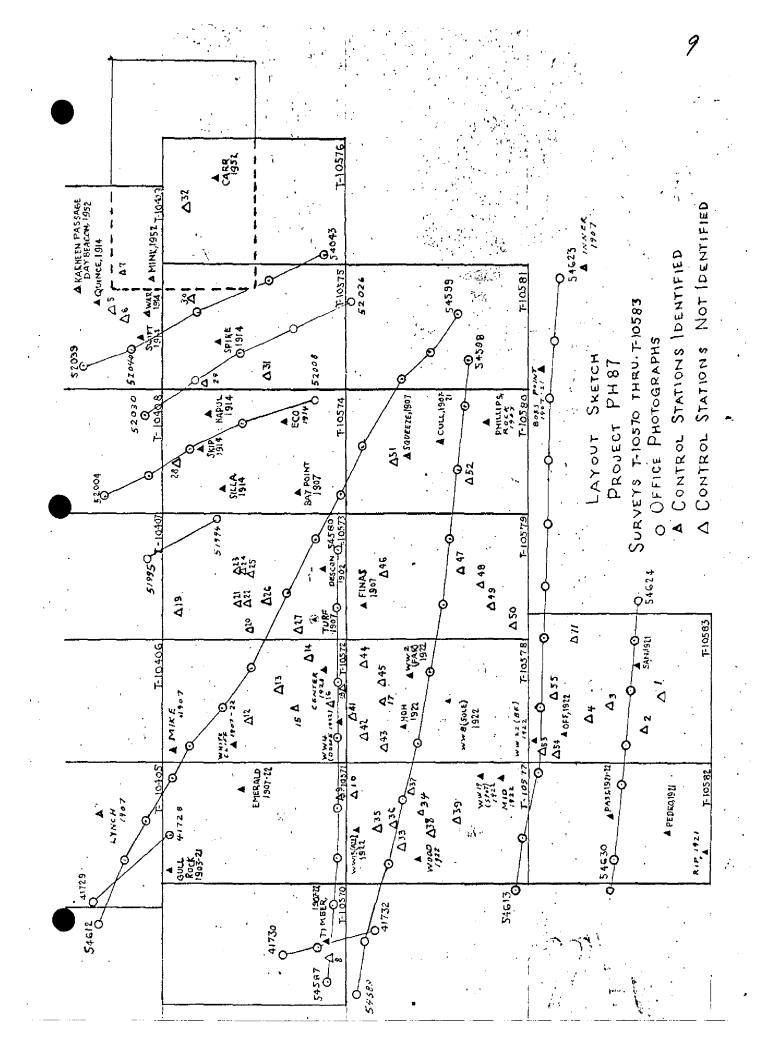
A sketch showing a layout of surveys and the distribution of control and photograph centers is attached to this report.
