FORM C&GS-504	
U.S. DEPARTMENT OF COMMERCE ENVIRONMENTAL SCIENCE SERVICES ADMINISTRATION COAST AND GEODETIC SURVEY	
DESCRIPTIVE REPORT	
Type of Survey	SHORELINE
Field No.	Office No. T-10724
LOCALITY	
State	ALASKA
General locality	KUIU ISLAND - SUMNER STRAIT
Locality	BEAR HARBOR
1955	
CHIEF OF PARTY J. E. Waugh, Chief of Field Party W.E. Randall, Baltimore Photo Office Alfred C. Holmes, Director, A.M. C.	
LIBRARY & ARCHIVES	
DATE

## SHORELINE MAPPING PROJECT

CORONATION and  
KUIU ISLANDS,  
ALASKAOfficial Release For Cost Accounts

## DESCRIPTIVE REPORT T-10724

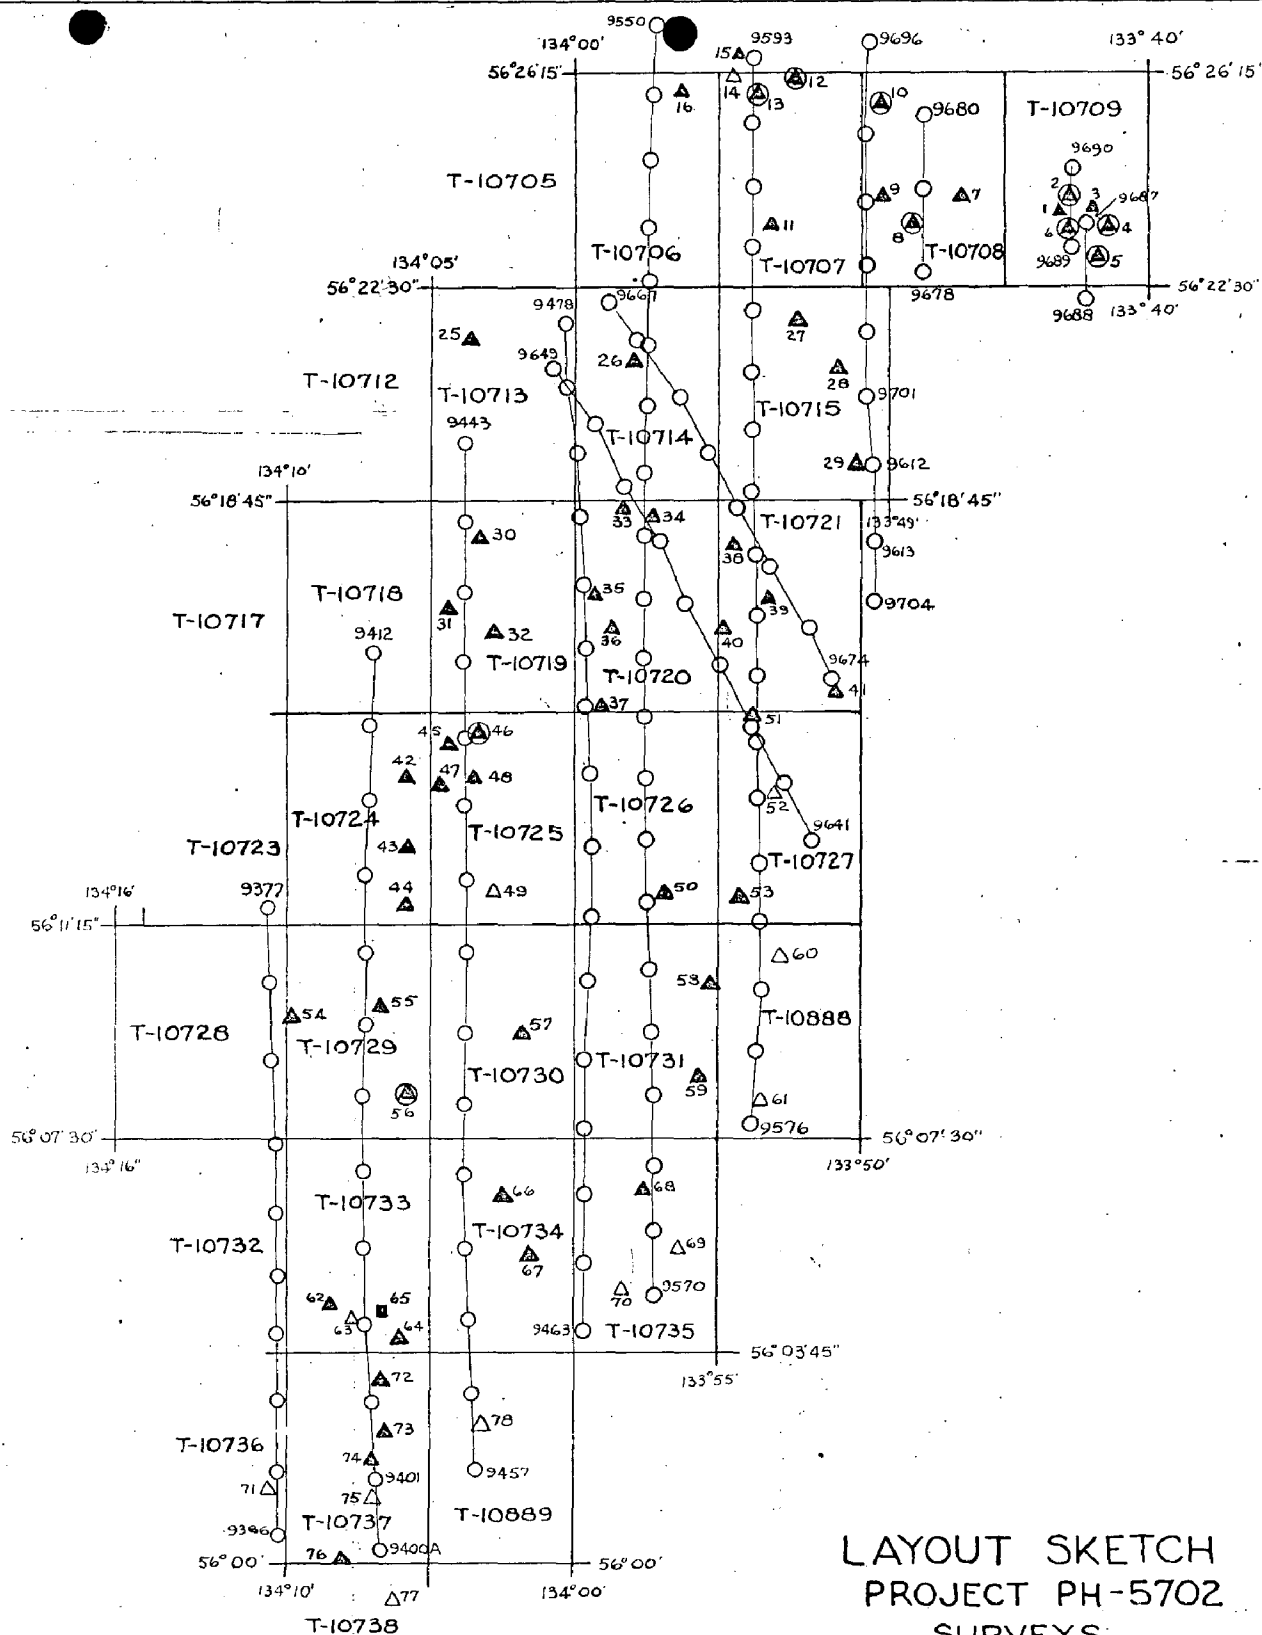
# LAYOUT SKETCH PROJECT PH-5702 SURVEYS

A sketch showing the layout of the surveys, distribution of control and photograph centers is attached to this report.

T-10706 THRU T-10709  
T-10713 THRU T-10715  
T-10718 THRU T-10721  
T-10724 THRU T-10731  
T-10733 THRU T-10735  
T-10737  
T-10888 AND T-10889

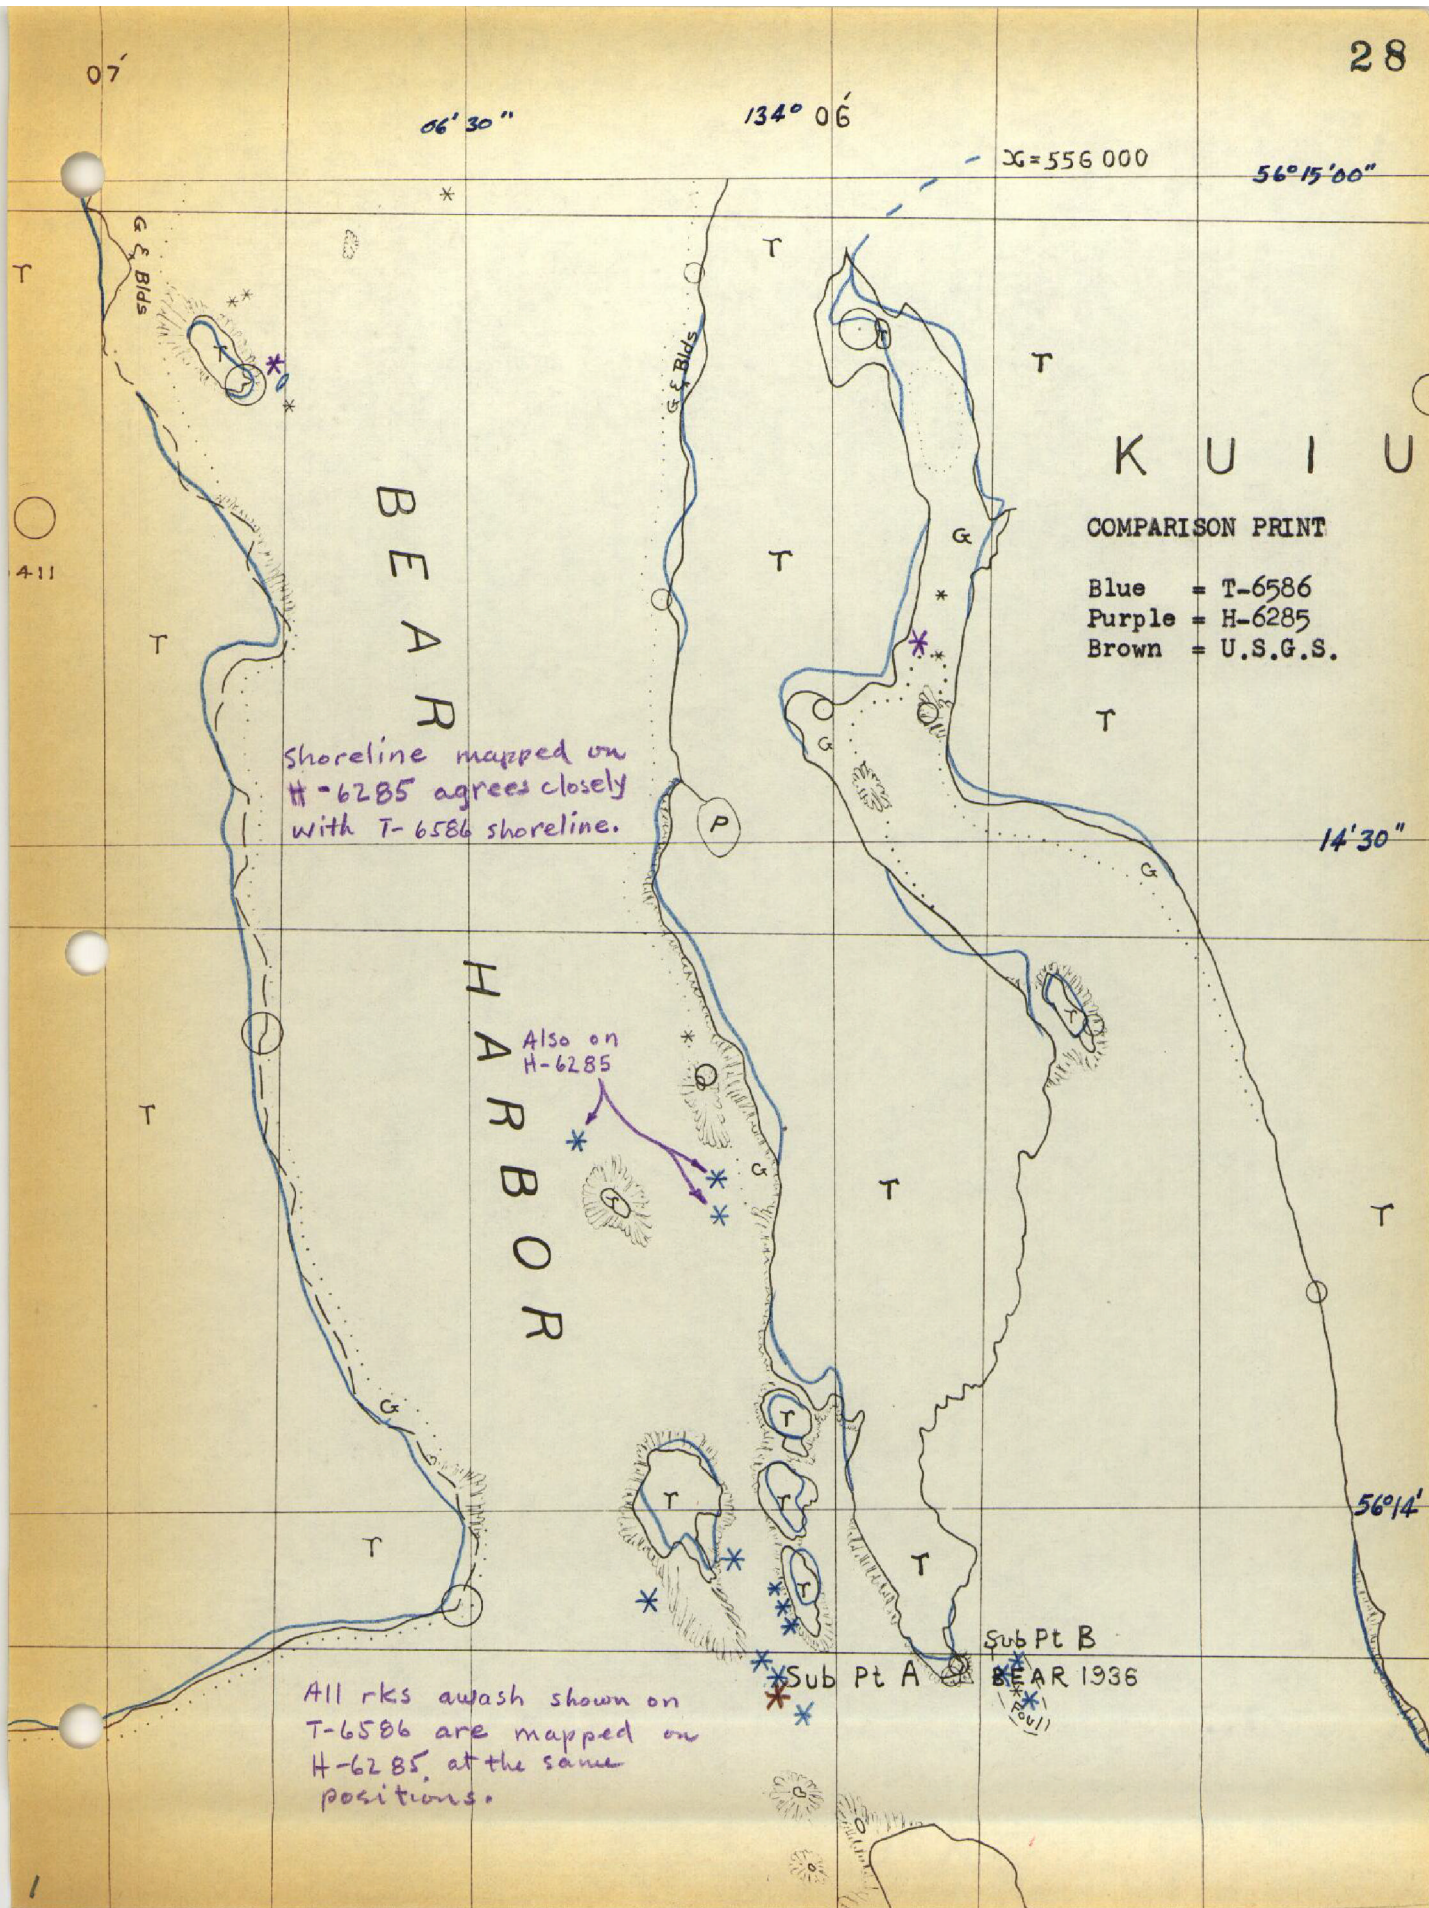
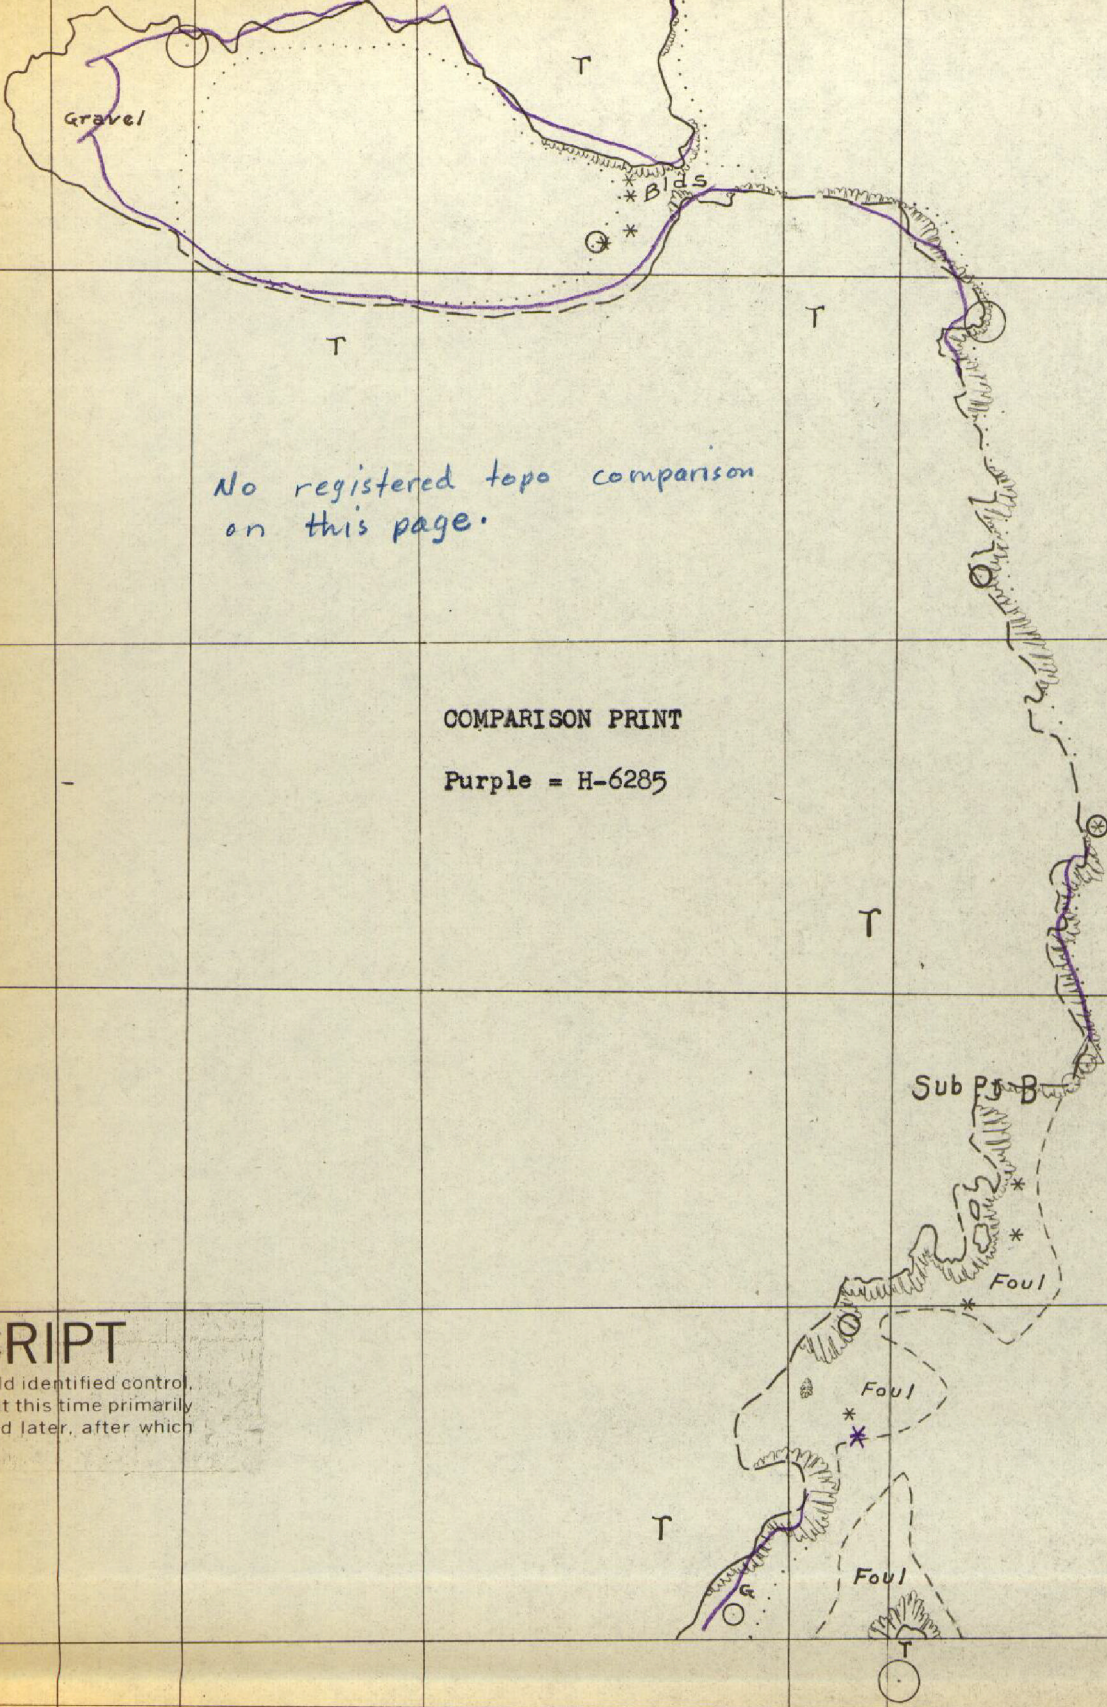
COMPARISON PRINT

An ozalid comparison print, pages 28 through 30, showing differences noted in Items 62 through 64, is bound with the original of this report.
