## DESCRIPTIVE REPORT

Type of Survey SHORELINEField No. \_\_\_\_\_ Office No. T-10726

State ALASKAGeneral locality KUTU ISLAND - SUMNER STRAITLocality LOUISE COVE19 55 - 61

## DESCRIPTIVE REPORT T-10726

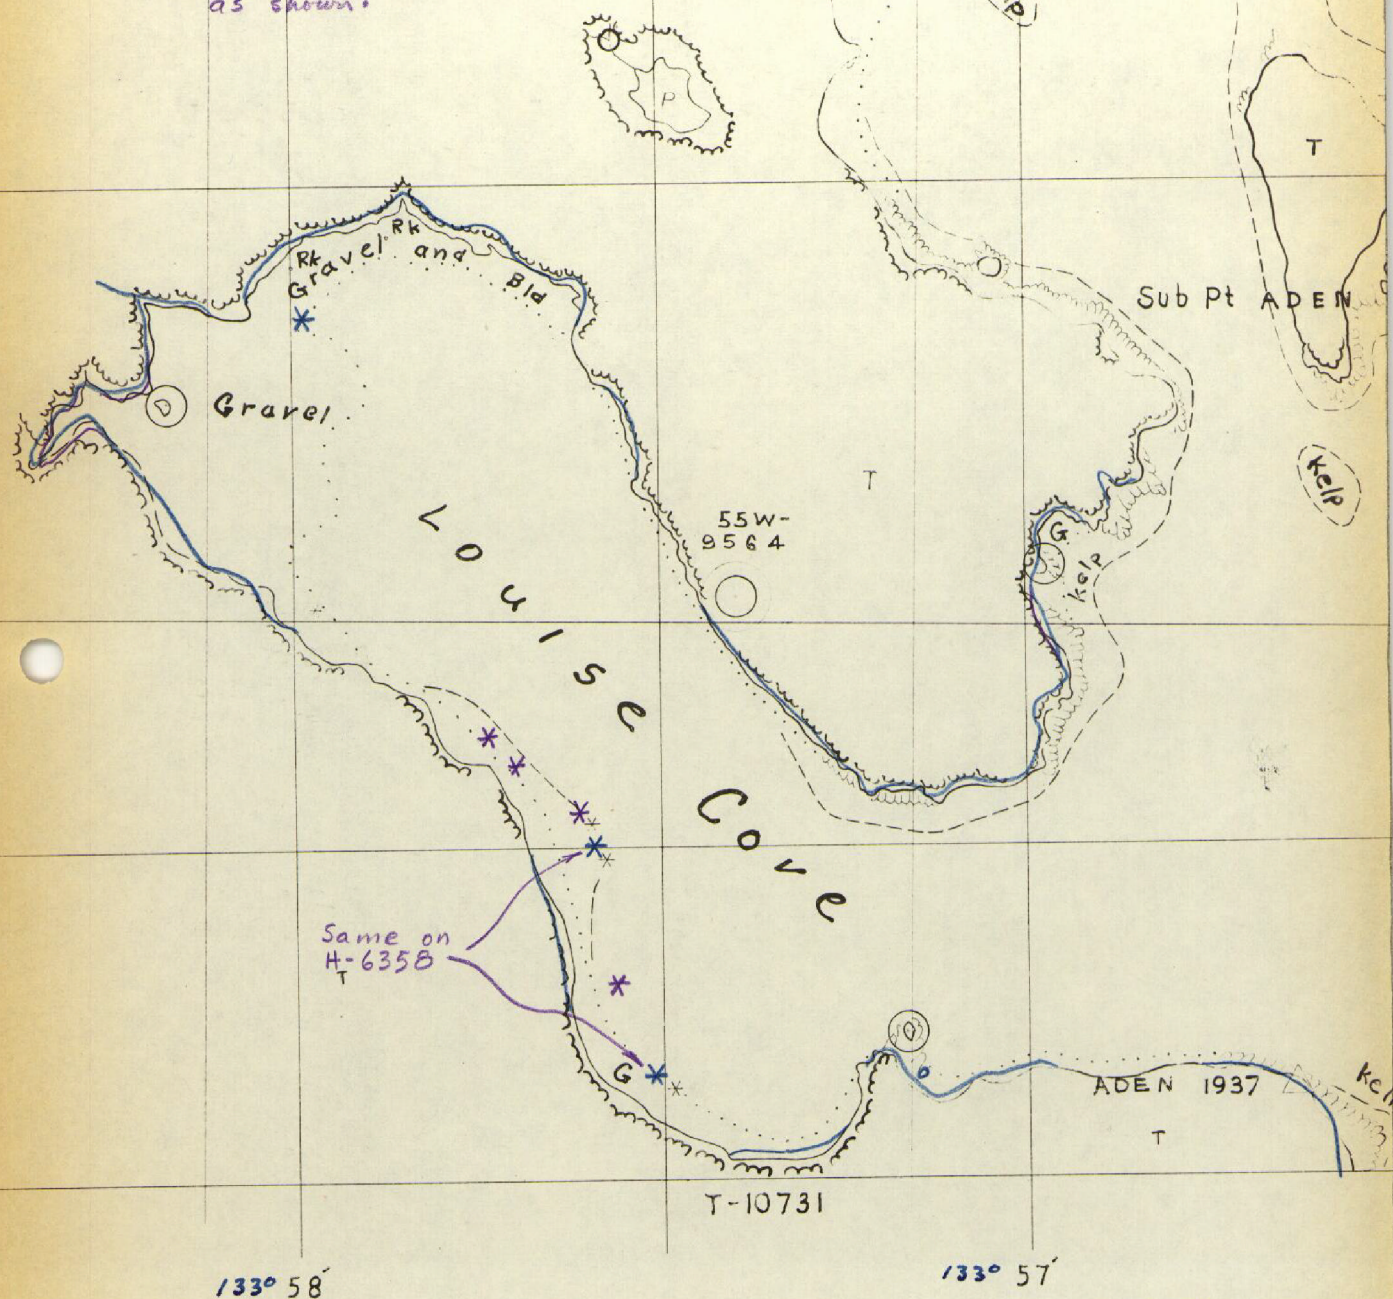
H-6358 shoreline is the same  
as T-6638 shoreline, except  
as shown.

NOTE. Unlabeled circles are photogrammetric  
plot points, not map features

An ozalid comparison print, pages 30 through 32, showing differences noted in Items 62 and 64, is bound with the original of this report.
