DESCRIPTIVE REPORT

Type of Survey	SHORELINE
Field No.	Office No. T-10728
LO	CALITY
State ALASKA	•
General locality KUIU IS	LAND - SUMNER STRAIT
Locality HEAD OF	KELL BAY
1	9.55
J. E. Waugh, Chief W. E. Randall, Balt Alfred C. Holmes,	
LIBRARY	& ARCHIVES
DATE

DESCRIPTIVE REPORT T-10728

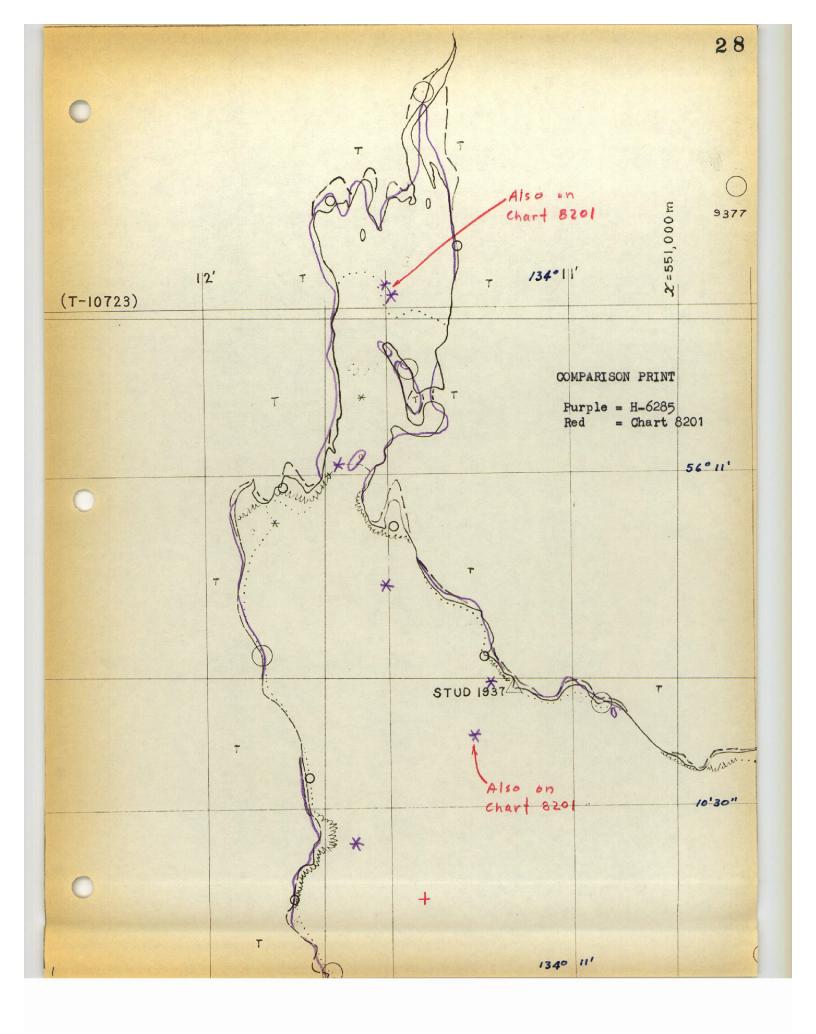
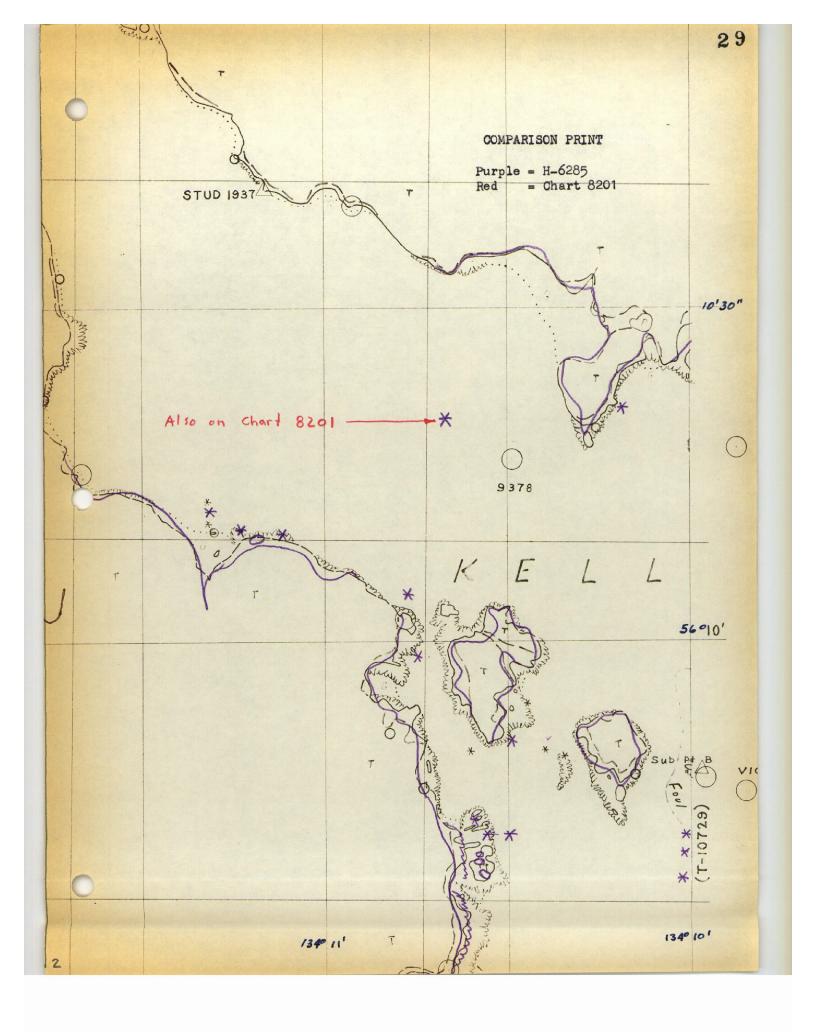
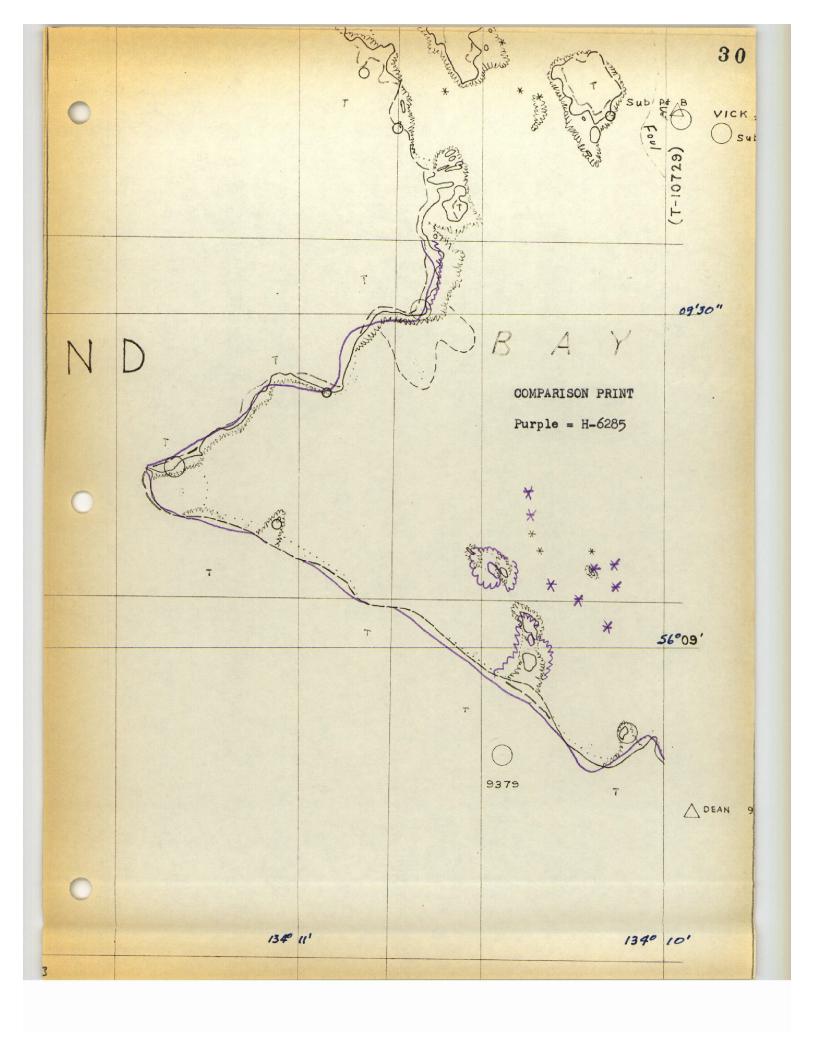
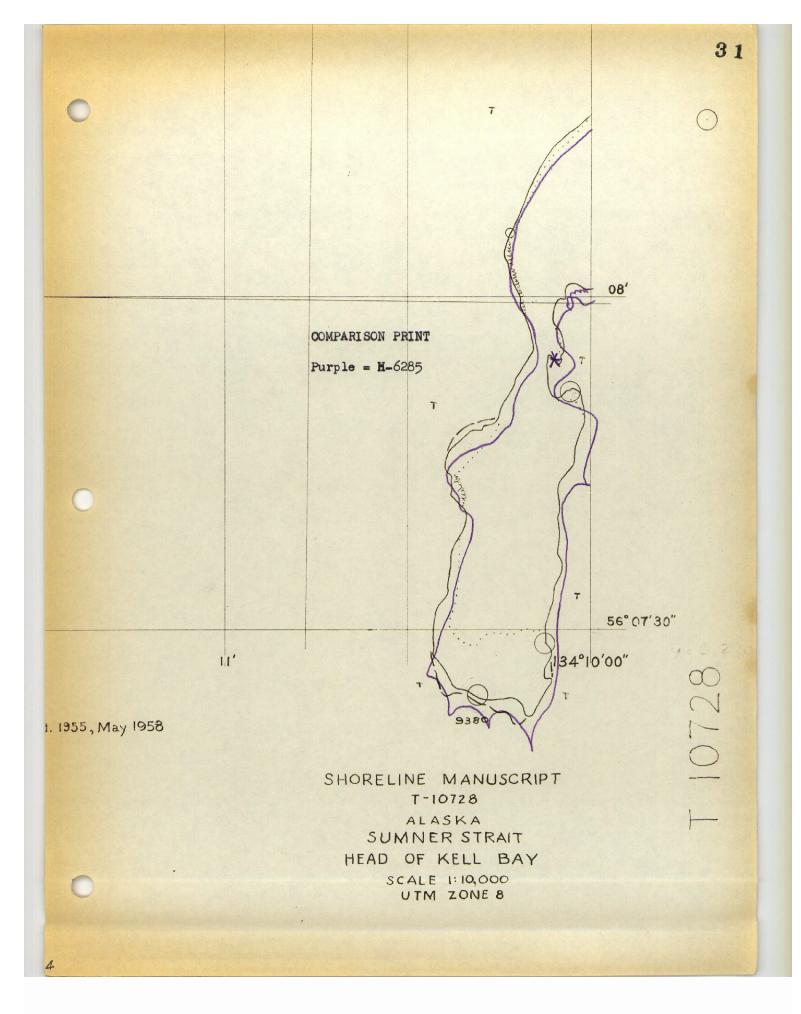
An ozalid comparison print, pages 28 through 31, showing differences noted in Items 64 and 65, is bound with the original of this report.

A comparison was made with a copy of the smooth sheet for Survey H-6285, scale 1:20,000, dated July-August 1937 and August 1938. Significant differences between this survey and T-10728 are shown in purple on the comparison print.

A visual comparison was made with Chart 8201, scale 1:217,828, 16th edition, dated 7 November 1970. Significant differences are noted in red on the comparison print.
