DESCRIPTIVE REPORT

Type of Survey SHORELINEField No. _____ Office No. T-10733

State ALASKAGeneral locality KUIU ISLAND - SUMNER STRAITLocality PORT MCARTHUR1955

T - 10733

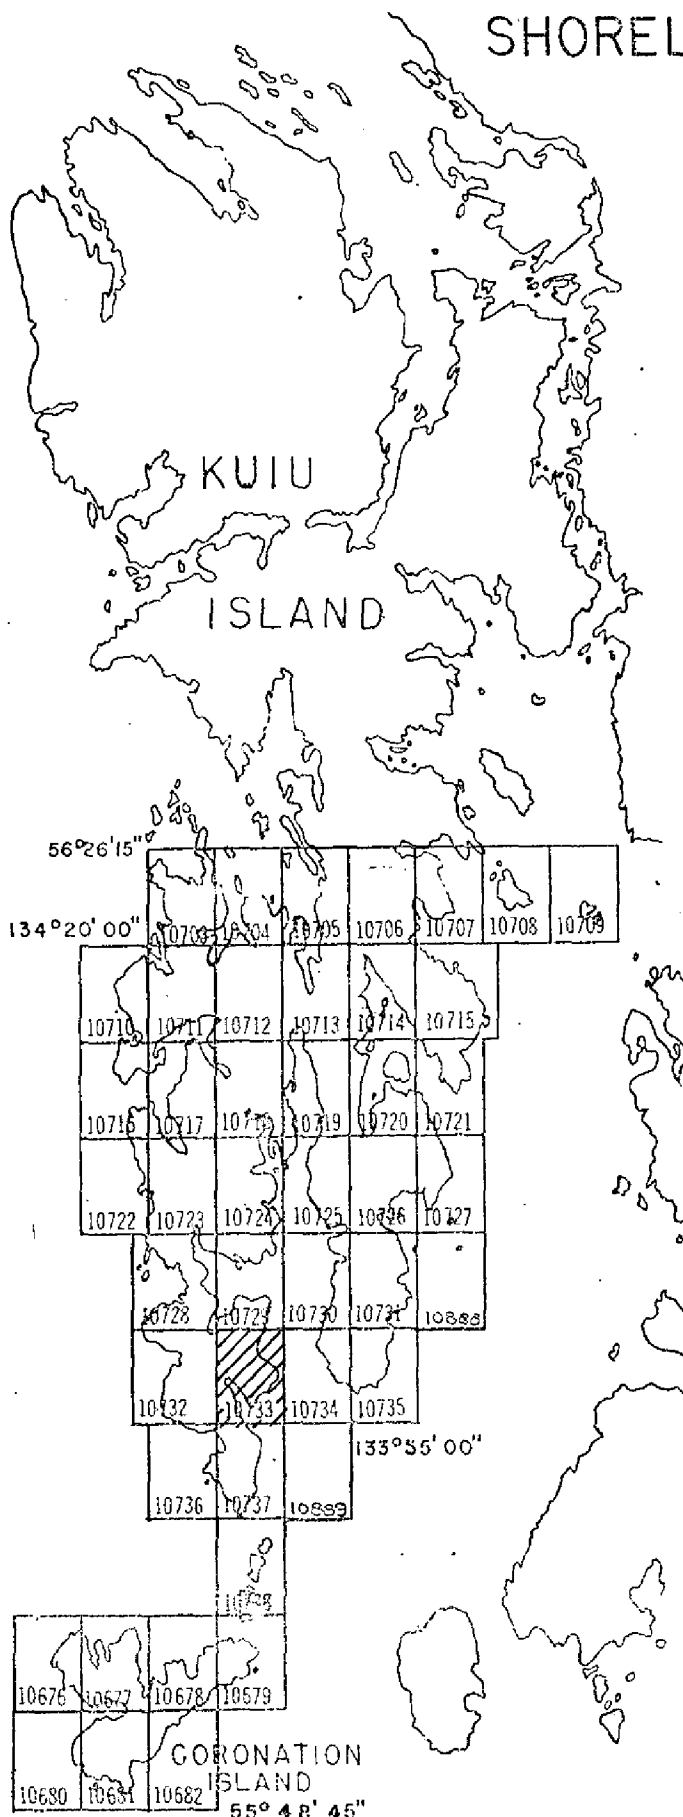
SHORELINE MAPPING PROJECT

CORONATION and
KUIU ISLANDS,
ALASKAOfficial Mileage For Cost Accounts

Sheet No.	Area Sq. Mi.	Lin. Mi. Shoreline
10676	2	3.4
10677	8	11.1
10678	6	7.7
10679	3	6.0
10680	1	1.5
10681	8	7.7
10682	2	2.6
10703	10	11.5
10704	6	12.8
10705	9	11.9
10706	14	2.6
10707	4	7.7
10708	2	9.4
10709	1	3.0
10710	5	6.8
10711	11	7.7
10712	14	.9
10713	12	9.4
10714	5	8.5
10715	11	6.8
10716	4	5.2
10717	9	11.1
10718	13	6.0
10719	8	11.1
10720	9	8.5
10721	4	8.5
10722	2	4.3
10723	14	3.1
10724	11	10.2
10725	8	7.7
10726	11	4.3
10727	3	4.5
10728	10	14.5
10729	6	11.9
10730	5	4.3
10731	10	6.0
10732	10	8.5
10733	9	8.5
10734	3	3.4
10735	4	4.3
10736	1	4.3
10737	6	8.5
10738	1	6.8
TOTAL	295	298.8

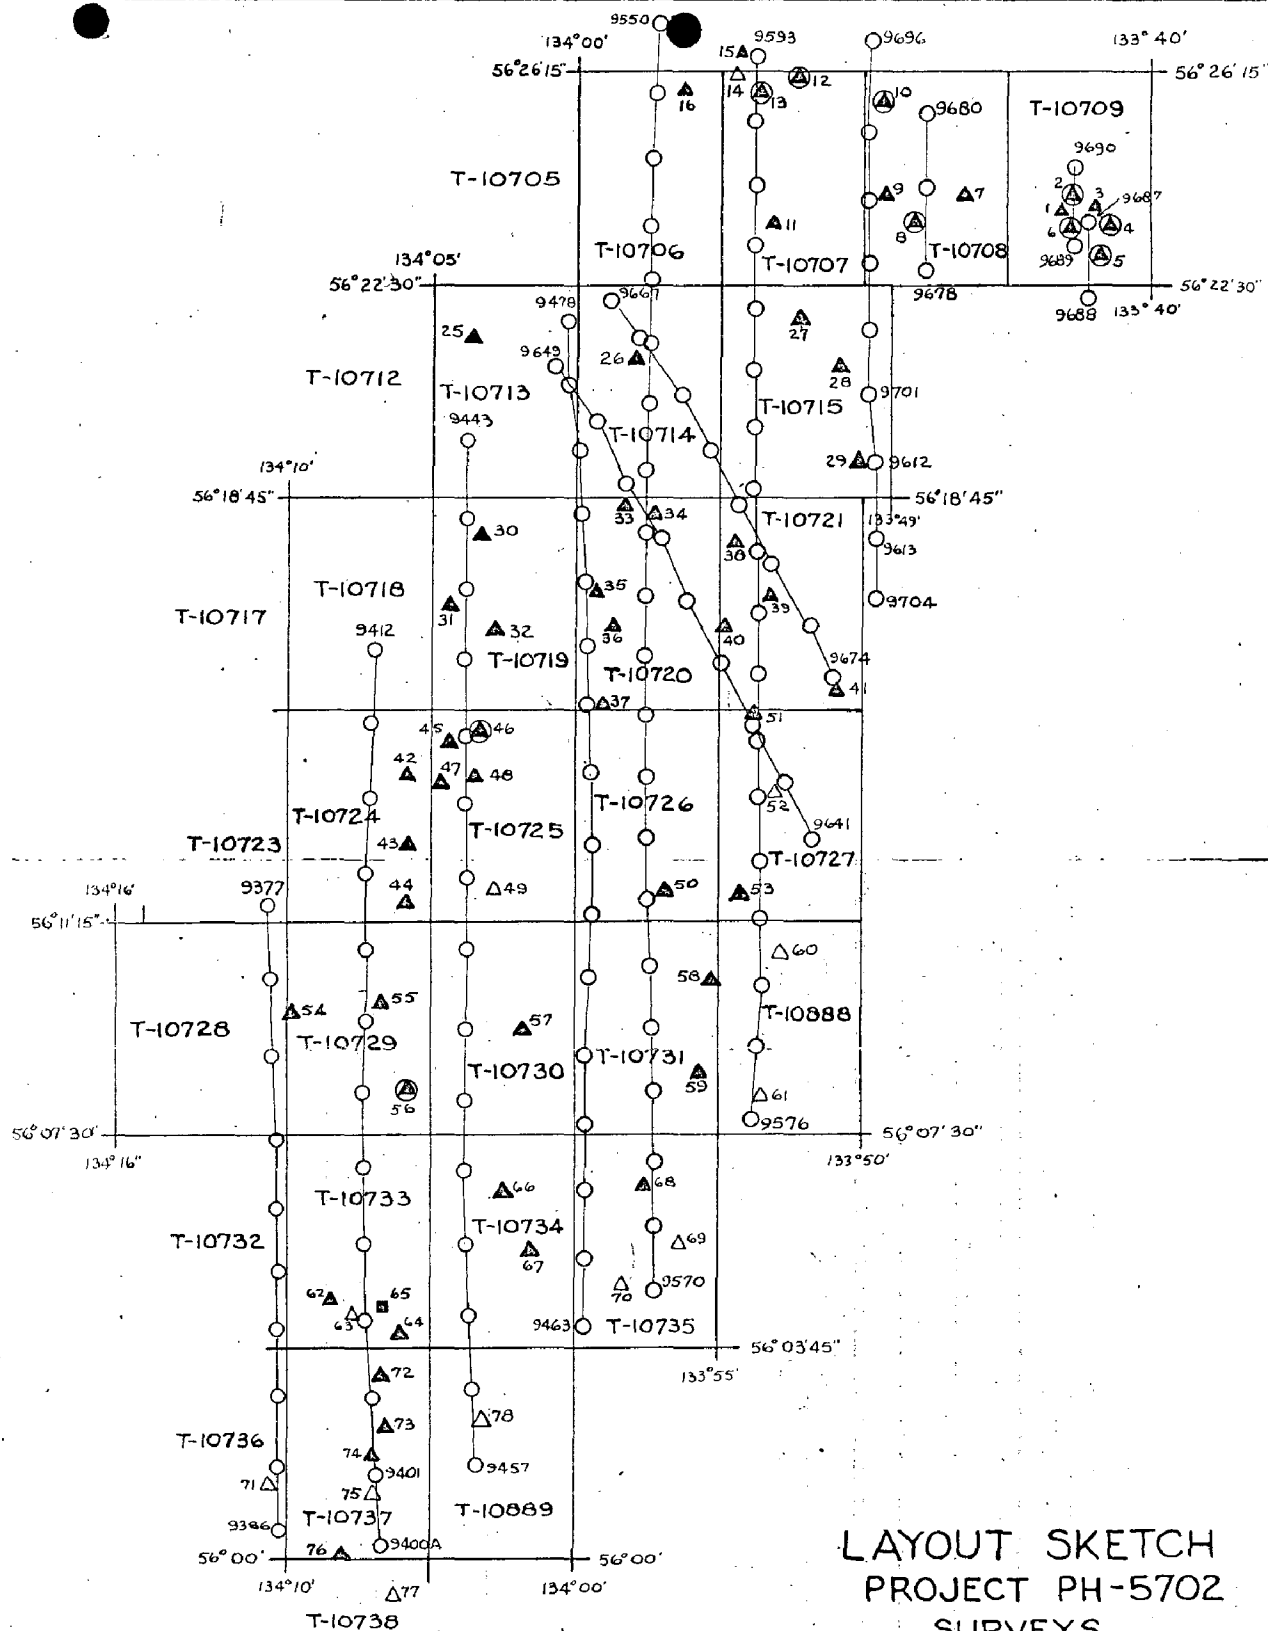
LAYOUT SKETCH PROJECT PH-5702 SURVEYS

- Single lens office photographs
- ▲ Control station identified
- ⊗ Control station not held in plot
- △ Control station office identified
- Recoverable topo with field position

A sketch showing the layout of the surveys, distribution of control and photograph centers is attached to this report.

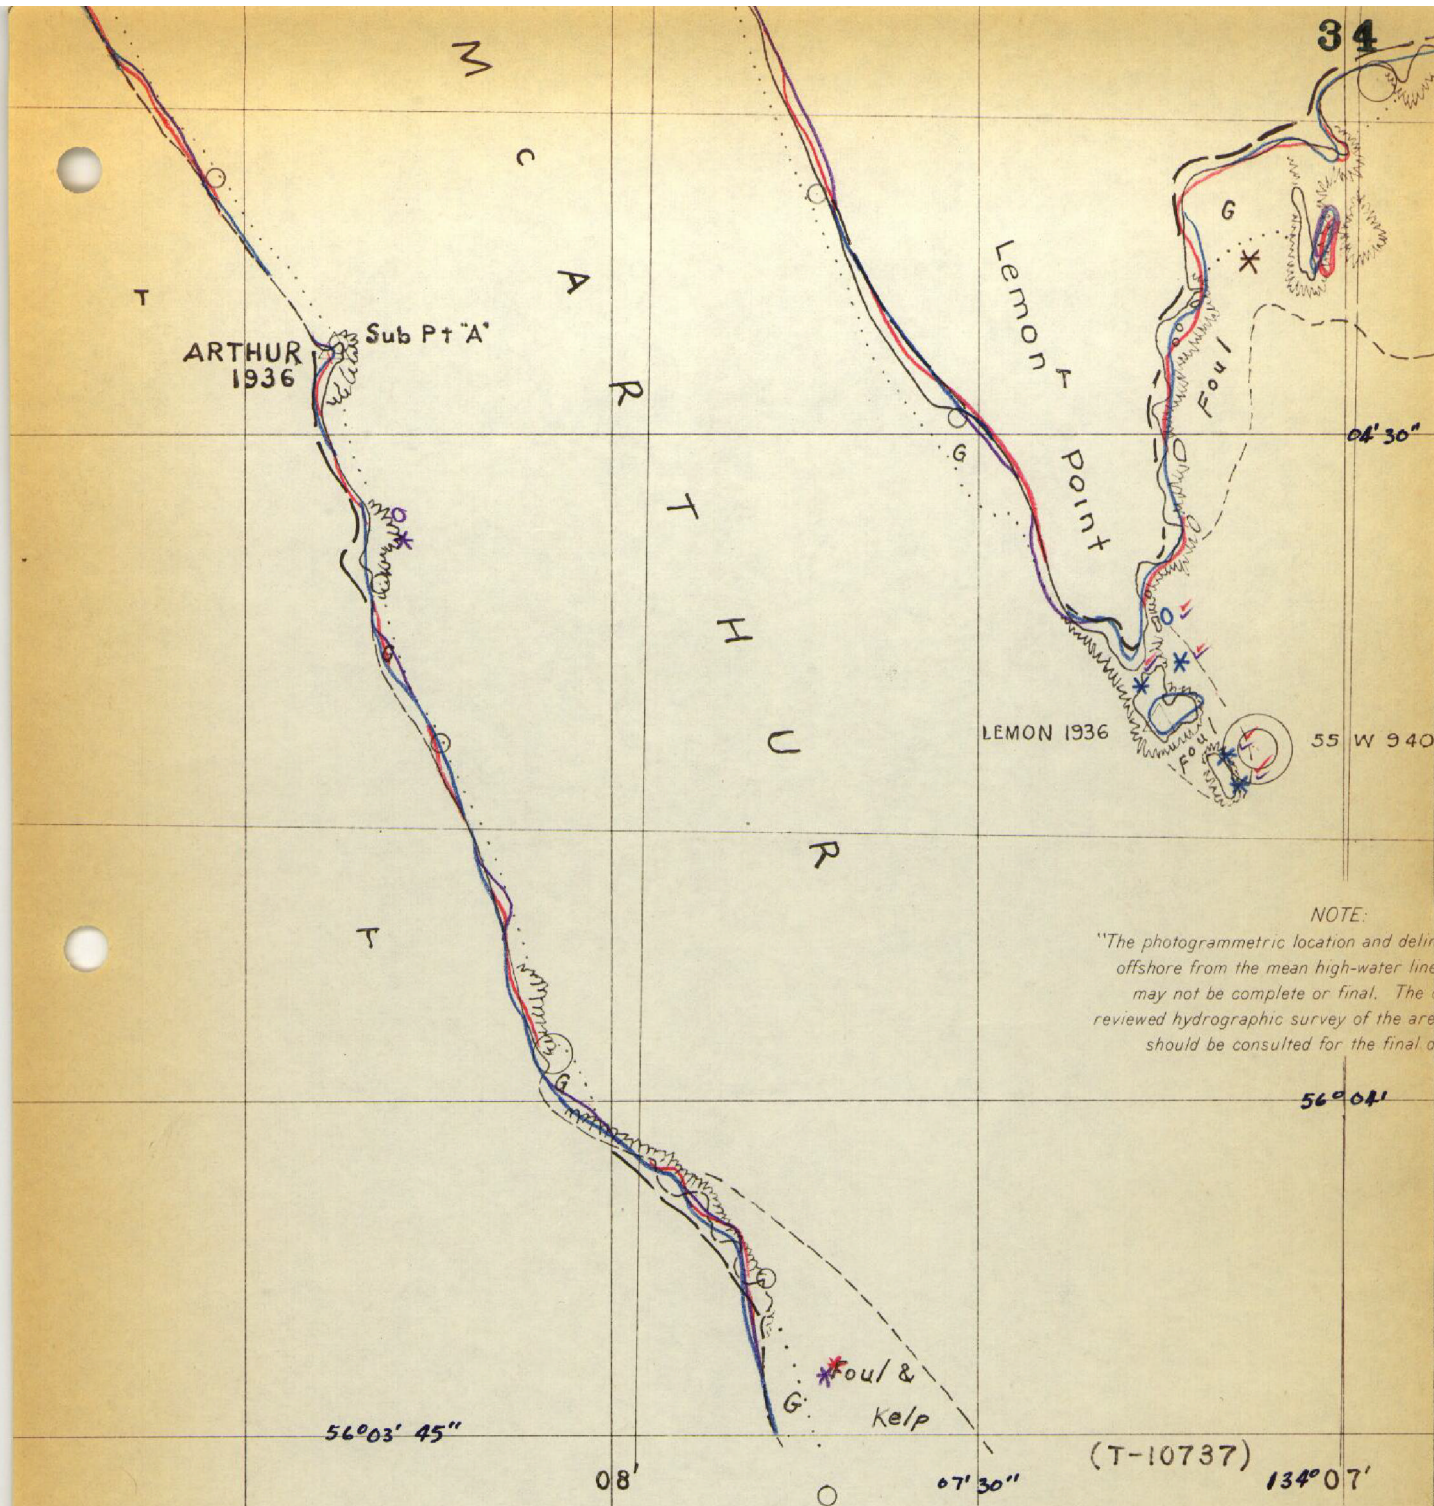
COMPARISON PRINT

overable horizontal control station of third-order or higher accuracy
 overable horizontal control station of less than third-order accuracy
 roximate mean lower low water line
 heavy shoreline defines the approximate mean high water.

NOTE: Unlabeled circles are photogrammetric plot points, not map features

An ozalid comparison print, pages 31 through 35, showing differences noted in Items 62 through 65, is bound with the original of this report.

It was noted that most of the shoreline and many of the offshore features are approximately the same on the hydrographic surveys as on the topographic surveys. Where this is the case, only blue was used to show the differences between the old survey and T-10733.
