DESCRIPTIVE REPORT

Type of Survey Shoreline (photogrammetric)
Manuscript Nos.
Field No. PH 10000-800 Office No. T-11190, T-11191

Locality Crater Lake1957

to accompany shoreline manuscripts T-11190 and T-11191

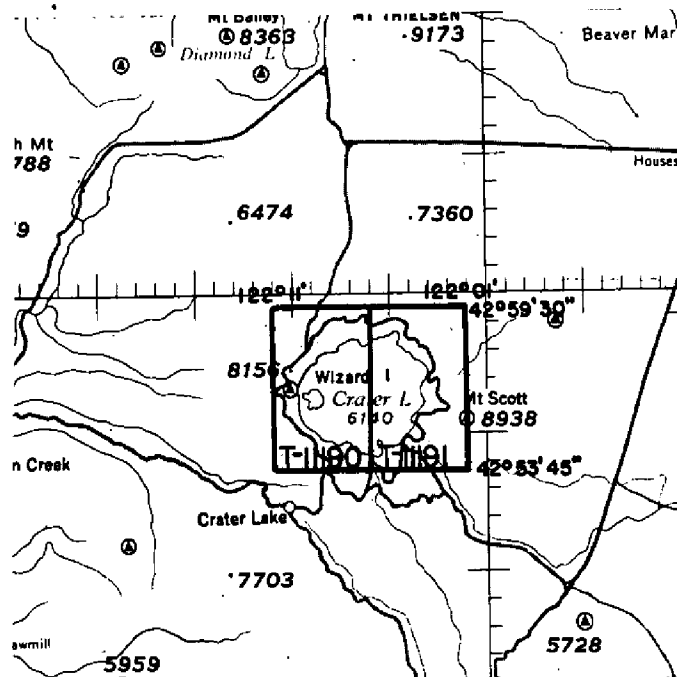
Project 10,000 - 809

Shoreline Mapping

Crater Lake Oregon

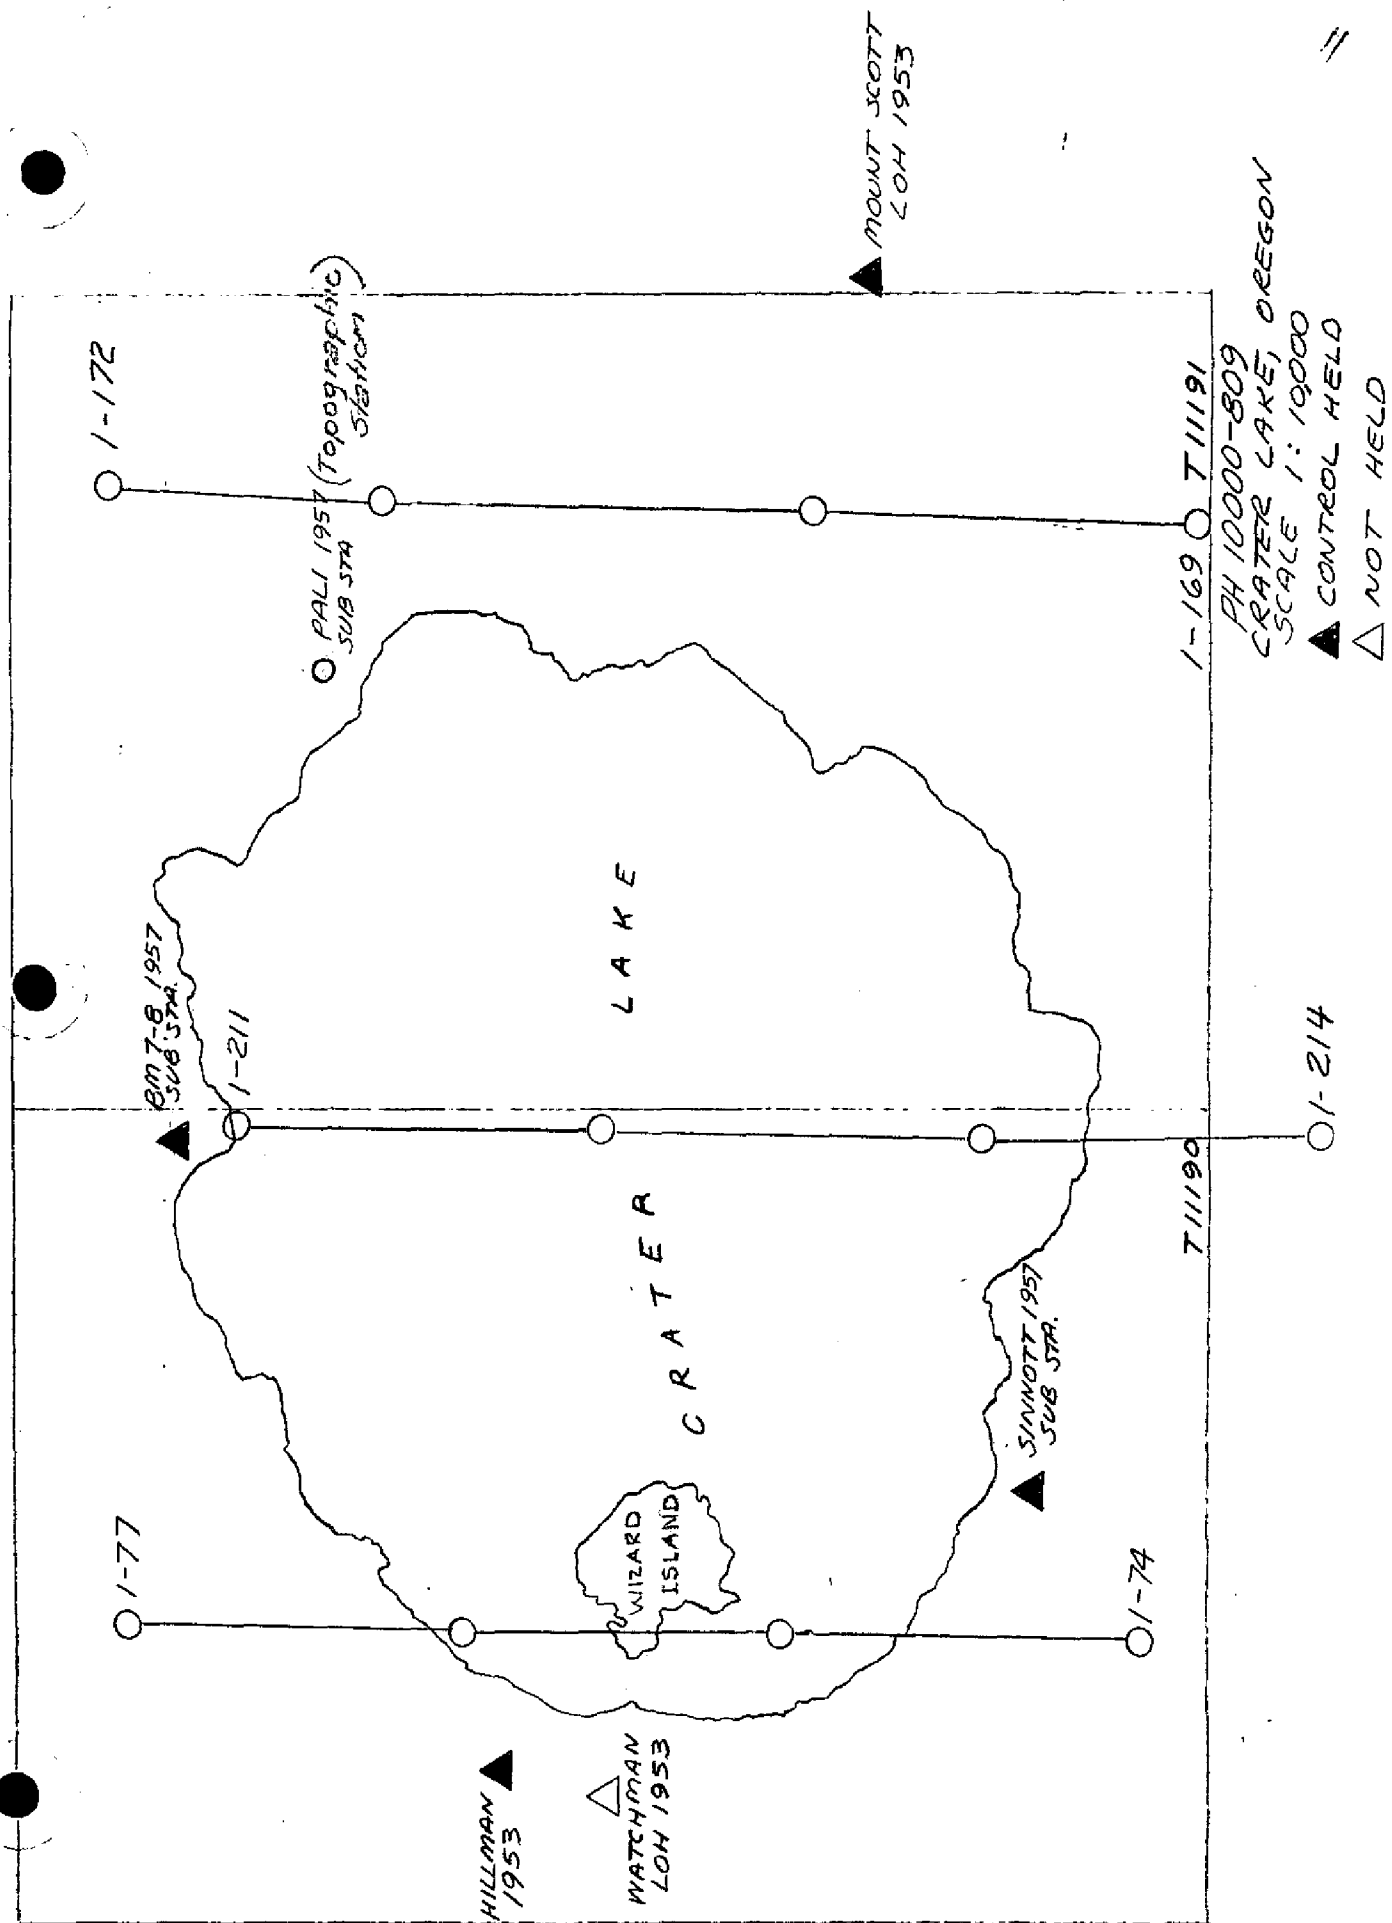
The C-8 stereoplanigraph was used for bridging two strips of Geological Survey photography. Strip No. 1 consisted of photos 1-74 through 1-77, and strip No. 2 consisted of photos 1-169 through 1-172. A third strip falls in between strips No. 1 and No. 2. Models in this third strip will be set up for detailing ~~and~~ bridge points established while stereotriangulating strips No. 1 and No. 2.

Strip No. 1 had 4 control stations, two of which had sub stations. Due to the short length of the bridge (3 models) a straight line mathematical adjustment was performed. An additional supplemental shift was necessary. Station Watchman L O H 1953 did not hold by approximately 38 feet. The station was difficult to identify in the stereoplanigraph. All other control together with the bridge points are believed to be within the necessary accuracy requirements.

Strip No. 2 had a minimum amount of control. There were two stations, with one of the stations having two sub stations. A straight line mathematical adjustment was performed due to the minimum control availability and the short length of the bridge (3 models). *Mt. Scott L O H, 1953 was very difficult to see in the stereo model. The station was not occupied by the field party - see field report. The most likely stereo instrument location of the station was used in adjusting strip No. 2. As a check, model 1-214 and 213 was set up on bridge points dropped in strips No. 1 and No. 2 (near Mt. Scott L O H). All the bridge points held thus indicating that the stereoplanigraph location of Mt. Scott L O H was correct.
