DESCRIPTIVE REPORT

Type of Survey Planimetric

Field No. Ph-5907 Office No. T-11700
CLASS II & III (Refer to page 6)

Locality Mockhorn Channel

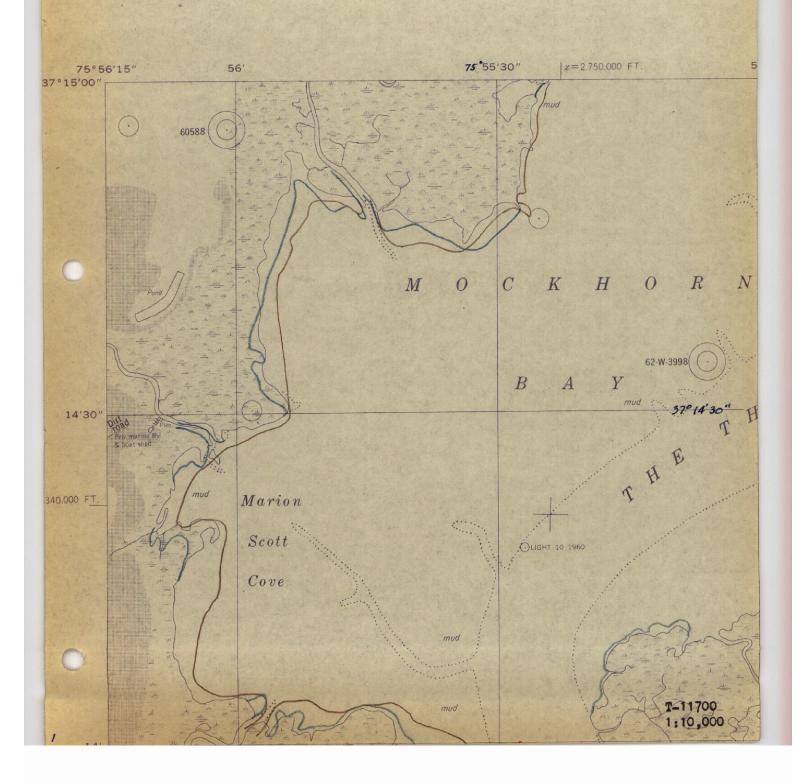
COMPARISON PRINT

Blue = T-11246 Brown = USGS

An ozalid comparison print, showing differences noted in Par. 62 and 63, is bound with the original of this report.

Very few differences between the two maps were found to exist.

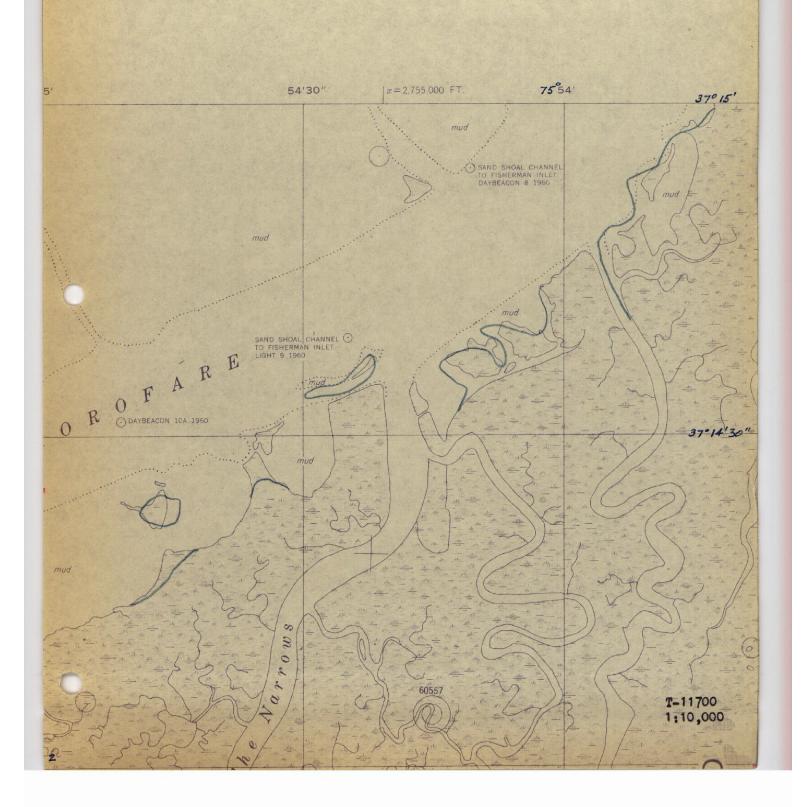
COMPARISON PRINT

Blue = T-8181 and USGS Brown = USGS where it differs from T-8181
