Form 504	
U. S. DEPARTMENT OF COMMERCE	
COAST AND GEODETIC SURVEY	
DESCRIPTIVE REPORT	
Type of Survey	Shoreline
Field No. Ph-5907	Office No. T-11703
CLASS II & III	
LOCALITY	
State	VIRGINIA
General locality	Cape Charles
Locality	Smith Island
19 59 - 62	
CHIEF OF PARTY	
George F. Wirth, Photo Party 723	
W. E. Randall, Baltimore District Officer	
Alfred C. Holmes, Director, AMC	
LIBRARY & ARCHIVES	
DATE	1 JUL 1975

CAPE CHARLES TO ASSATEAGUE, VA

SUMMARY TO ACCOMPANY
DESCRIPTIVE REPORT T-11703

This 1:10,000 scale shoreline manuscript is one of 43 maps that comprise Project PH-5907, Cape Charles to Assateague, Virginia. The project diagram on page 5 indicates the location of this map in the project.

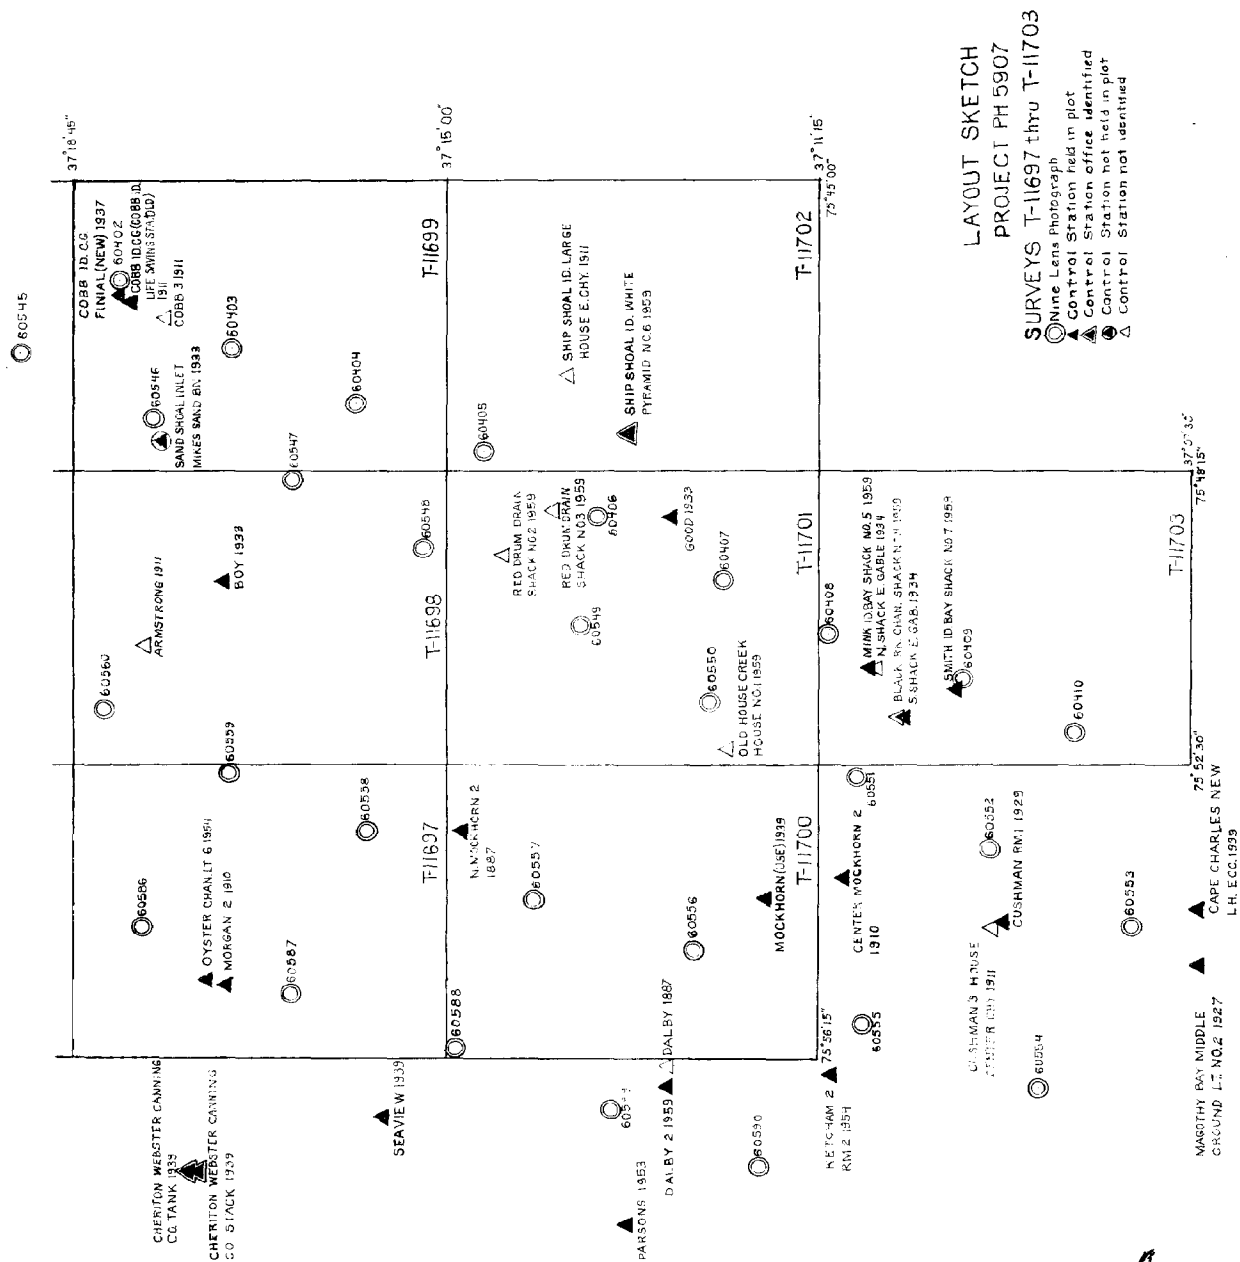
A sketch showing the layout of the surveys, distribution of control, and photograph centers is attached to this report.

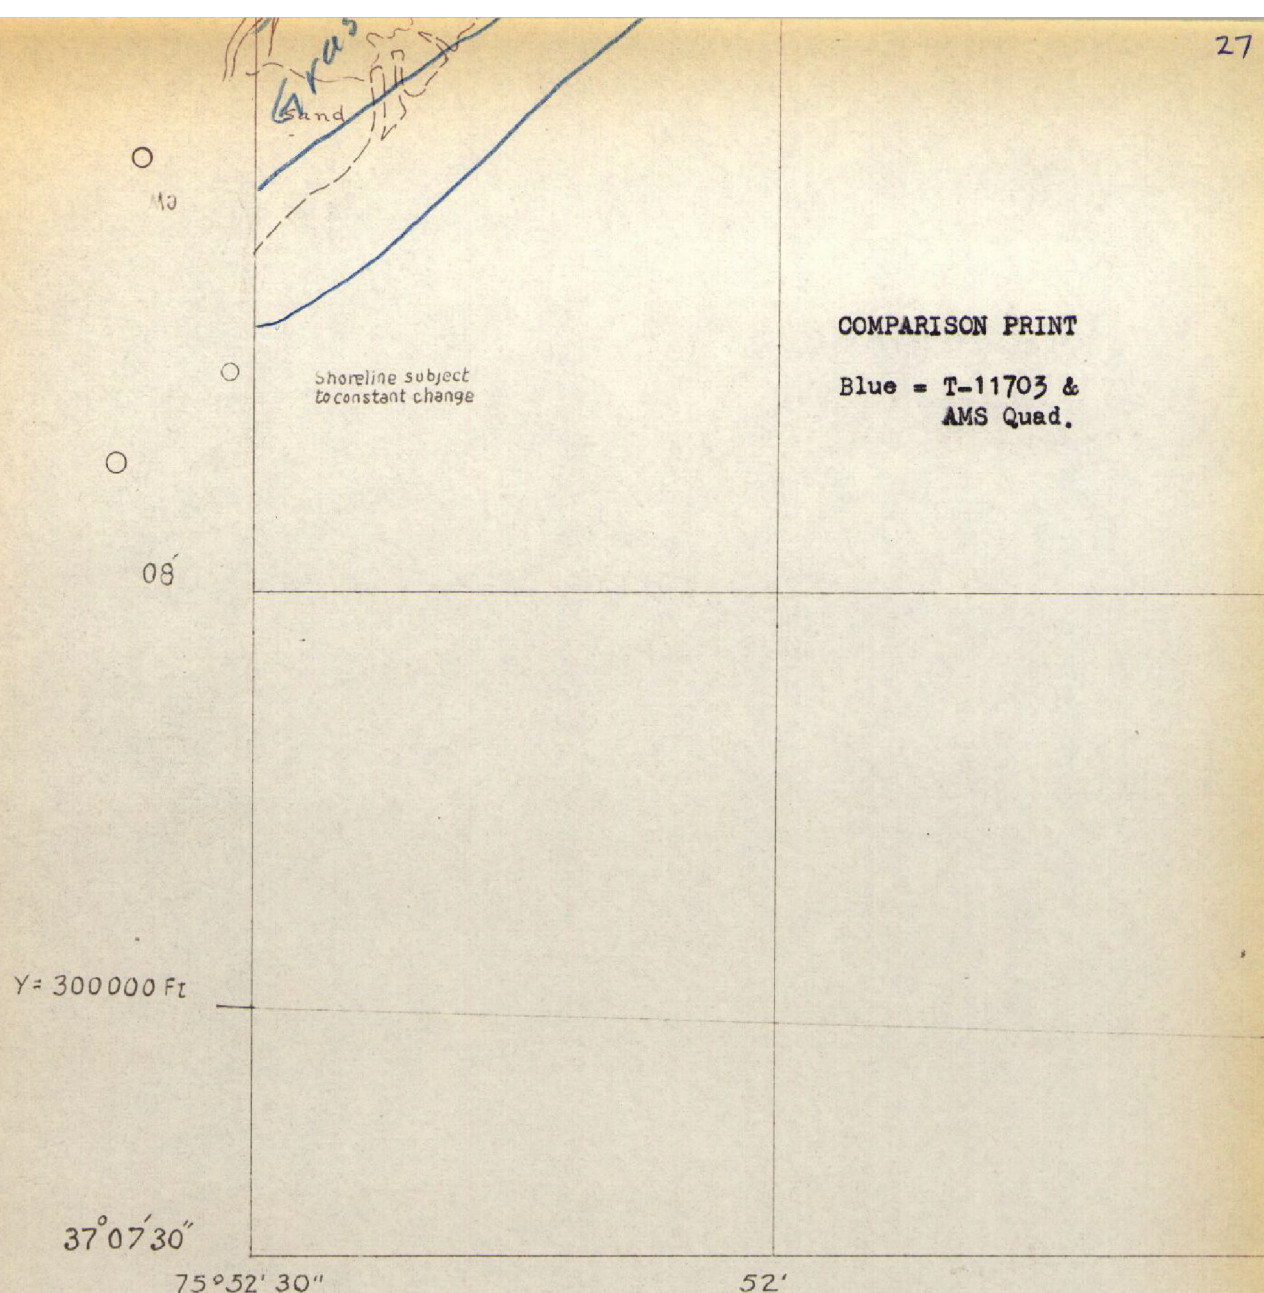
T-11703
1:10,000

Class II Map, except Atlantic Ocean shoreline, which is Class III

This map is based on aerotriangulation that meets the requirements for National Standards of Map Accuracy and a pre-compilation field inspection of the mapping photography. It is subject to correction by field edit and final review. Landmarks and aids to navigation were investigated during field inspection.

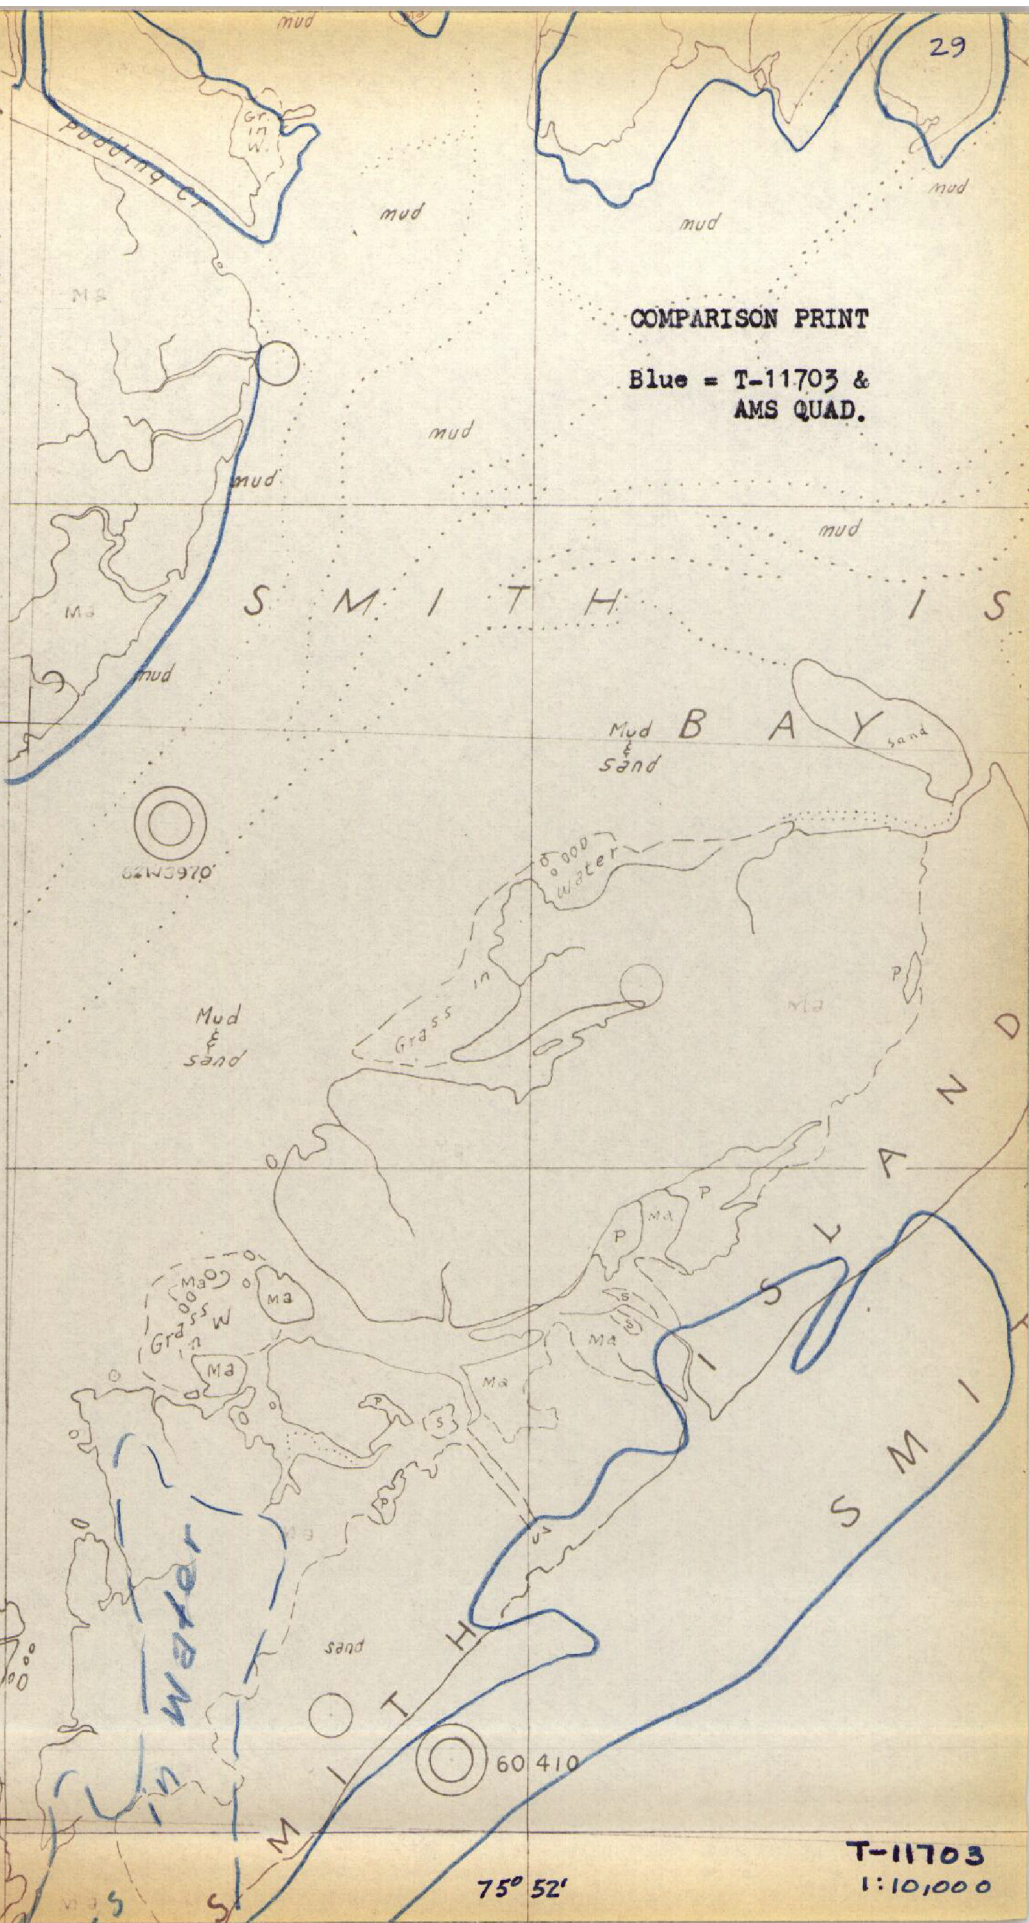
COMPARISON PRINT

Blue = T-11703 & AMS QUAD.

An ozalid comparison print, showing differences noted in Par. 62, is bound with the original of this report.
