Form 504	
U. S. DEPARTMENT OF COMMERCE	
COAST AND GEODETIC SURVEY	
DESCRIPTIVE REPORT	
Type of Survey	SHORELINE (Photogrammetric)
Field No.	Office No. T-11806
LOCALITY	
State	Mississippi
General locality	Mississippi Sound
Locality	Ocean Springs
19 66 - 1967	
CHIEF OF PARTY	
J. Bull, Director, Atlantic Marine Center	
LIBRARY & ARCHIVES	
DATE

JOB PH-6625  
MISSISSIPPI SOUND  
MISS.  
SHORELINE MAPPING  
1:10,000 SCALE

SUMMARY TO ACCOMPANY  
DESCRIPTIVE REPORT T-11806

REVIEW REPORT T-11806  
SHORELINE  
OCT. 1968

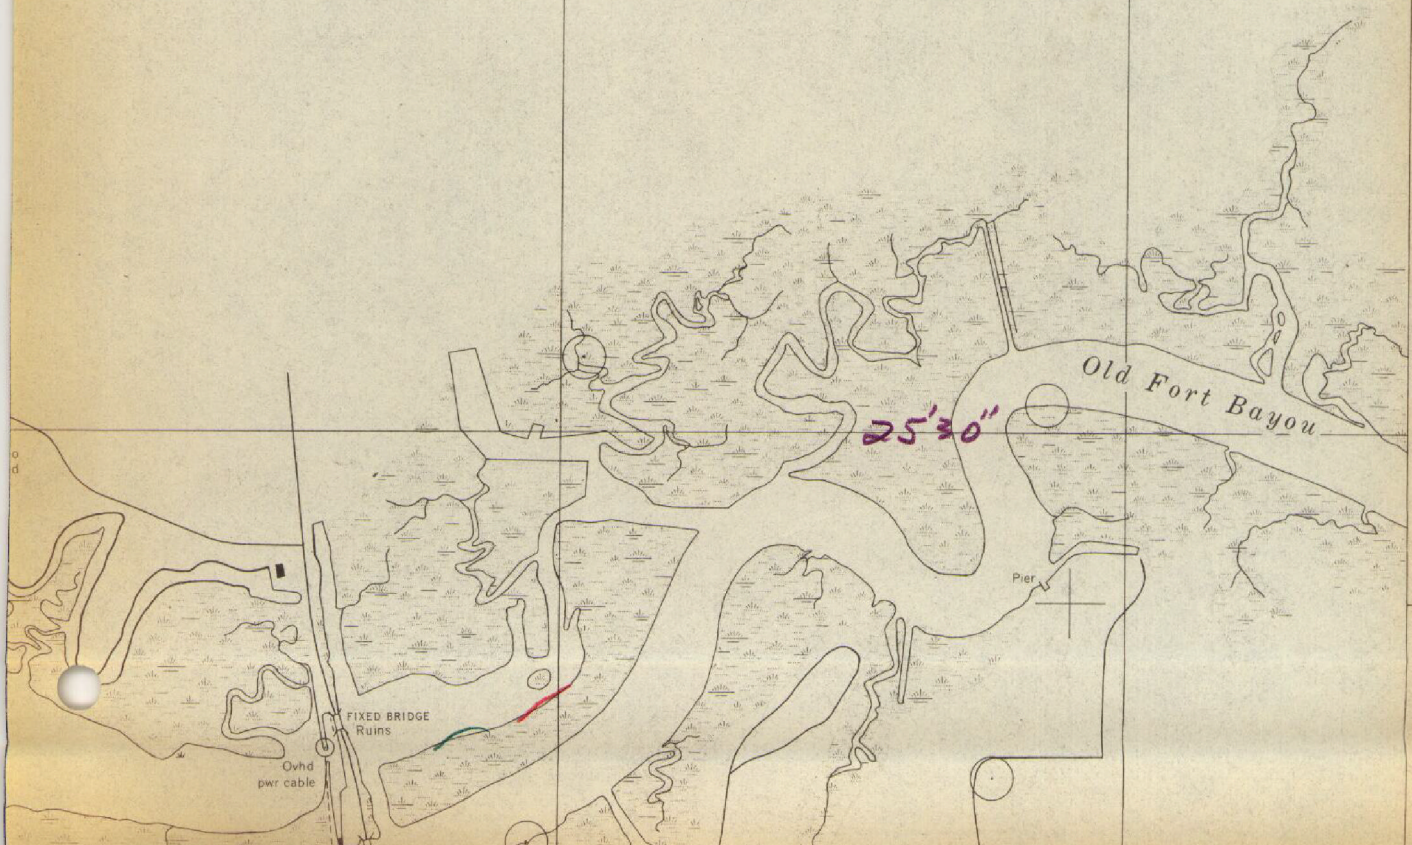
shoal

Wreck  
(5') on T-9378

A = Not on 876 S.C.

Not on 9378

Marine Ry  
Piling  
shoal  
Marine railway  
T-4 Piles

A = Not on T-9378

Area under construction

93(95)

Piles on T-9378

Point Caddie

STACK 1967  
steel ht = 96 (99)

Pier end in ruins

Pier ruins

(b) Shoreline changes in the vicinities of:  
latitude  $30^{\circ} 24.5'$ , longitude  $88^{\circ} 52.2'$  (page 29)  
"  $30^{\circ} 24.1'$ , "  $88^{\circ} 51.6'$  (page 29)  
"  $30^{\circ} 23.75'$ , "  $88^{\circ} 51.5'$  (page 29)  
"  $30^{\circ} 24.6'$ , "  $88^{\circ} 50.5'$  (page 30)

(2) The T-9378 position for the wreck near  $30^{\circ} 24.62'$ ,  $88^{\circ} 52.4'$  (page 29) is about 100 meters northwest by west of the T-11806 position. It is not visible on the photographs, but was located by field editor by sextant fix with a check angle.

(6) The heights of the two landmarks are slightly different from those in 1954; stack at latitude  $30^{\circ} 23.8$ , longitude  $88^{\circ} 51.64$  (page 29) is 96 (99) against 93 (95), and the Water Tank at latitude  $30^{\circ} 24.64$ , longitude  $88^{\circ} 49.62$  (page 31), is 135 (160) against 135 (155) in 1954.

(a) The shoreline change at Point Caddie, near latitude  $30^{\circ} 24'$ , longitude  $88^{\circ} 51.6'$  (page 29) is from the field editor due to construction since photography. An "Overlay to Accompany Boat Sheet (HFP 742 10-2-66) H-8922" shows some differences with T-11806. The Comparison Print reflects the Overlay where it applies. The photo hydro support party checked this area in Nov. 1968 at the request of the final reviewer. \* See below

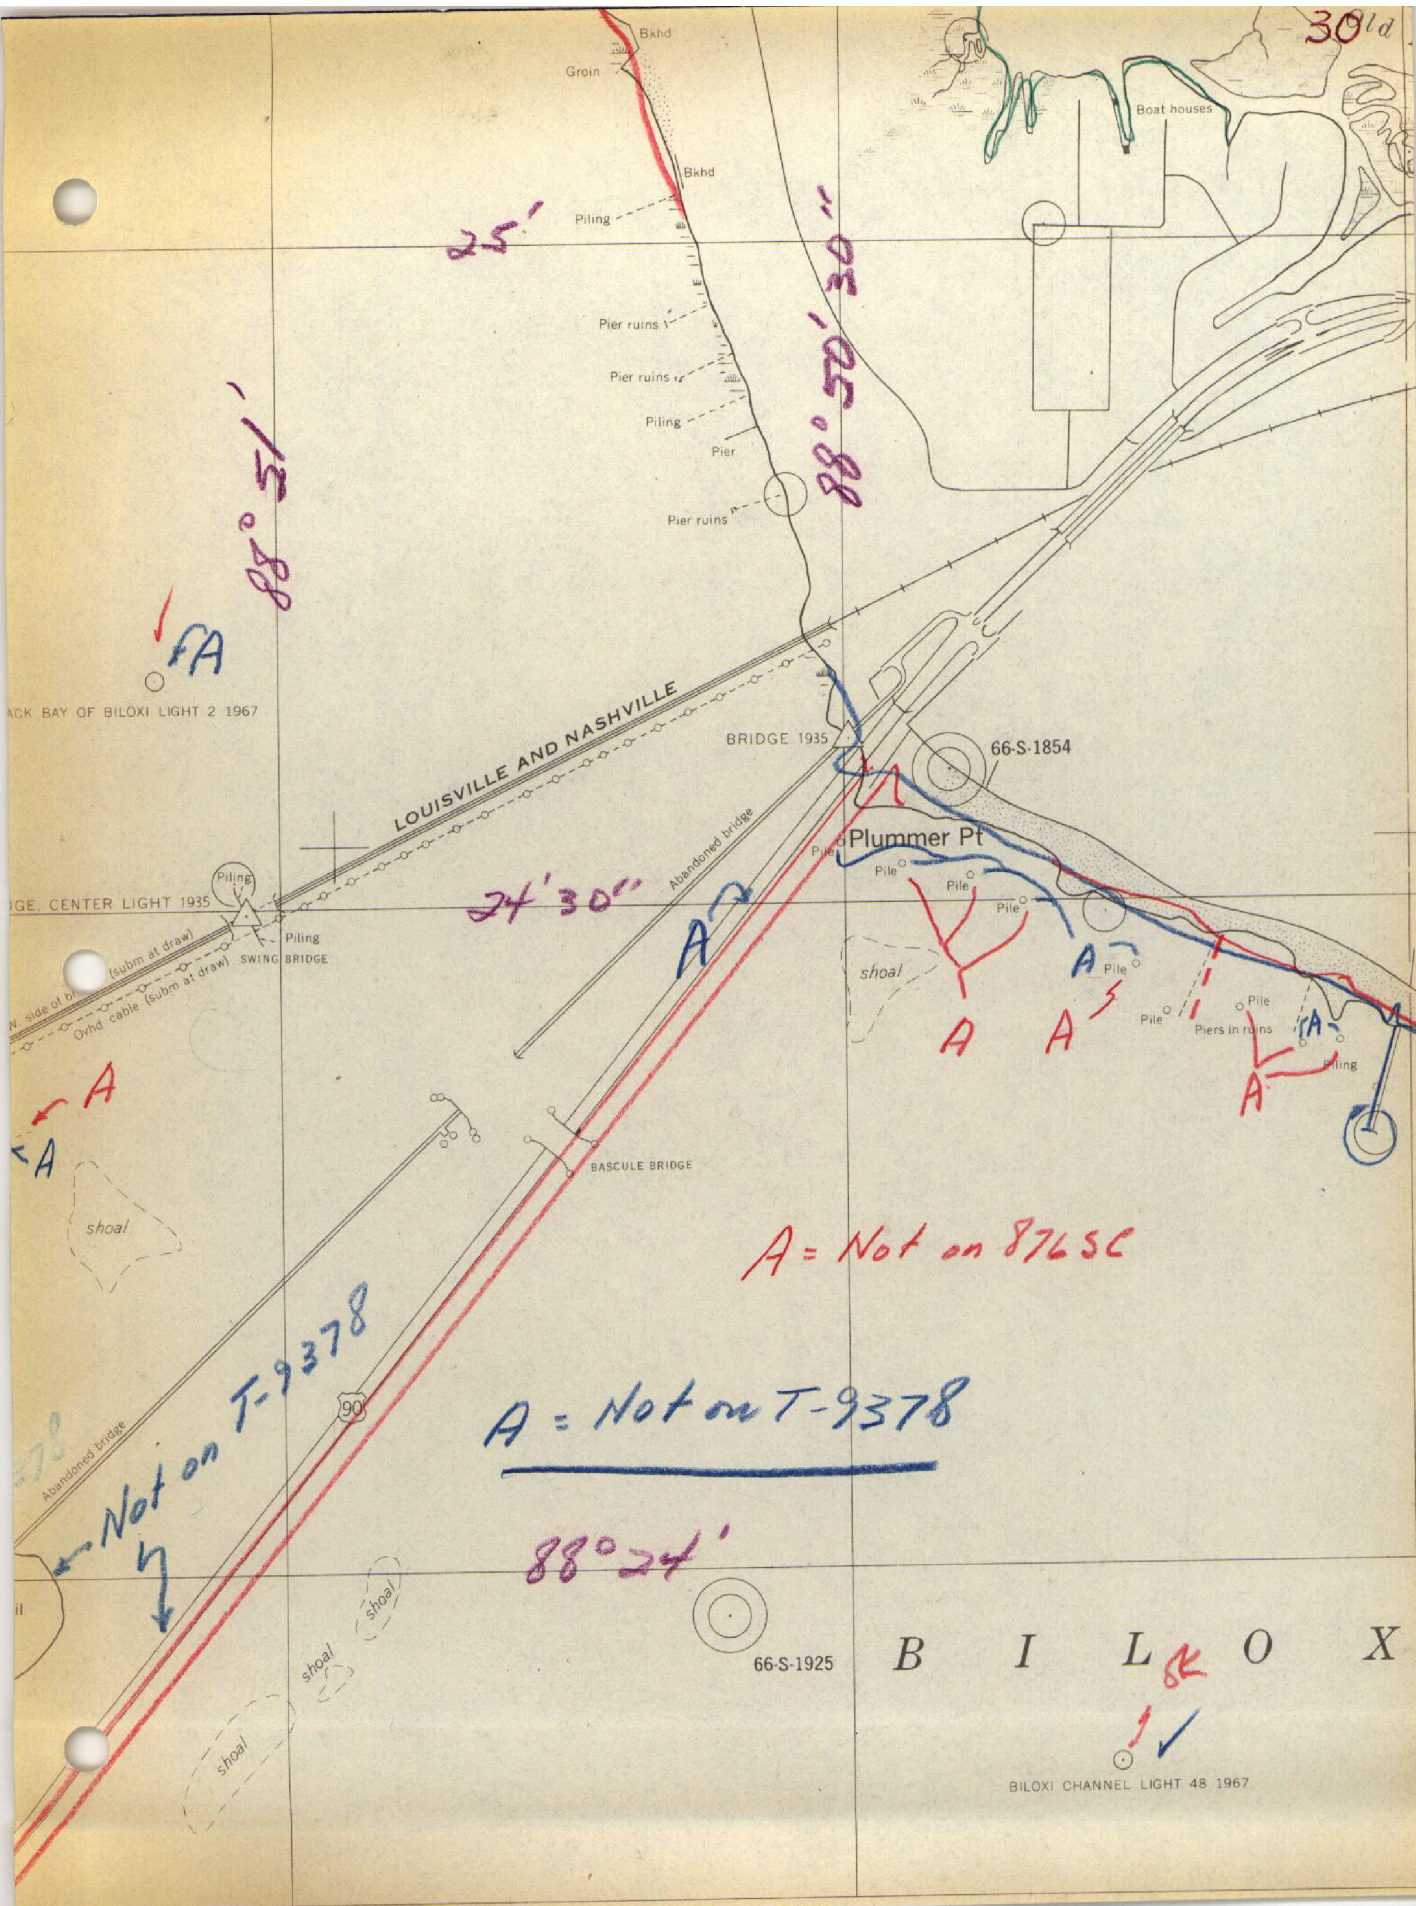
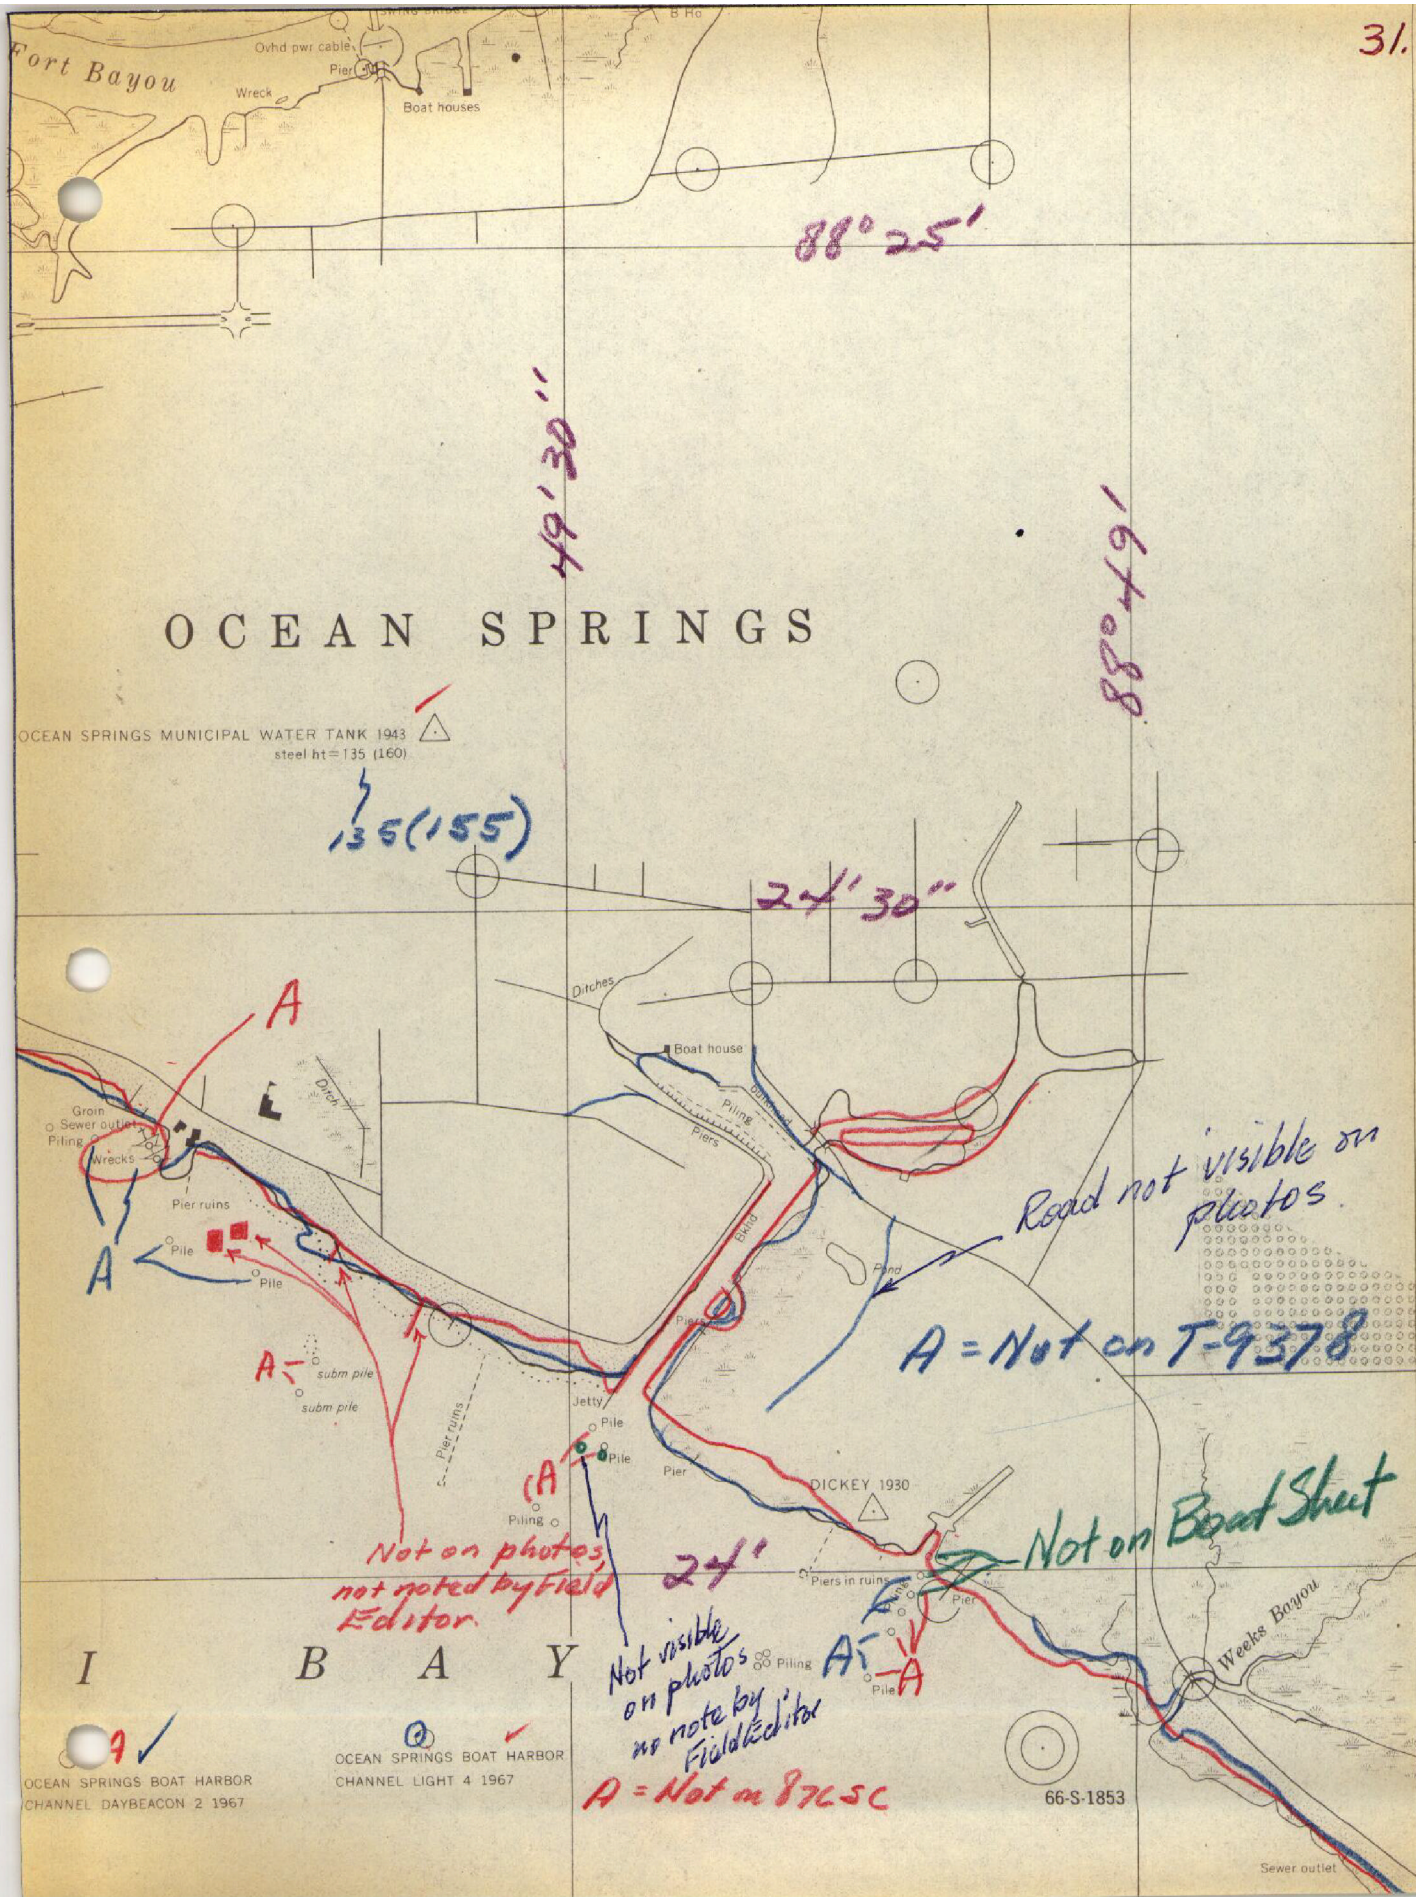
An ozalid Comparison Print (pages 26 through 31), which shows the differences noted in Items 62, 64 and 65, is included with the original copy of this report.

T-9378 S/2 differences with this map are on the Comparison Print in blue.

The boat sheet differences with this map are shown on the Comparison Print in green.

The chart differences with T-11806 are shown on the Comparison Print in red.
