## DESCRIPTIVE REPORT

DESCRIPTIVE REPORT
Type of Survey ShoreLine (Photogrammetric)
Field No. Office No. T-11953
LOCALITY
State Hawa I I
General locality MOLOKAI
Locality Kaunalu
19.6x°- 1968
CHIEF OF PARTY H. J. Seaborg, Chief of Party P. A. Stark, Photogrammetric Office
LIBRARY & ARCHIVES
DATE

## PROJECT PH-6201

## SHORELINE MAPPING

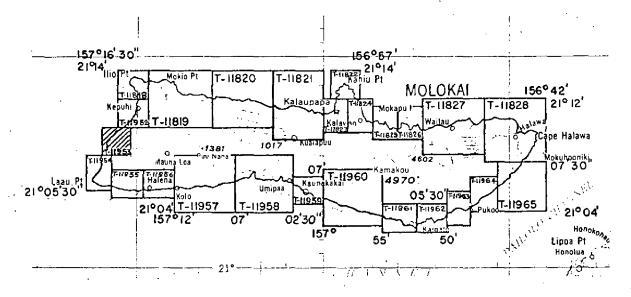
1:5,000 AND 1:10,000 SCALES MOLOKAI ISLAND HAWAII

Shoreline survey T-11953 is one of twenty-five similar surveys in Project PH-6201. The surveys in this project cover the entire coast of Molokai. This survey covers that part of the west coast from Kapuhikani northeastward to Papohaku Beach. See page 5 of this report for the area within the project.
