DESCRIPTIVE REPORT

Type of Survey Shoreline (Photogrammetric)Field No. _____ Office No. T-11961

State HawaiiGeneral locality MolokaiLocality Kamalo Harbor19 61 - 1967²

1:5,000 AND 1:10,000 SCALES
MOLOKAI ISLAND HAWAII

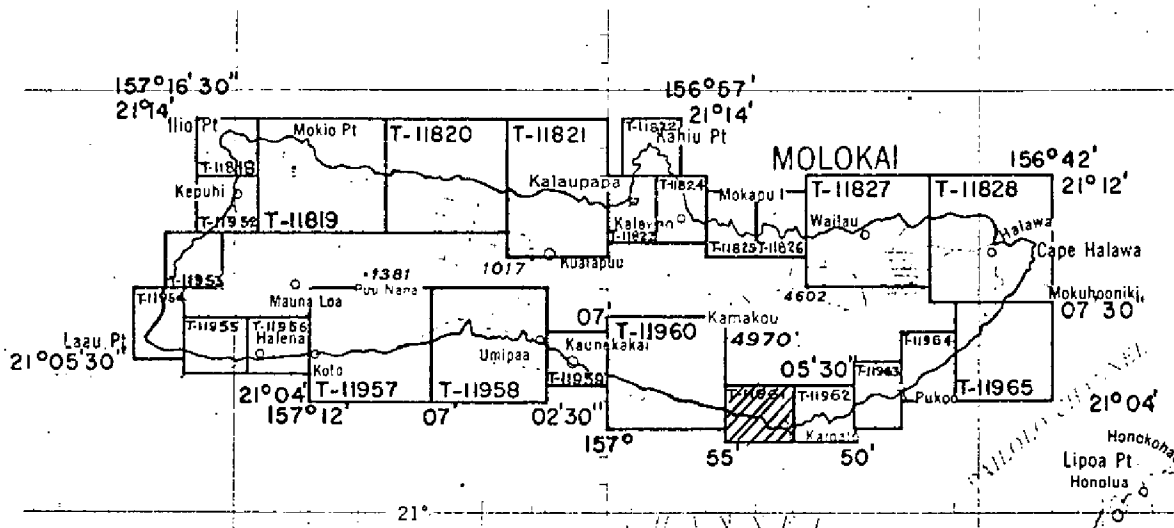
PROJECT PH-6201

SHORELINE MAPPING

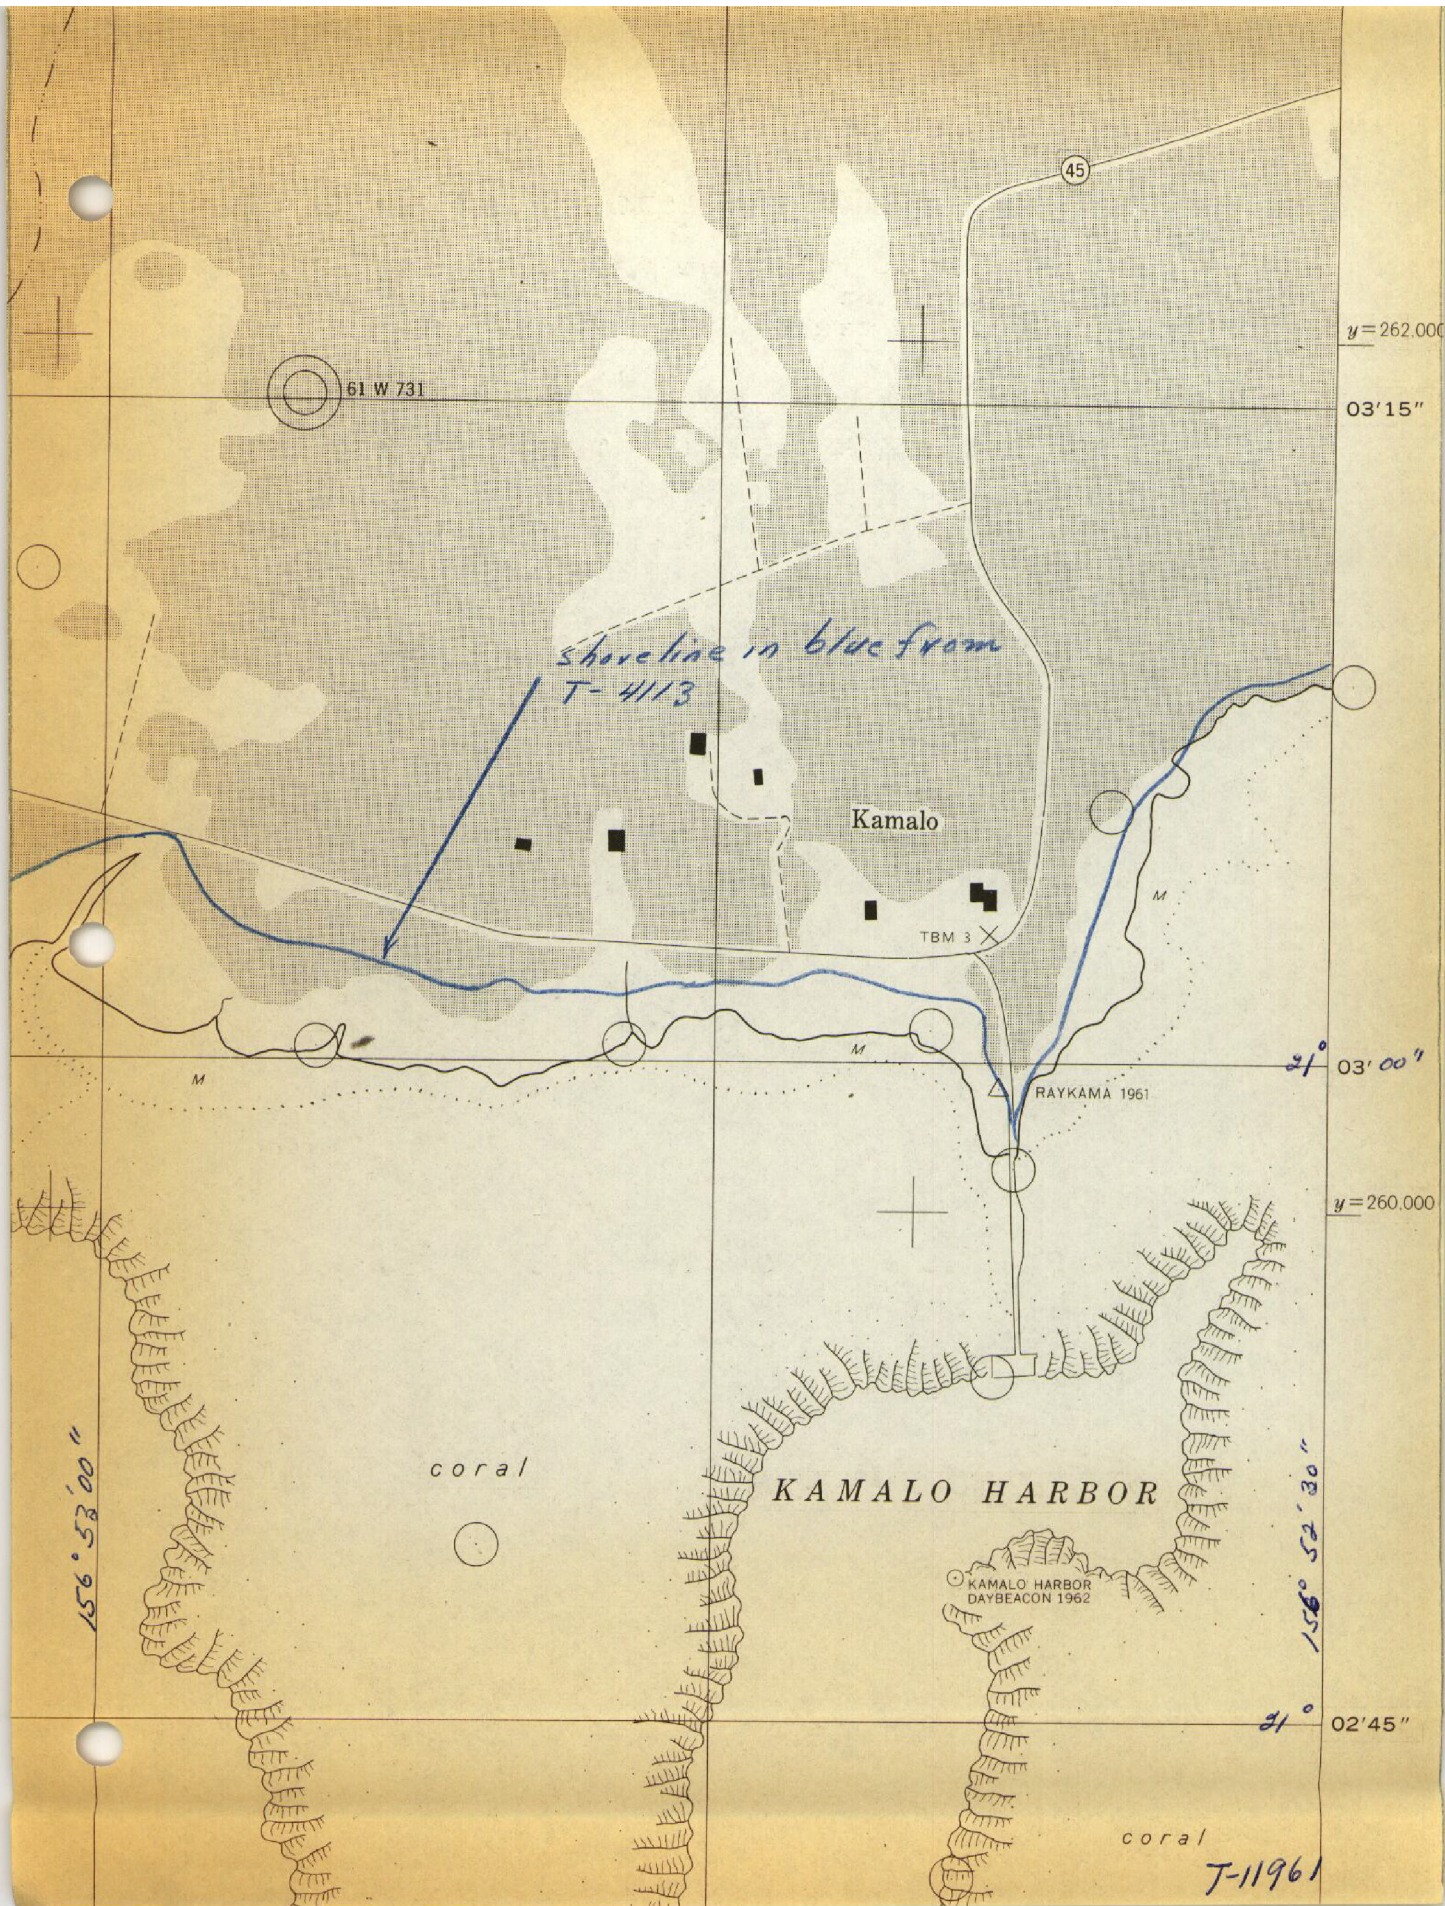
Shoreline from T-4113

Comparison was made with a copy of registered survey T-4113, 1:5,000 scale, dated January 1925. The shoreline of these surveys is not in good agreement. The difference has been indicated on the comparison print in blue.
