Form 504	
U. S. DEPARTMENT OF COMMERCE	
COAST AND GEODETIC SURVEY	
DESCRIPTIVE REPORT	
Type of Survey	<u>Shoreline</u>
Field No.	<u>PH 6309</u>
Office No.	<u>T-12437, T-12438</u> <u>T-12440</u> <u>T-12442-12562</u>
LOCALITY	
State	<u>North Carolina</u>
General locality	<u>Outer Banks</u>
Locality	<u>Hatteras Island</u>
<u>1963-1965</u>	
CHIEF OF PARTY	
<u>J. E. Waugh</u> <u>Division of Photogrammetry, Wash, D. C.</u>	
LIBRARY & ARCHIVES	
DATE	<u>1964-1966</u>

SUMMARY TO ACCOMPANY DESCRIPTIVE REPORT
T-12437, 12438, 12440 ~~and 12441~~ and T12562
PROJECT 21068

FIELD INSPECTION REPORT
MAPS T-12437 THROUGH T-12442
PROJECT PH-6309, 21068

AEROTRIANGULATION REPORT
Cape Hatteras, North Carolina
PH-21068

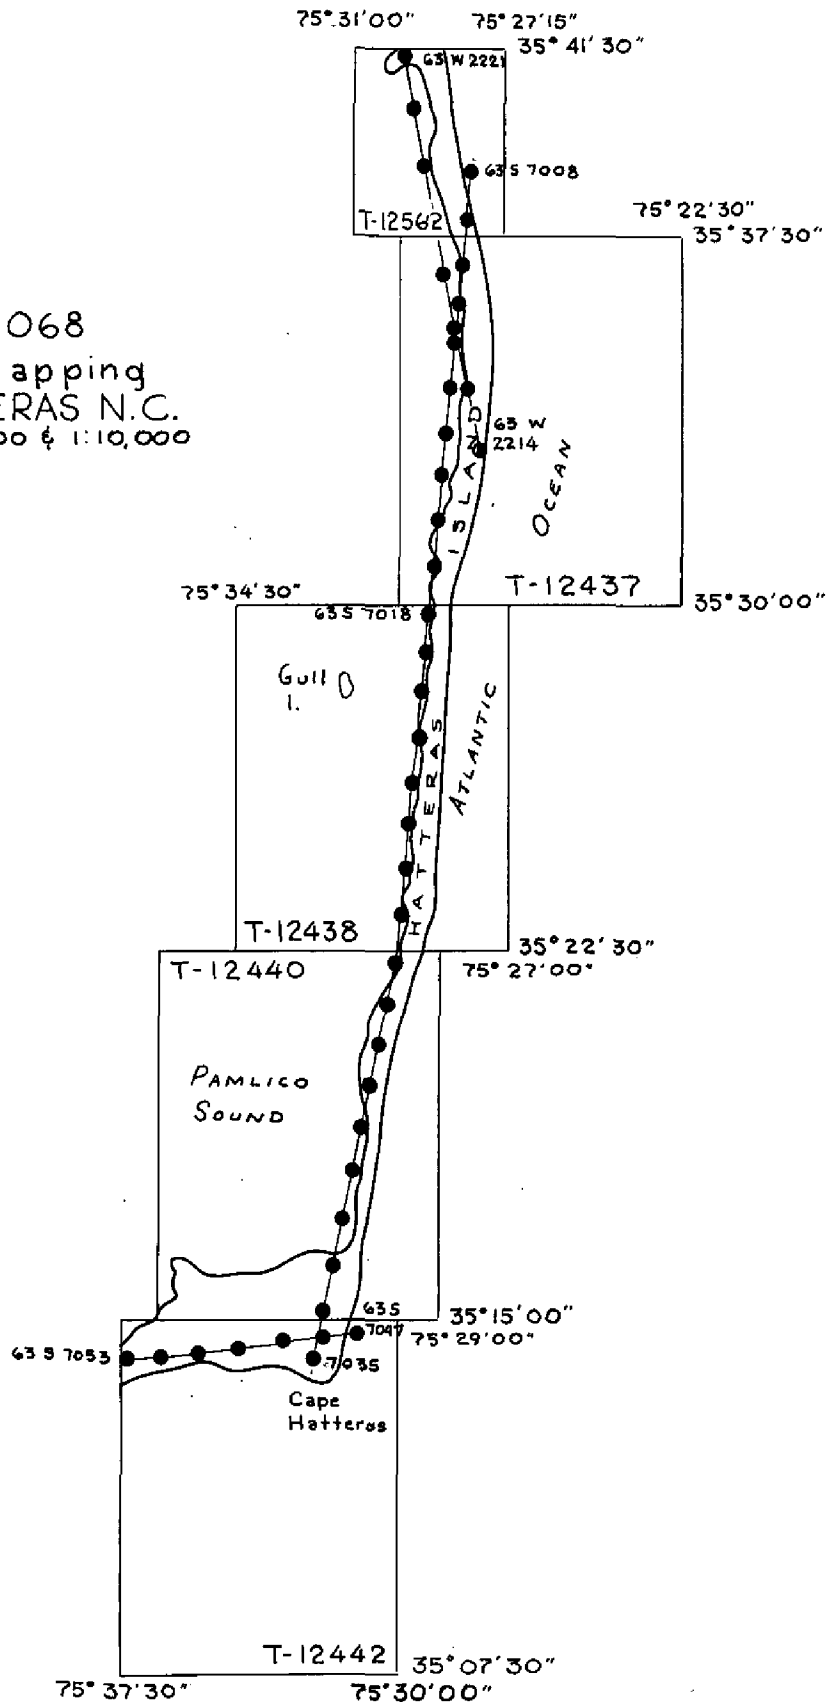
Project 21068
 Shoreline Mapping
 CAPE HATTERAS N.C.
 SCALE 1:20,000 & 1:10,000
 APRIL 1964

This report discusses the compilation of ~~four of five~~ ~~T-12562~~ sheets covering the Outer Banks of North Carolina from the southern edge of Pea Island, south to Cape Hatteras. (see Layout Sketch)

Junctions were made with adjoining sheets. (see Layout Sketch for T-sheet arrangement.)
