U. S. COAST AND GEODETIC SURVEY
DEPARTMENT OF COMMERCE

DESCRIPTIVE REPORT

Topographic Sheet No. 1953.

Washington Sound.

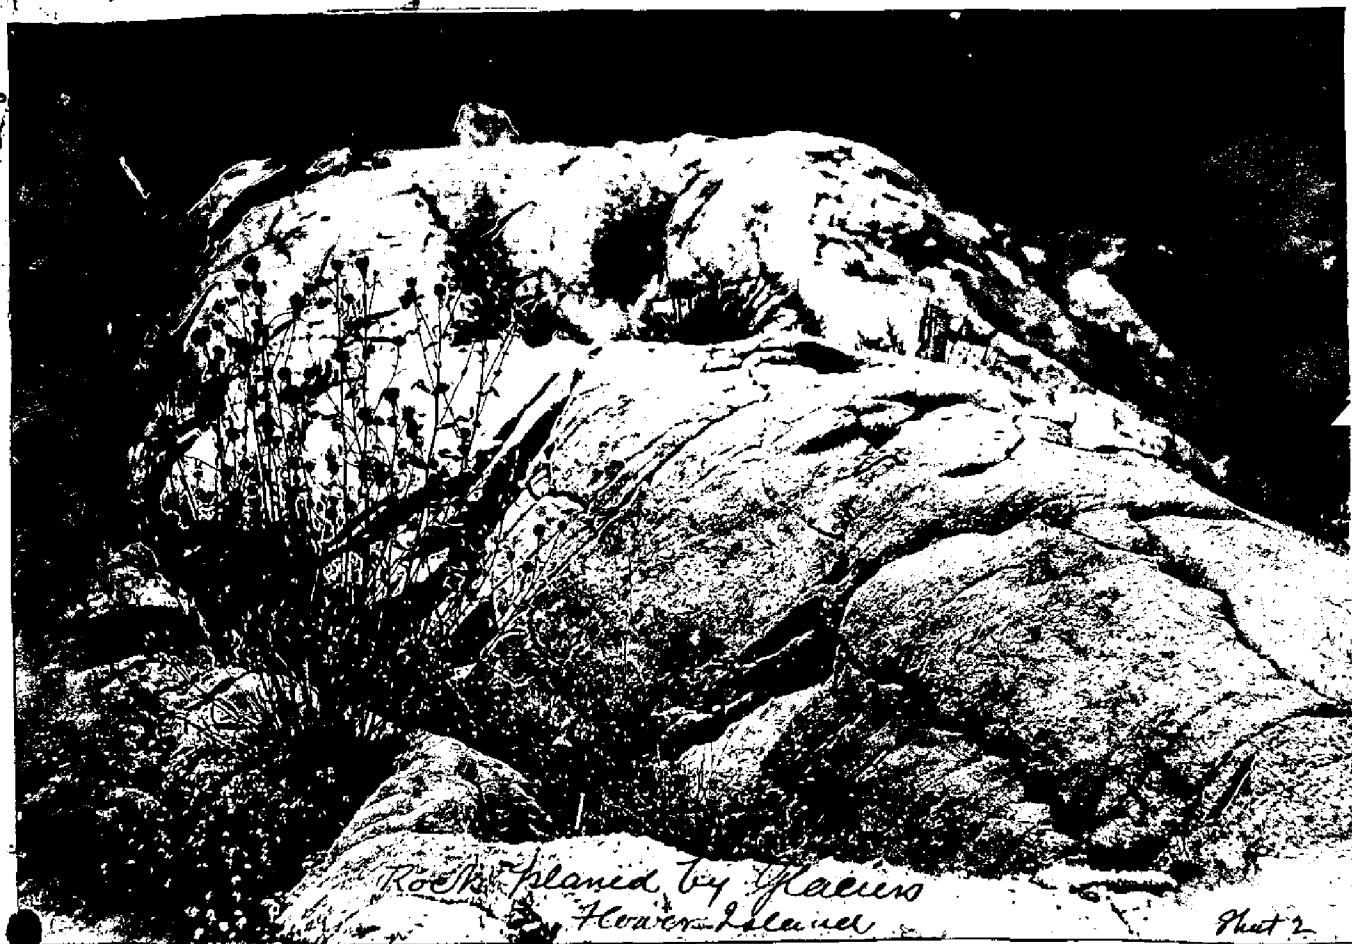
Plate 2

This photograph is of the rocks on the N.E. part of Flower Island, but the same markings are seen every where, from Hopy Pass to Boulder Id. On all the small islands & rocks, and along the west shore of Hopy Sound. Probably the most conspicuous are at a Tumow, where the grooves

are cut very deep, as much as 10 feet. Another characteristic of these markings is that they appear most conspicuously on the East and N.E. faces of all the shores.

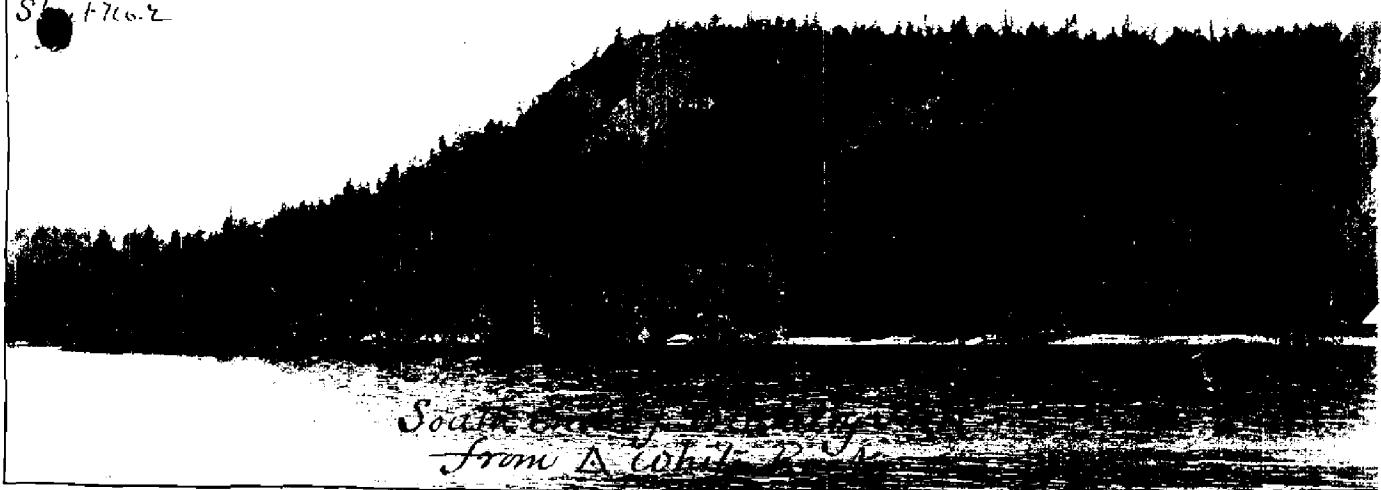
South end
from White Rock

The S. W. End of the Island as seen from White Rock, in Thatcher Pass is represented in the two prints on this page, - the second taking the N.W. point of Decatur Island.

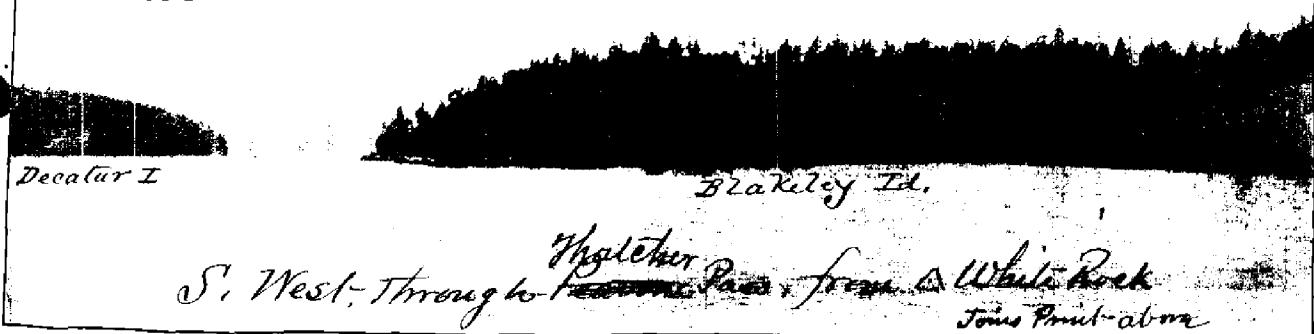
S. West, through ~~Thatcher Pass~~, from White Rock
Toms Point above

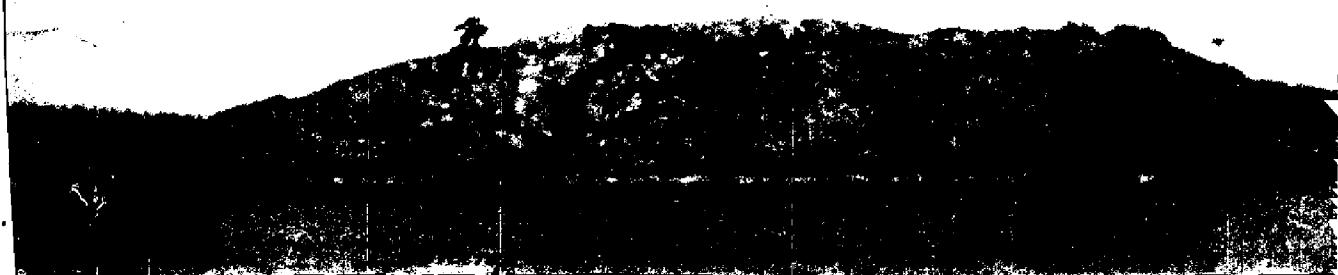
Sheet No. 2

Frost Island is rocky, it lies only 60 or 80 metres off the end of Specers Spit, but the channel through between the spit and island is deep, - not less than 8 fms, - The shores of the

Flower Island, with bold rocky shores, is almost bare rock - a few trees on the low point at NW, part, near the top in a glacial groove filled with soil are some scrub Oaks, having a tendency to trail along the ground like vine maple, - it appears to be a new variety not hitherto described in any of the books, Specimens were sent

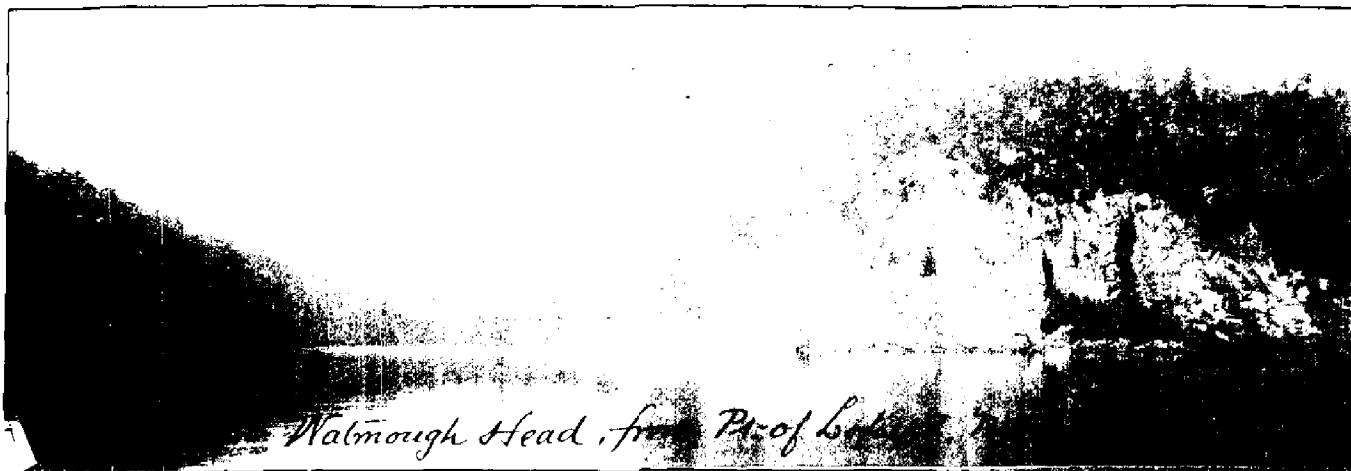
Watmough light, is shallow near the head, it
affords good anchorage at all times in 4 to
8 fms. Watmough Head is very steep toward
the light, is 460ft high, and its character
is well represented in the print.

Watmough Head, from Proof Boat

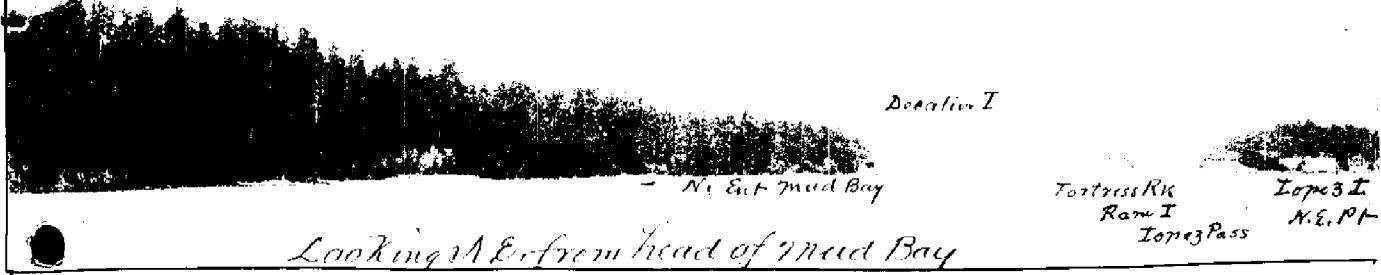
Looking N.E. from Head of Mud Bay

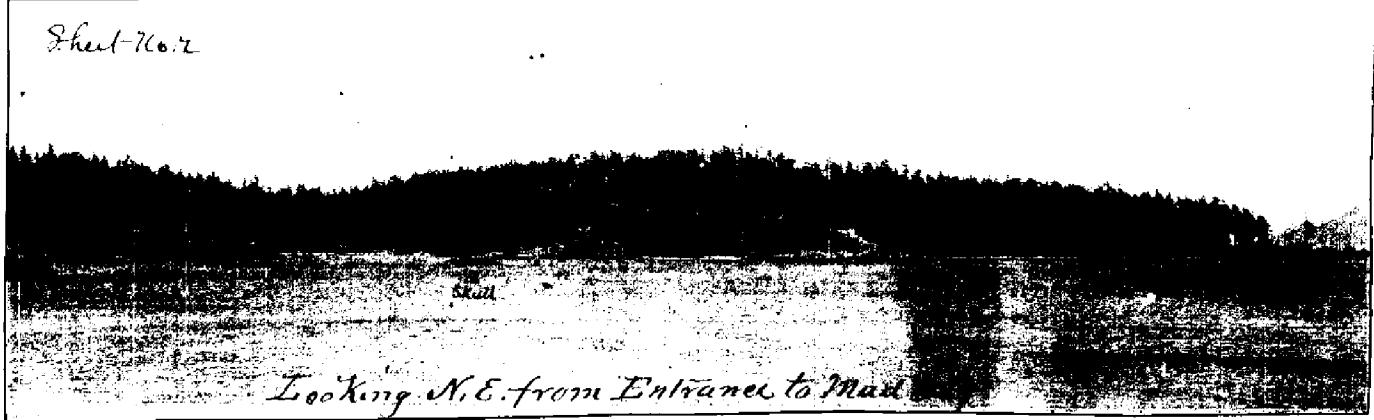
Looking N.E. from Entrance to Mud
