FORM 504 DEPARTMENT OF COMMERCE U. S. COAST AND GEODETIC SURVEY								
State: Florida								
DESCRIPTIVE REPORT.								
7 Тероgraphis SheetsNo.								
LOCALITY:								
Lake Okeechobee								
1924-25								
CHIEF OF PARTY:								
L. D. Graham

A TOPOGRAPHICAL SURVEY OF

LAKE OKEECHOBRE FLORIDA

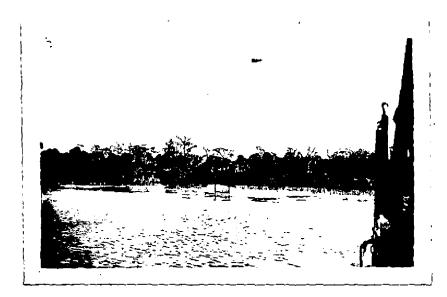
Typical high trees along northern and eastern shores

Around the greater part of the northern and eastern shores of the lake from Ragle Bay to Bacom Point there runs a narrow, comparatively high sandy ridge which is covered with high trees.

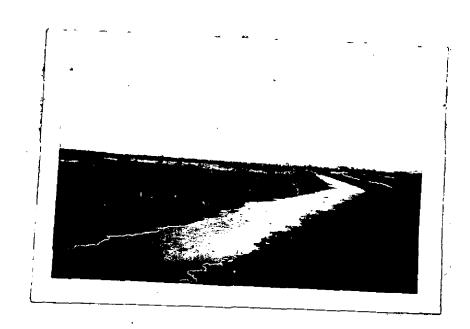
Typical view of earth dike along south shore of lake showing boat channel alongside and profusion of vegetation water. The lake is on the left.

Most of the land along the south shore of the lake was, at the time of the survey, below the level of the water in the lake. This condition was brought about by dikeing the entire southern end of the lake, partially closing the locks in the various canals and draining the land away from the lake. This dike runs, with the exception of two places where it is supplemented by natural ridges, the entire distance from Bacom Point to the town of Moore Haven. It is constructed of earth and is about six feet in height and protected from storm erosion in most places by the growth of grass, water weeds and hyacinths in the water of the lake adjacent.

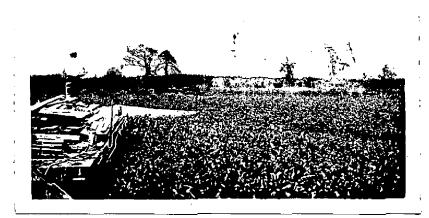
Water hyacinths along shore at Signal Kiss.

The shallow waters along the shore furnish an abundant growth of water hyacinths which float about with the wind and greatly obstruct navigation along some sections of the shore and in various streams. These hyacinths also grow in the streams and float downstream into the lake.

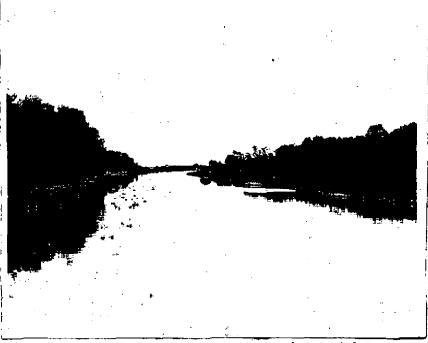
Taylor creek near mouth looking toward lake.

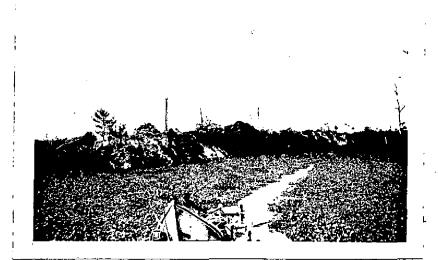
Hyacinths in Taylors Creek.
