Form 504	
DEPARTMENT OF COMMERCE	
U. S. COAST AND GEODETIC SURVEY	
State: <u>Washington</u>	
11-5613	
DESCRIPTIVE REPORT.	
C	
Topographic	Sheet No. <u>4224</u>
LOCALITY:	
<u>Strait of Juan de Fuca</u>	
<u>Port Townsend,</u>	
<u>Irondale and Port Hadlock</u>	
<u>1926</u>	
CHIEF OF PARTY:	
<u>O.S. Reading</u>

TOPOGRAPHIC SHEET NO - 4224
(Field Letter "C")

PORT TOWNSEND

REVISION OF LANDMARKS OF CHART 6405

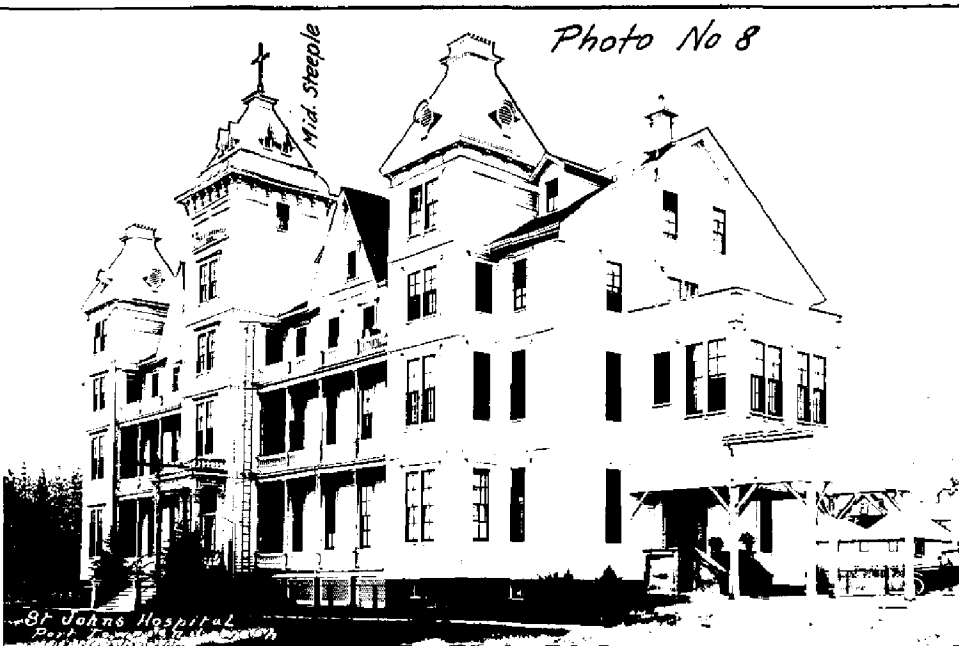
Photo No 8

Name	Description	Photographs	Suitability for landmark
Steeple	City Hall	2a, 6	Conspicuous for anchorage near town.
Light	Point Hudson		Not conspicuous in day time
Weather Mast	Skeleton Steel Tower	6	Not conspicuous except when signal is being shown.
Cupola	Marine Hospital	1a, 2a, 6	Conspicuous, permanent
Highest East peak	Post Office & Fireable Custom House	1a, 2b	Conspicuous, permanent
Clock tower	Jefferson County Court House, red brick building	1b, 2b, 7	Best landmark in Port Townsend, lighted at night. Permanent
Belfry	Lincoln School	1b, 7, 9	Conspicuous at a distance from wharves, permanent
Mid Steeple	St Johns Hospital	1b, 8	Very conspicuous white building south of town. permanent.
