Form 504	
DEPARTMENT OF COMMERCE	
U. S. COAST AND GEODETIC SURVEY	
....., Director	
<div></div>	
State: SE. Alaska	
DESCRIPTIVE REPORT	
Topographic Hydrographic	Sheet No. F 4244
LOCALITY	
Cape Fairweather	
Lituya Bay	
1926	
CHIEF OF PARTY	
A.M. Sobieralski

Lituya Bay, SeE. Alaska

TOPOGRAPHIC TITLE SHEET

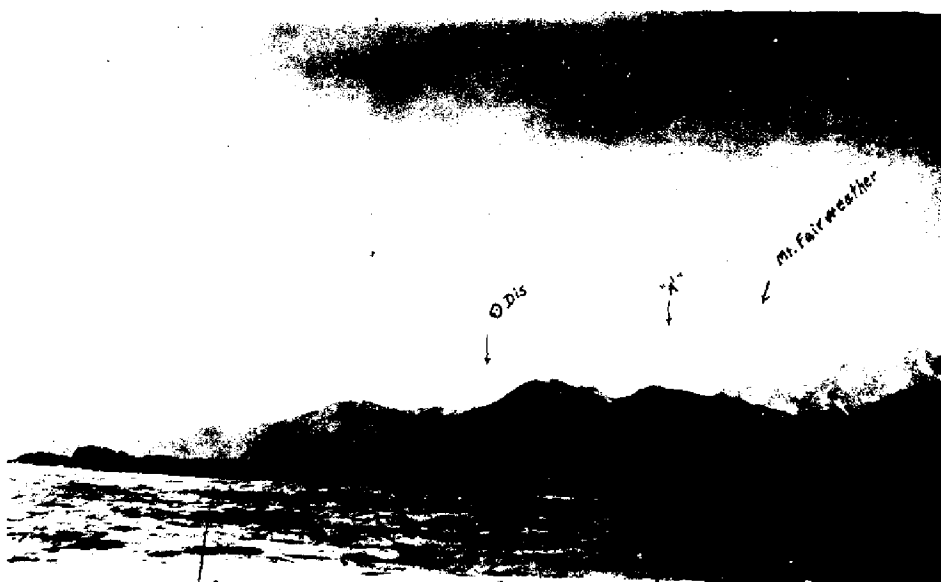
A South Base

Cormorant Rock

30' Rock

On ebb tide, the entrance to the bay can be identified at a distance of several miles by the strong current which flows from the entrance, causing swells and tide rips for several miles out to sea. Cormorant Rock is the largest of three rocks, bare at all stages of the tide, lying on the southeastern side of the entrance. The other two rocks lie off-shore from Cormorant Rock and have deep water close in on their seaward side, but a rocky reef makes off to northwestward of the smaller one. The last rock of this reef, shown as submerged on the sheet, is awash at minus 2 feet of tide. Passage Rock marks the end of a rocky reef

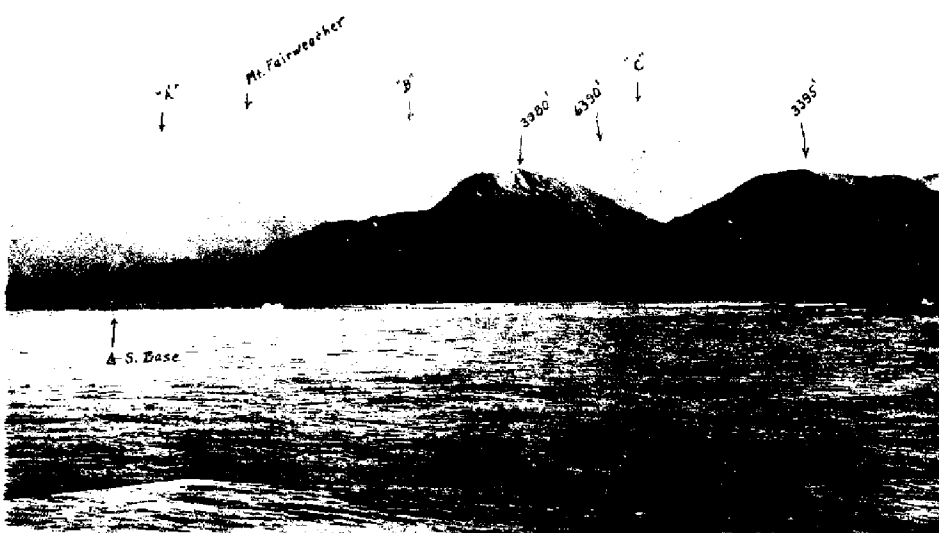
A S. Base

Photographs are transmitted with this sheet, showing the principal features. These photographs are numbered and the positions and directions from which they were taken are indicated on the sheet in pencil. The locations of many of the peaks shown are to be found only on the small scale hydrographic sheets of this season.
