Form 504	
DEPARTMENT OF COMMERCE	
U. S. COAST AND GEODETIC SURVEY	
....., Director	
<div></div>	
State: Alaska	
DESCRIPTIVE REPORT	
Topographic Hydrographic	Sheet No. 4370
LOCALITY	
Kenai Peninsula	
Day Harbor - North Part	
<div></div>	
<div></div>	
1928	
CHIEF OF PARTY	
R. R. Lukens

DESCRIPTIVE REPORT

To accompany Hydrographic Sheet "G" ^{#F} 4370

Day Harbor, S. W. Alaska.

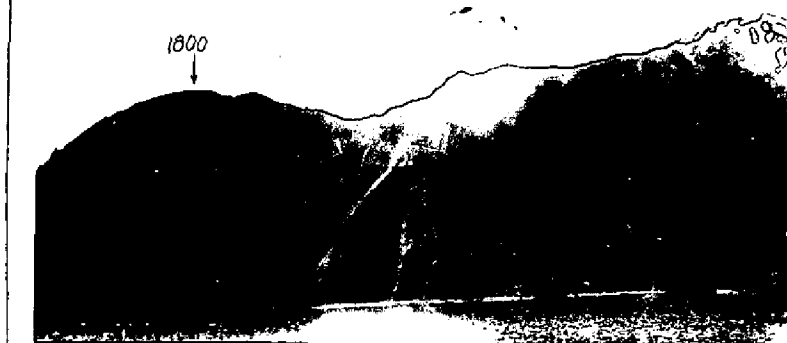
The headland north of Δ Pyramid viewed from L 59-57.3; L₄ 149-02.1

The headland north of Station Pyramid is steep and rocky and

scarred by numerous rock slides. The accompanying photographs furnish the best description that can be given.

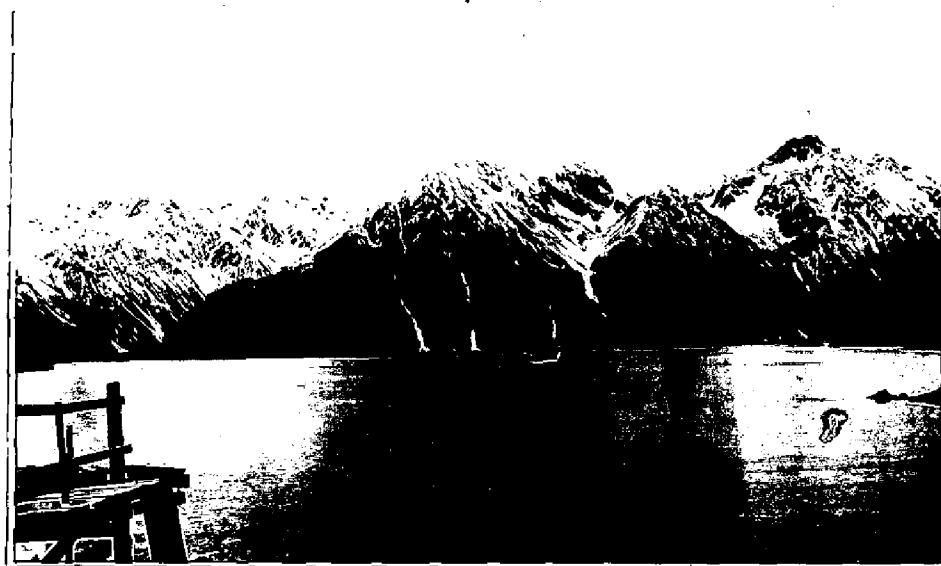
From head of Bowen Anchorage

The east side of Day Harbor as far south as Lat. 59-59 is less precipitous than the west and more densely covered with forest; especially in the region of Bowen Anchorage and the bight to the south. Bowen Anchorage is shown in detail in the insert on a scale of 1:10,000.

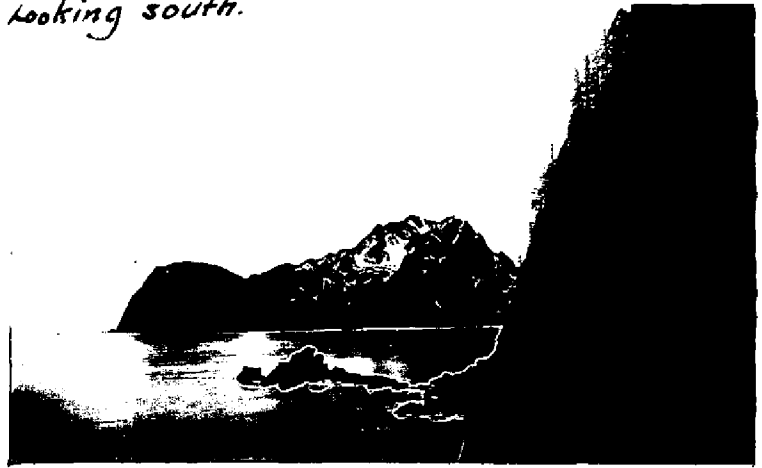
*Cape Resurrection from the cliffs at A CHIMNEY
Looking south.*

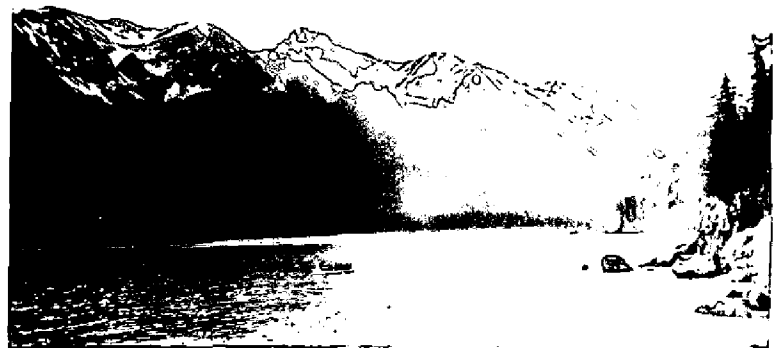
*Horsehead Bay viewed from the entrance
near the East side.*

Horsehead Bay:- Name assigned by the field party to the bay in Lat. 59 - 57.5 Long. 149 - 03 because of its resemblance to the front half of a horses head. *Submit to G.B. NB.*
