DESCRIPTIVE REPORT

Topographic Sheet No. C 4774

Lake Charles Deep Water Channel.

Lake Charles.

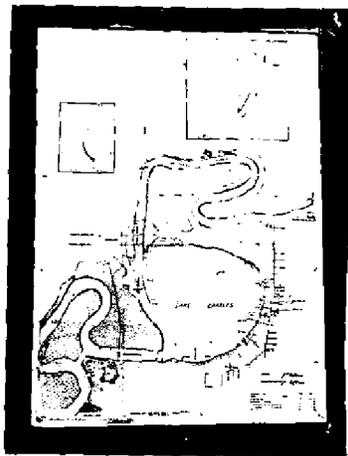
Silver Tank  
Noble-Trotter  
Rice Mill.

Between the Silver Tank, Noble Trotter Rice Mill and the Lake Charles Boat Club, the waterfront consists mostly of business buildings, warehouses, petroleum companies and a few dwellings. A rice mill is in operation at the station mentioned above.

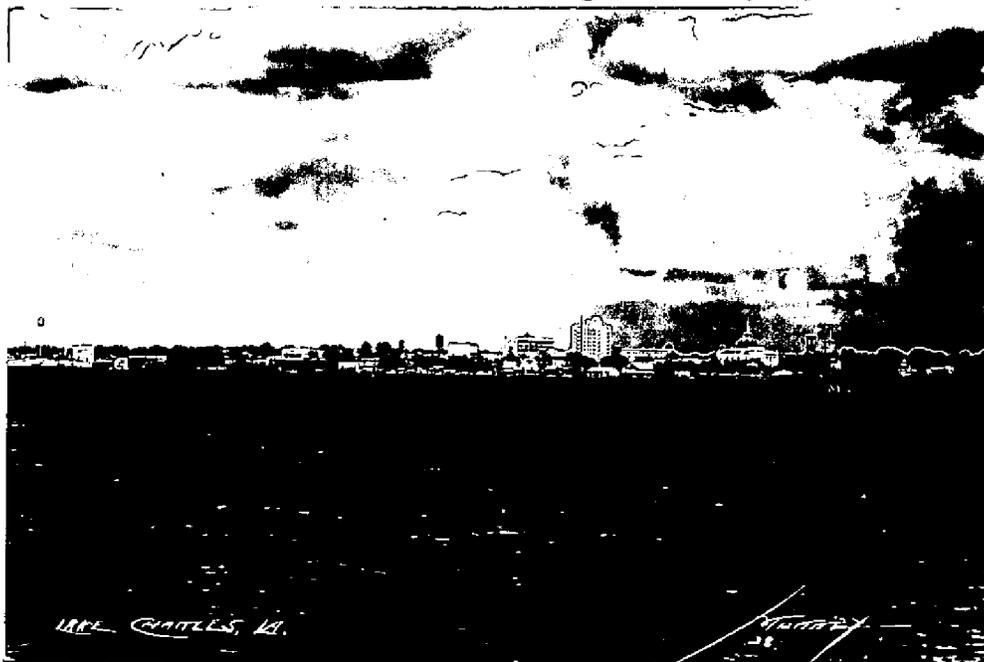
Charleston Hotel  
Court House  
Catholic Church  
City Hall

LAKE CHARLES, LA.

It was not possible to begin the survey from a set-up on the ground at a triangulation station because none of the stations were intervisible from the ground; neither could a point be found where three stations would give a strong fix. A start was made on the roof of the Charleston Hotel by setting up on the line through  $\Delta$  Stack, Charleston Hotel" and  $\Delta$  Airways Beacon Majestic Hotel". A fix was obtained here and cuts taken to all prominent objects and several signals that had been built. These signals were then occupied and by orienting back on the initial set-up and by resection, these signals were located and finally, all prominent objects located by graphic triangulation.

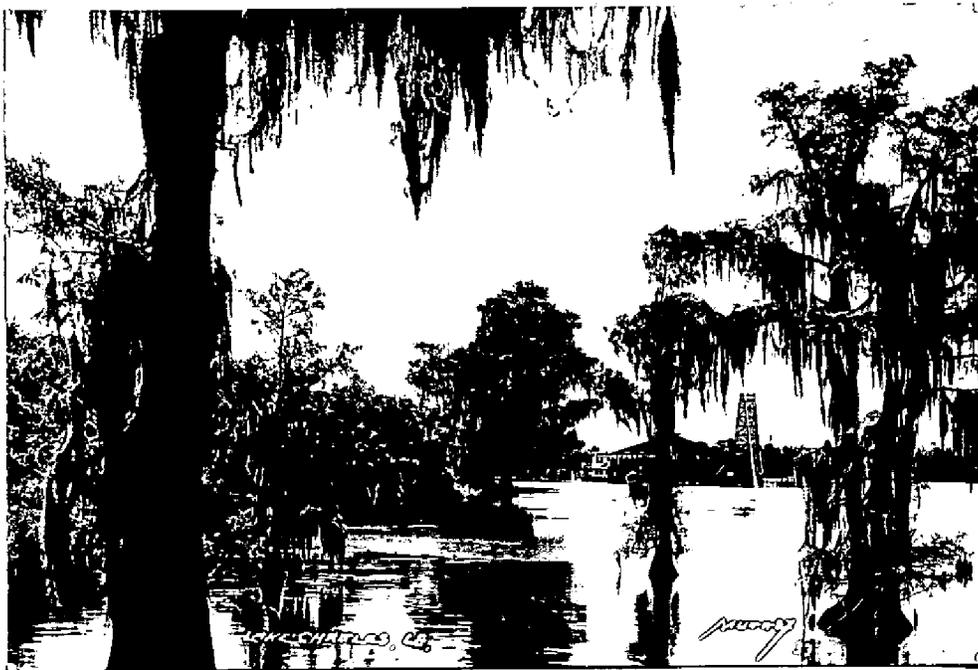
Typical Cypress Shore. South Shore of  
Lake Charles, Looking West to Barbe's Pavilion.

South of the coulee, or stream, nearest the Boat Club the lake shore is dotted with homes. The yards of the homes contain many trees and there is a broken fringe of cypress trees along the S. lake shore. Several small private boat landings exist along the south shore of the lake. Barbe's Pavilion is a dance hall built over the water.
