U. S. COAST AND GEODETIC SURVEY
DEPARTMENT OF COMMERCE

DESCRIPTIVE REPORT

Type of Survey Topographic

Locality Kiska Island

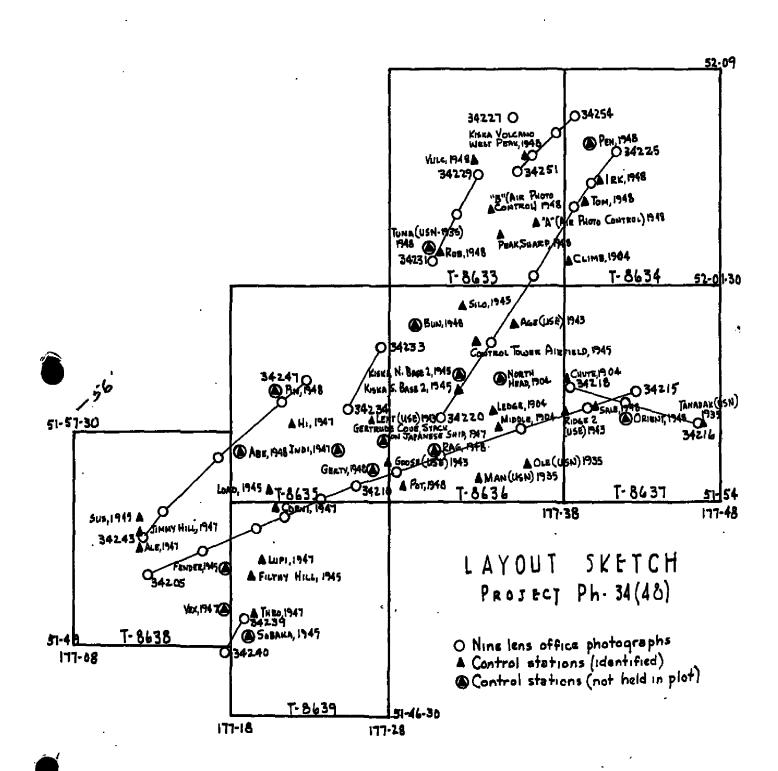
A sketch, showing the layout of surveys in this plot and the distribution of identified control and photograph centers, is attached to this report.
