Form 504	
U. S. COAST AND GEODETIC SURVEY	
DEPARTMENT OF COMMERCE	
DESCRIPTIVE REPORT	
Type of Survey <u>Shoreline</u>	
Field No.	Office No. <u>T-9123</u>
LOCALITY	
State <u>Alaska</u>	
General locality <u>Prince William Sound</u>	
Locality <u>McClure Bay</u>	
<u>1954</u>	
CHIEF OF PARTY	
Office: <u>L. W. Swanson</u>	
LIBRARY & ARCHIVES	
DATE

SHORELINE MAPPING PROJECT PH-152

SUMMARY TO ACCOMPANY
DESCRIPTIVE REPORT T-9123

This shoreline manuscript, scale 1:10,000, is one of 43 sheets that comprise Project PH-152, which is located in the western part of Prince William Sound. T-9123 includes the east side of Port Nellie Juan and McClure Bay.

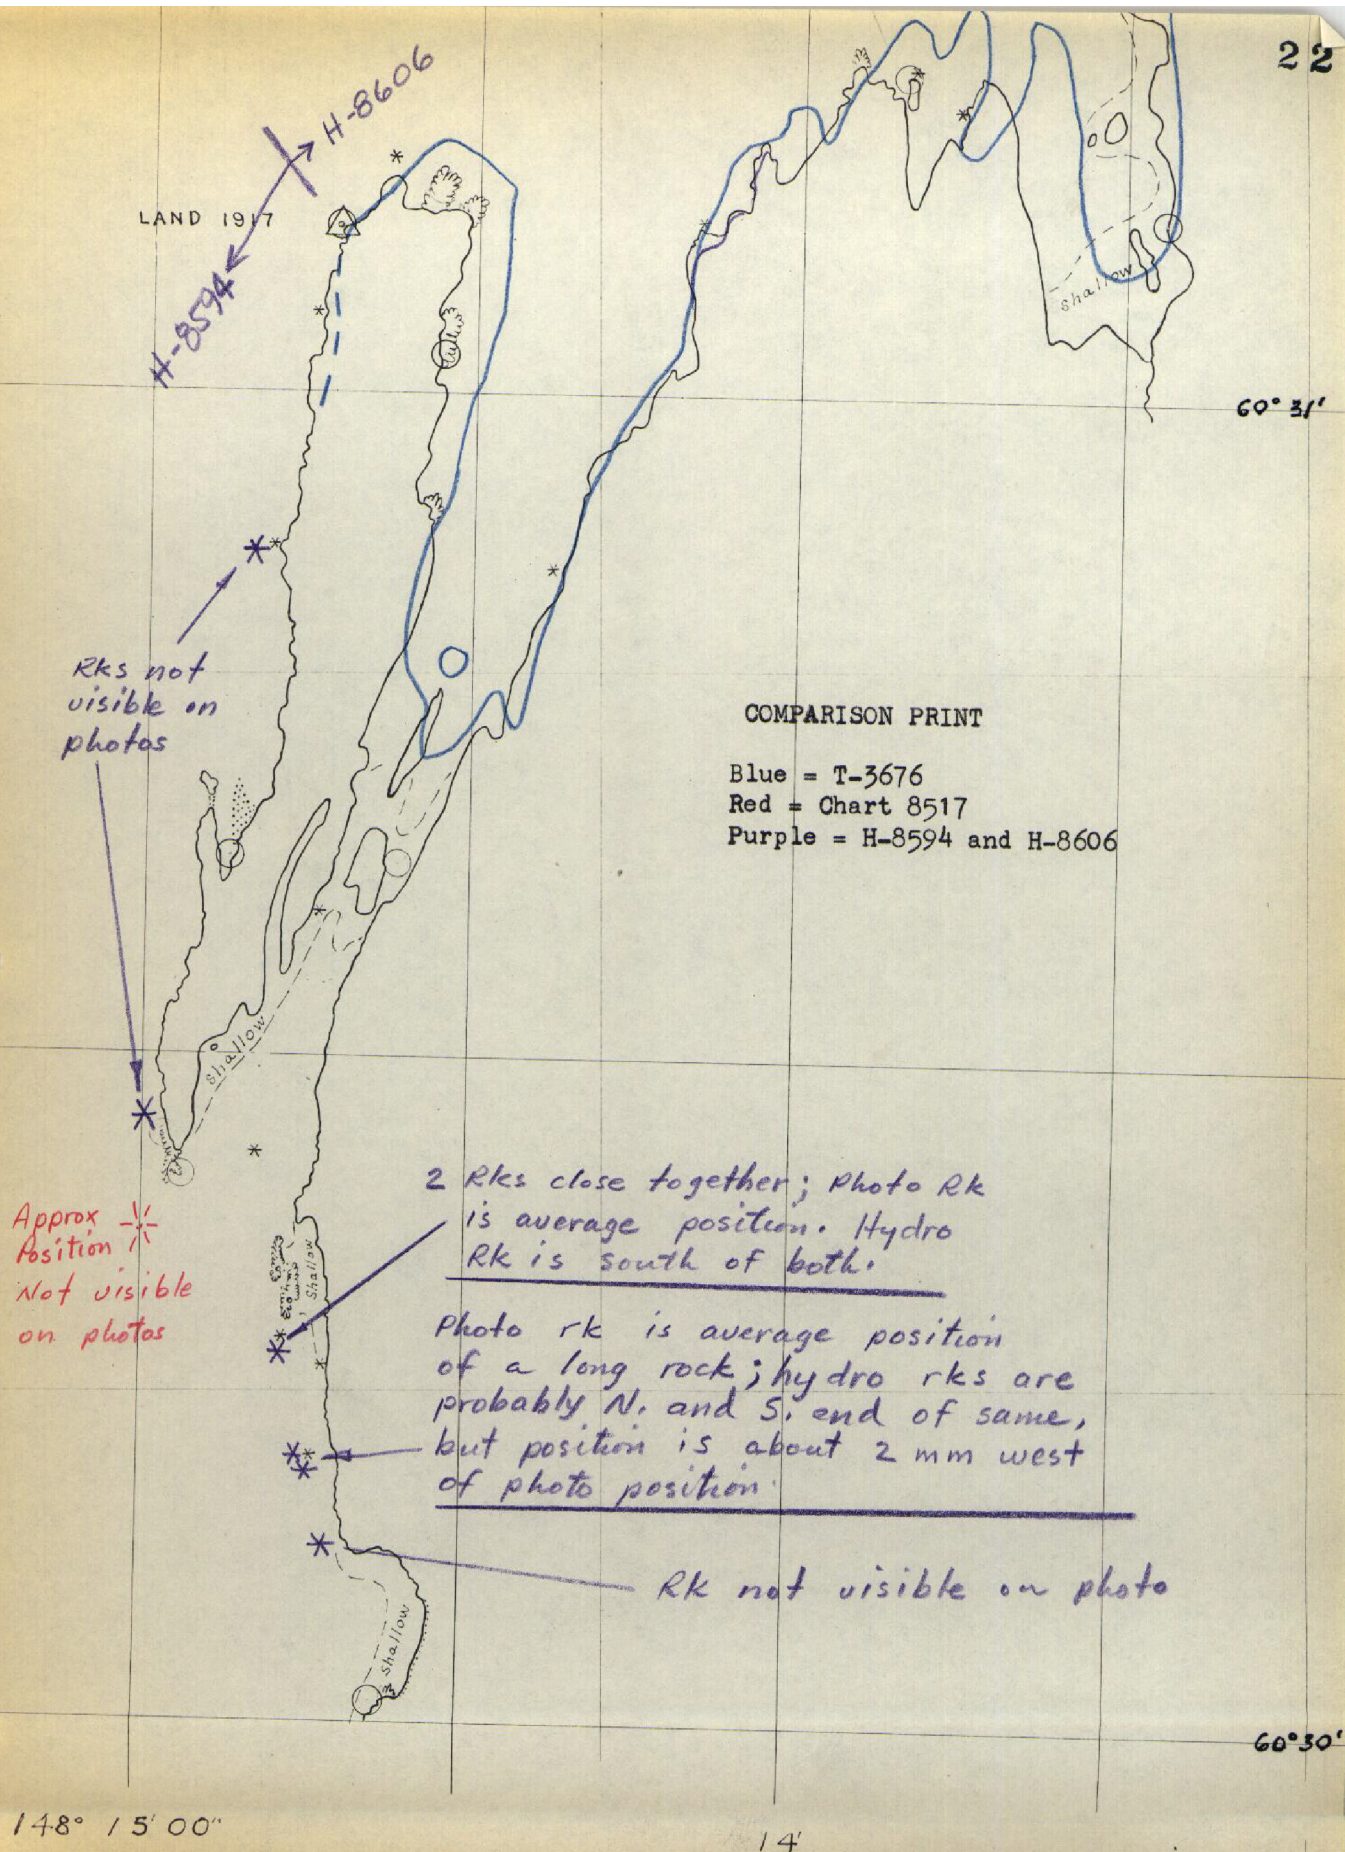
Comparison Print

Differences between T-3676 and T-9123 are shown in blue on the comparison print.

Blue = T-3676

The geographic position of shoreline compares more favorably at the north side of the sheet than at the south, the difference becoming increasingly greater from north to south. The general shape of the shoreline compares favorably.

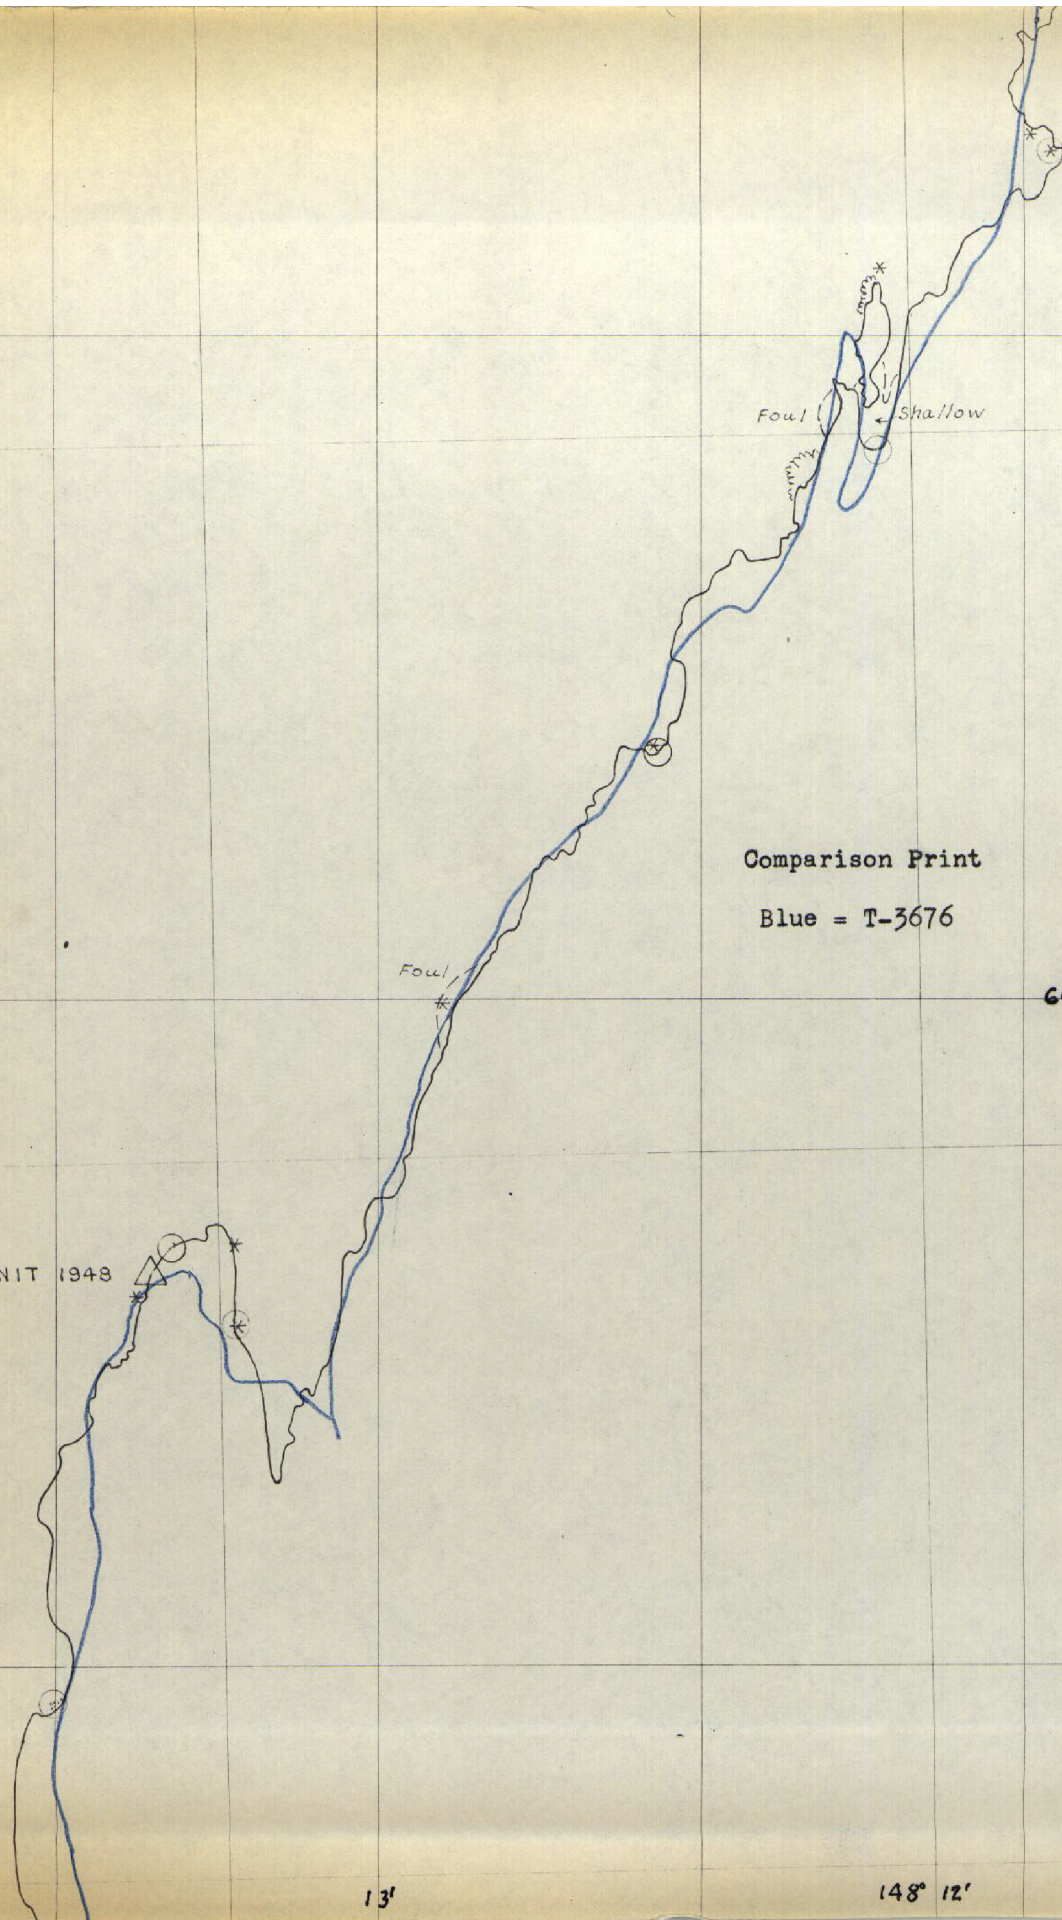
COMPARISON PRINT

Blue = T-3676
Purple = H-8606

Only one rock
visible on photos

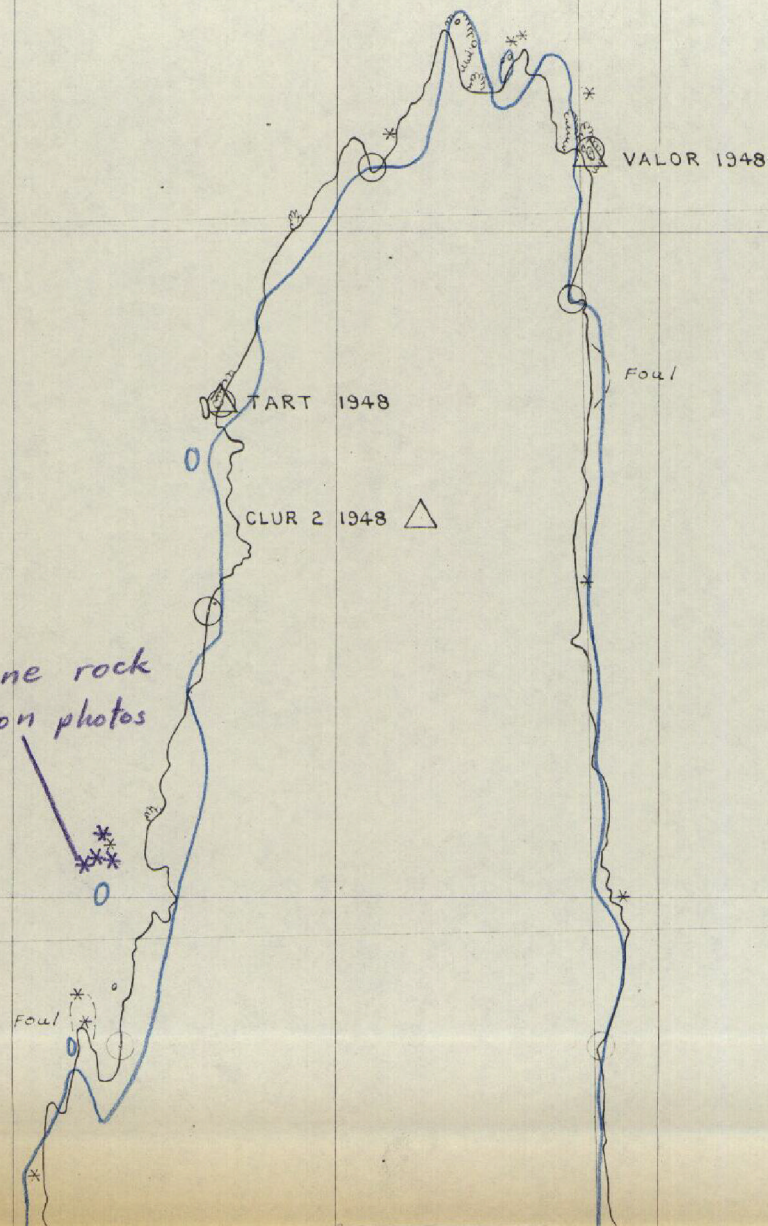
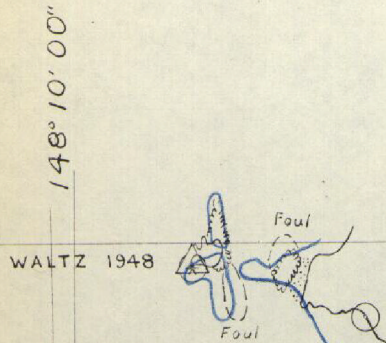
COMPARISON PRINT

Blue = T-3676
 Red = Chart 8517
 Purple = H-8595
 Brown = SEWARD (C-4)

(A) - See page 28

Concerning removal of rock
 & obstruction from T-9123
 6/8/76

Not visible on photos

Not visible on photos.
 C-4 shows Subm Rk

Subm Rk
 on Chart
 8517

The rock and the obstruction indicated by label "(A)" on page 25 were removed from registered map and negative on June 8, 1976. Removal was reported to the Marine Chart and Marine Surveys Divisions.

The rock was shown (compiled from office interpretation of photos) on the Incomplete (Class III) Manuscript, a copy of which was furnished for hydro support H-8595, 1961.

The area was investigated by the hydrographer at -3.0 ft. MLLW tide stage. The rock was removed from the hydro survey sheet by the hydro survey activity. Its deletion was not reported to the Coastal Surveys Division. As indicated on the Comparison Sheet (page 25), the photogrammetric survey final reviewer could not see a rock image on the photos covering this area.

The obstruction was reported as non-existent by the hydrographer.

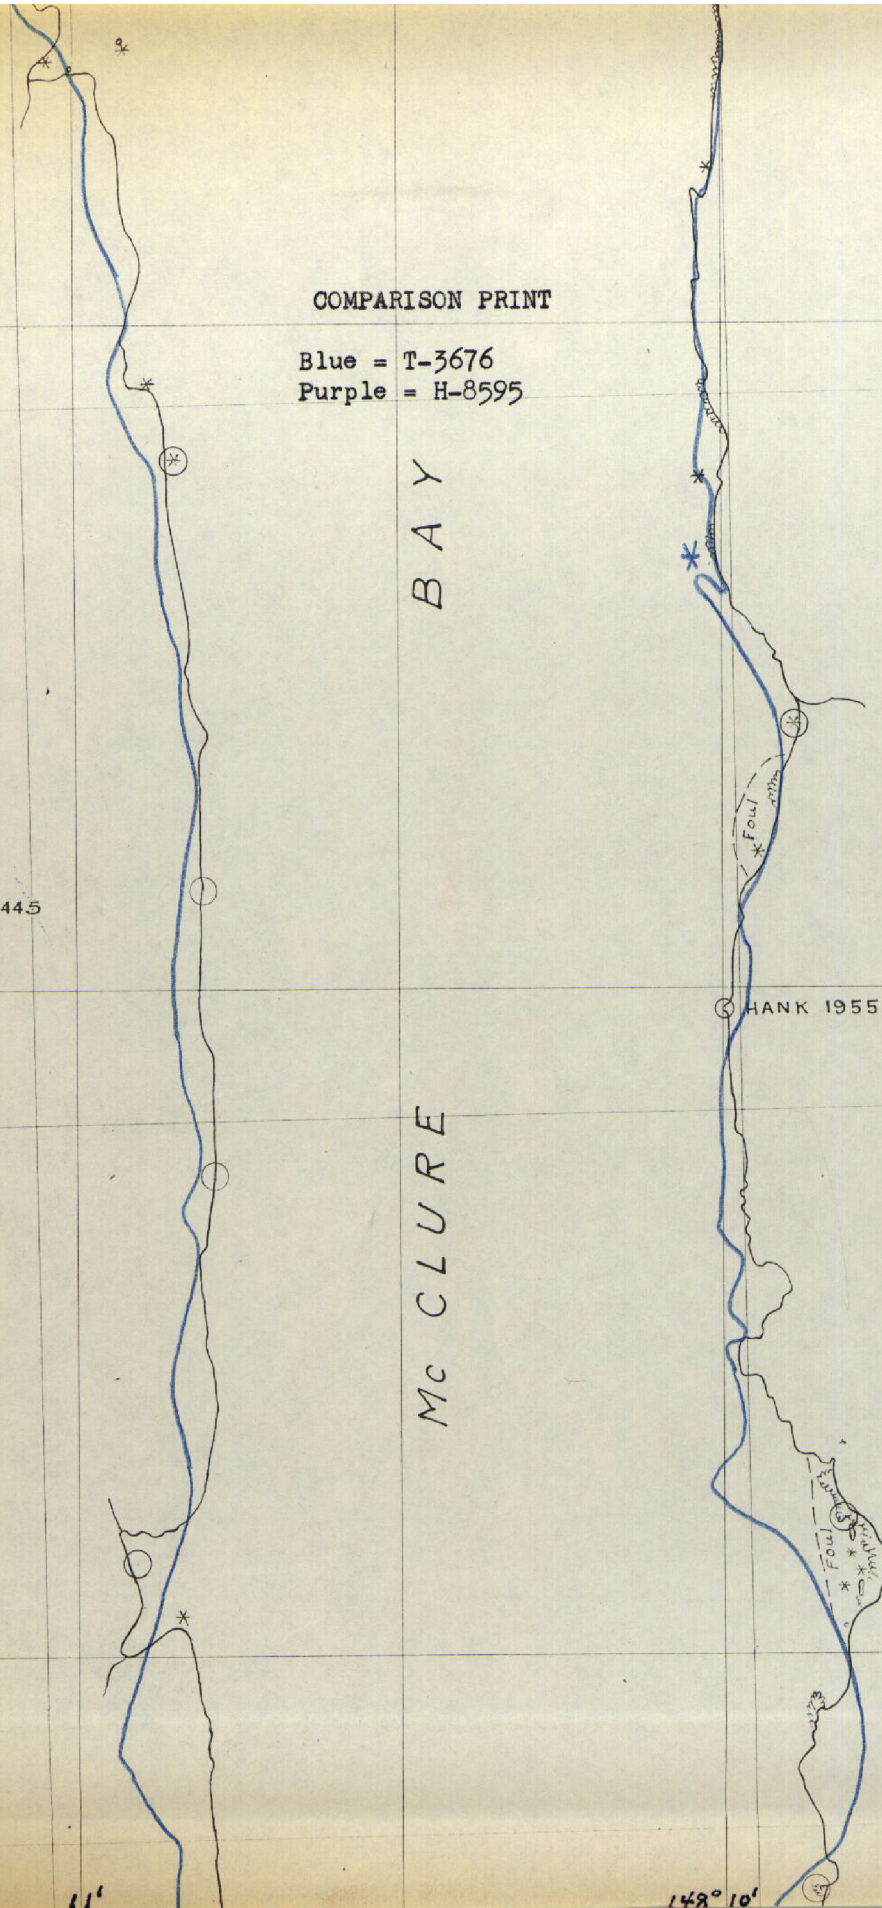
COMPARISON PRINT

Blue = T-3676
Purple = H-8595

H-8595 revised

only one Rk
visible on photo
