Form 504	
U. S. DEPARTMENT OF COMMERCE	
COAST AND GEODETIC SURVEY	
DESCRIPTIVE REPORT	
Type of Survey	SHORELINE
Field No.	Office No. T-9134
LOCALITY	
State	ALASKA
General locality	PRINCE WILLIAM SOUND
Locality	EWAN BAY
1954	
CHIEF OF PARTY	
Field:	G. A. Nelson
Office:	L. W. Swanson
LIBRARY & ARCHIVES	
DATE

This shoreline manuscript, scale 1:10,000, is one of 43 maps that comprise Project PH-152, which is located in the western part of Prince William Sound. T-9134 includes the northwest end of Ewan Bay.

COMPILATION REPORT
Shoreline Survey T-9134

REVIEW REPORT T-9134

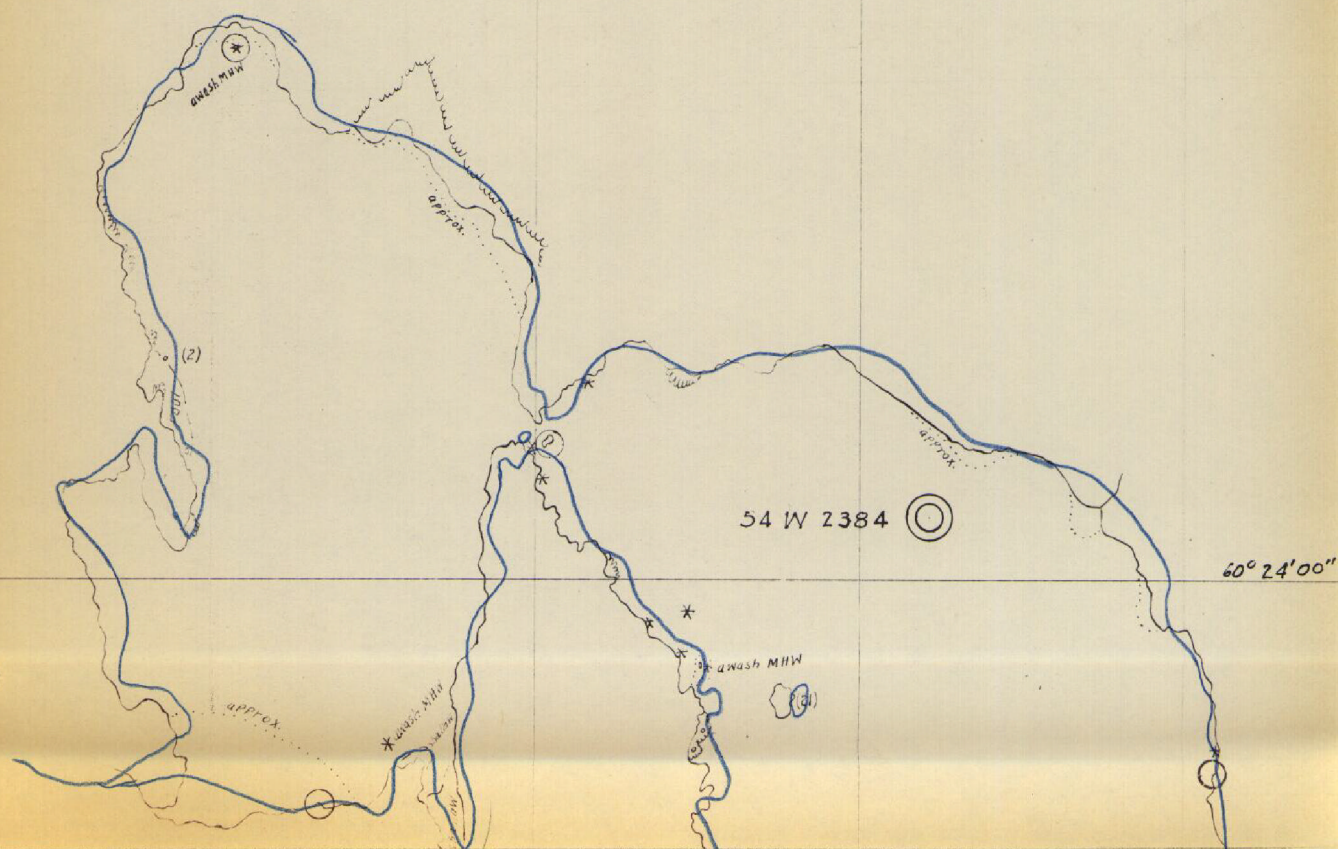
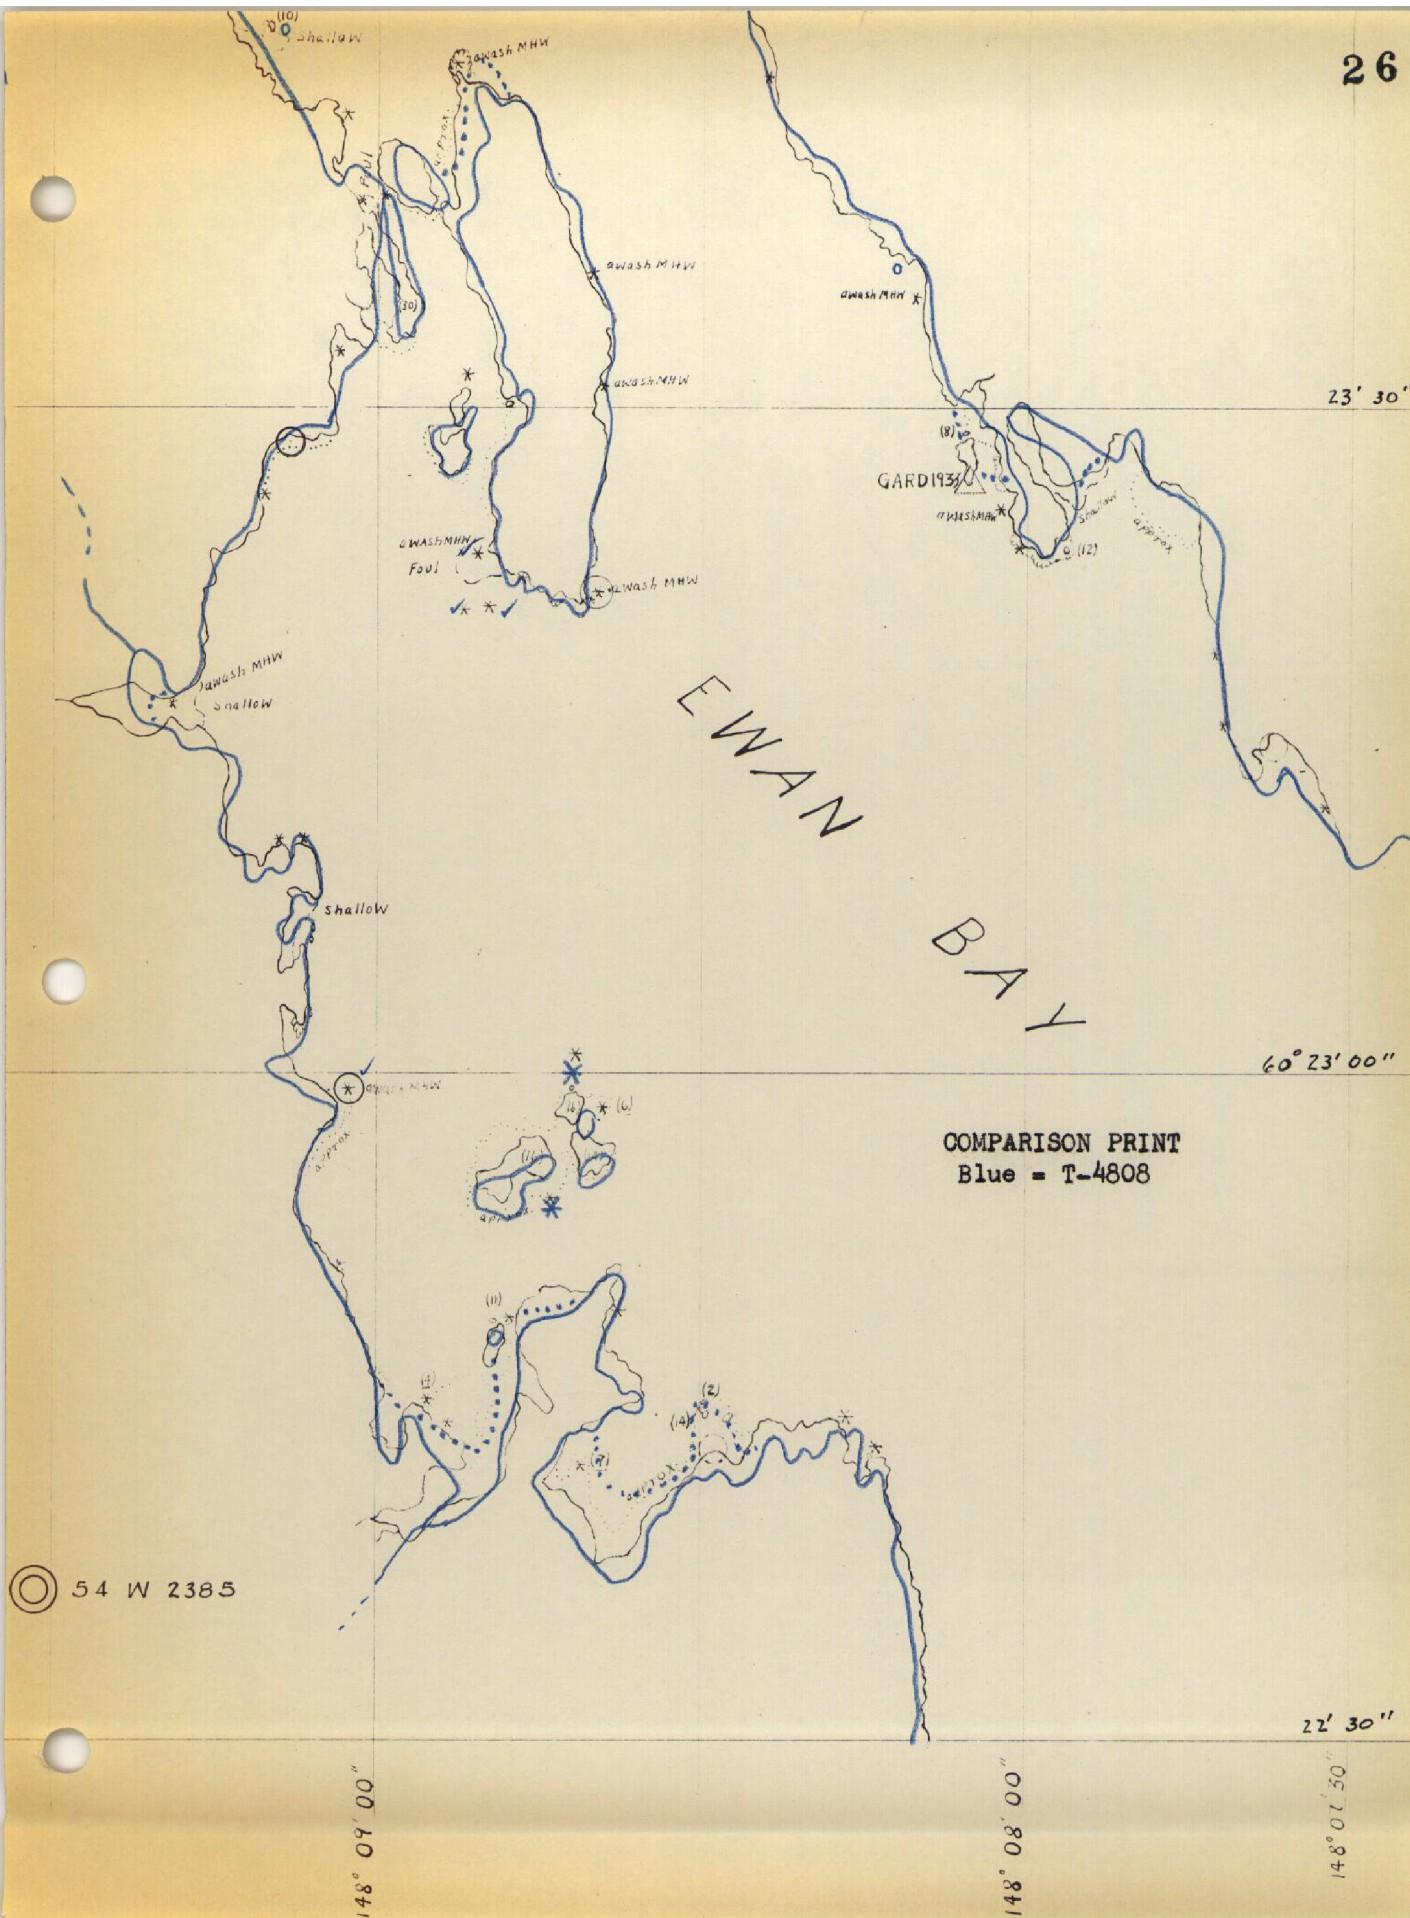
COMPARISON PRINT

A comparison was made with Survey T-4808, scale 1:20,000, dated May, June 1933. Differences with T-9134 are shown in blue on the comparison ozalid.

T-4808 is on a different datum from T-9134. Control for the comparison was poor.

Blue = T-4808

An ozalid comparison print (pages 25 and 26), with differences noted in Item 62, is bound with the original of this report.
