DESCRIPTIVE REPORT

Type of Survey	SHORELINE
Field No.	Office No. T-9151
	LOCALITY
State	ALASKA
General locality	PRINCE WILLIAM SOUND
	ELRINGTON PASSAGE
hashired an arrange of a second	
	1954-55
	CHIEF OF PARTY ranch, Photogrammetry Division ashington, D. C.
LIE	BRARY & ARCHIVES
DATE

T- 9151

DESCRIPTIVE REPORT T-9151

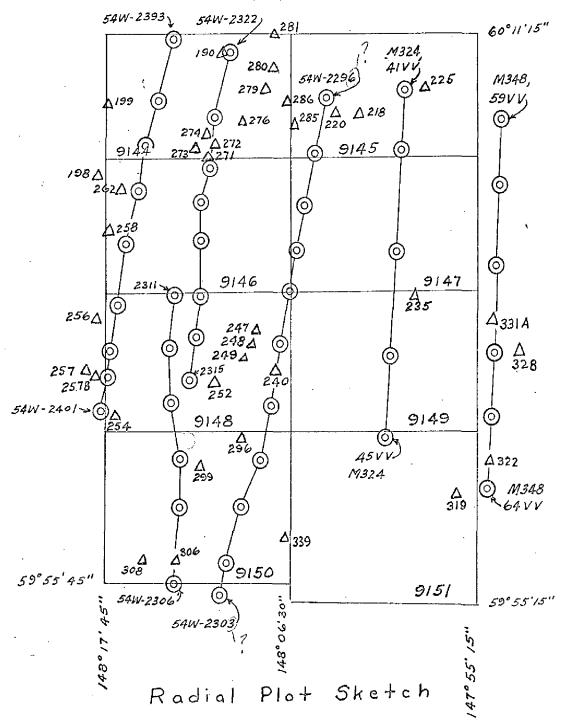
A Stations held

O Photo centers

An attached sketch indicates the density and distribution of control within the area covered by this report. The majority of control stations were office identified, and only seventy-two percent held in the plot. Control is inadequate/void at or near north end of Elrington Island and on west central coast of Latouche Island.

A sketch and list of geographic positions are attached.

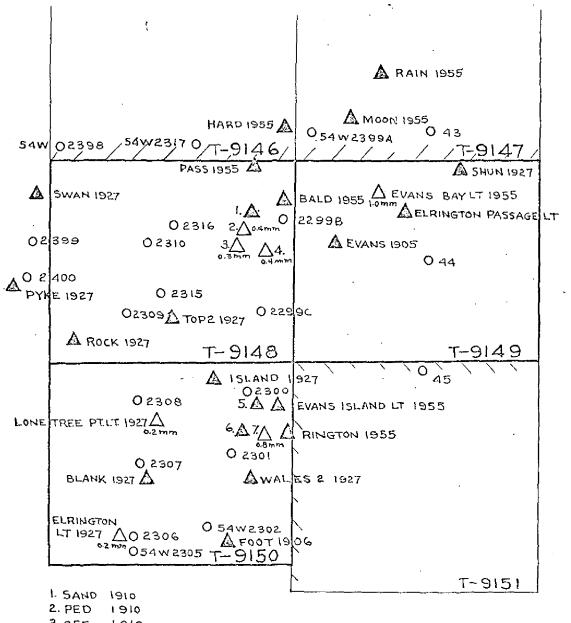
PHOTOGRAMMETRIC PLOT SKETCH
PROJ-6152 PRINCE WILLIAM SD
SCALE 1:10,000
MAY 1956

3.0FF 1910

4.15LE 1910

5. NOD 1955

6. DONALD 1955

7. ADD 1955

Δ STATION HELD Δ STATION NOT HELD

A sketch and list of geographic positions are attached.
