DESCRIPTIVE REPORT

Type of Survey Topographic

T-9430

Locality Coastal area about halfway  
between Point Hope and Cape  
Krusenstern.

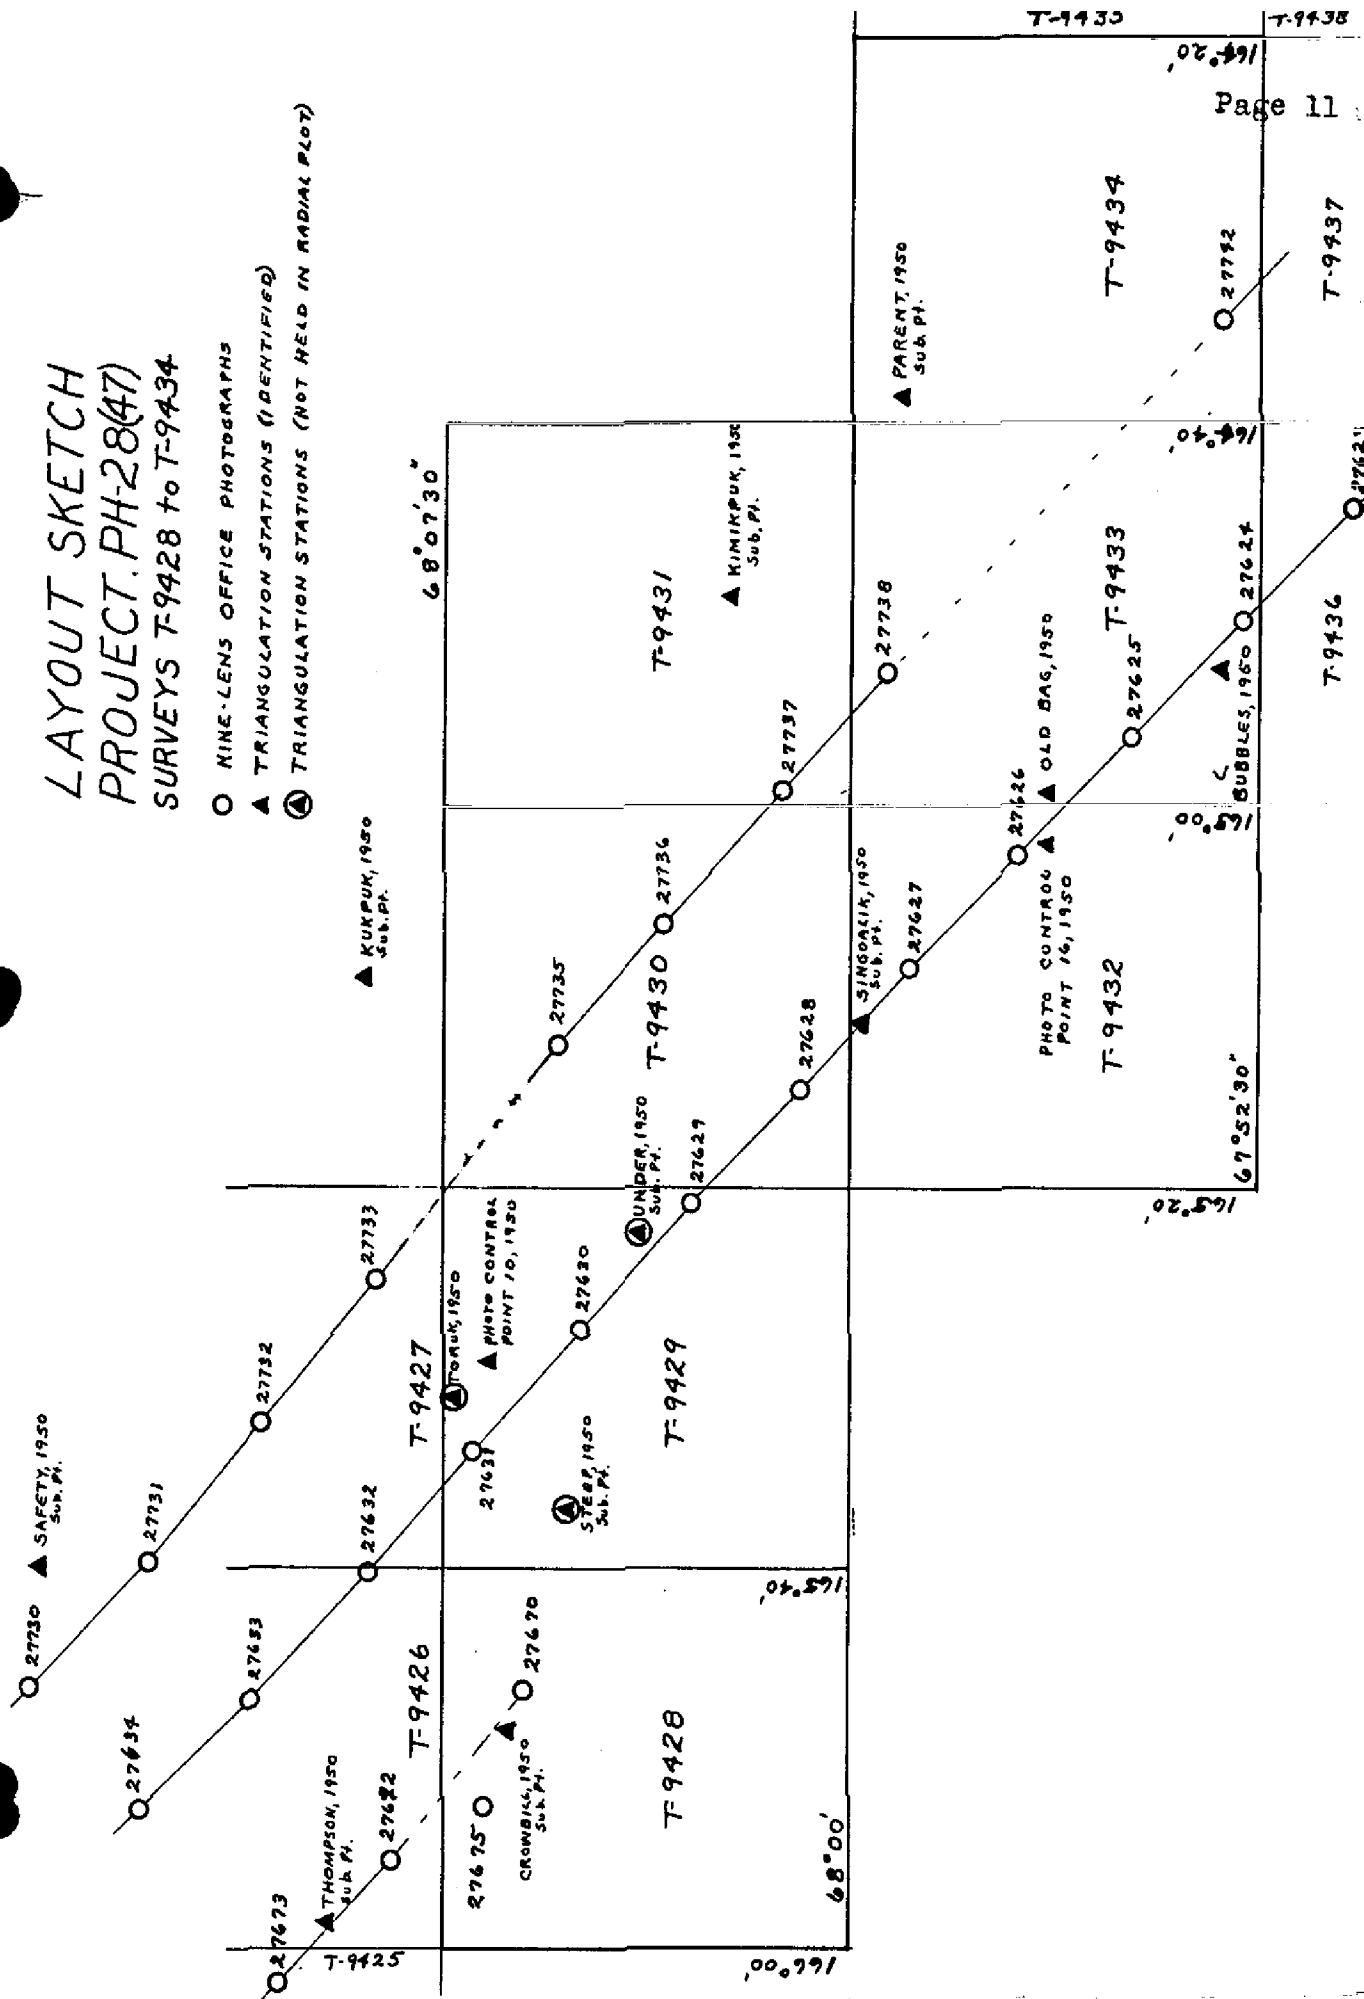
# LAYOUT SKETCH PROJECT PH-28(47) SURVEYS T-9428 to T-9434

A sketch showing the layout of these surveys and the distribution of photograph centers and control is attached to this report.

- NINE-LENS OFFICE PHOTOGRAPHS
- ▲ TRIANGULATION STATIONS (IDENTIFIED)
- ⊙ TRIANGULATION STATIONS (NOT HELD IN RADIAL PLOT)
