DESCRIPTIVE REPORT

Type of Survey Topographic

Field No. Ph-28 (47) Office No. T-9439 thru T-9443

General locality Kotzebue Sound

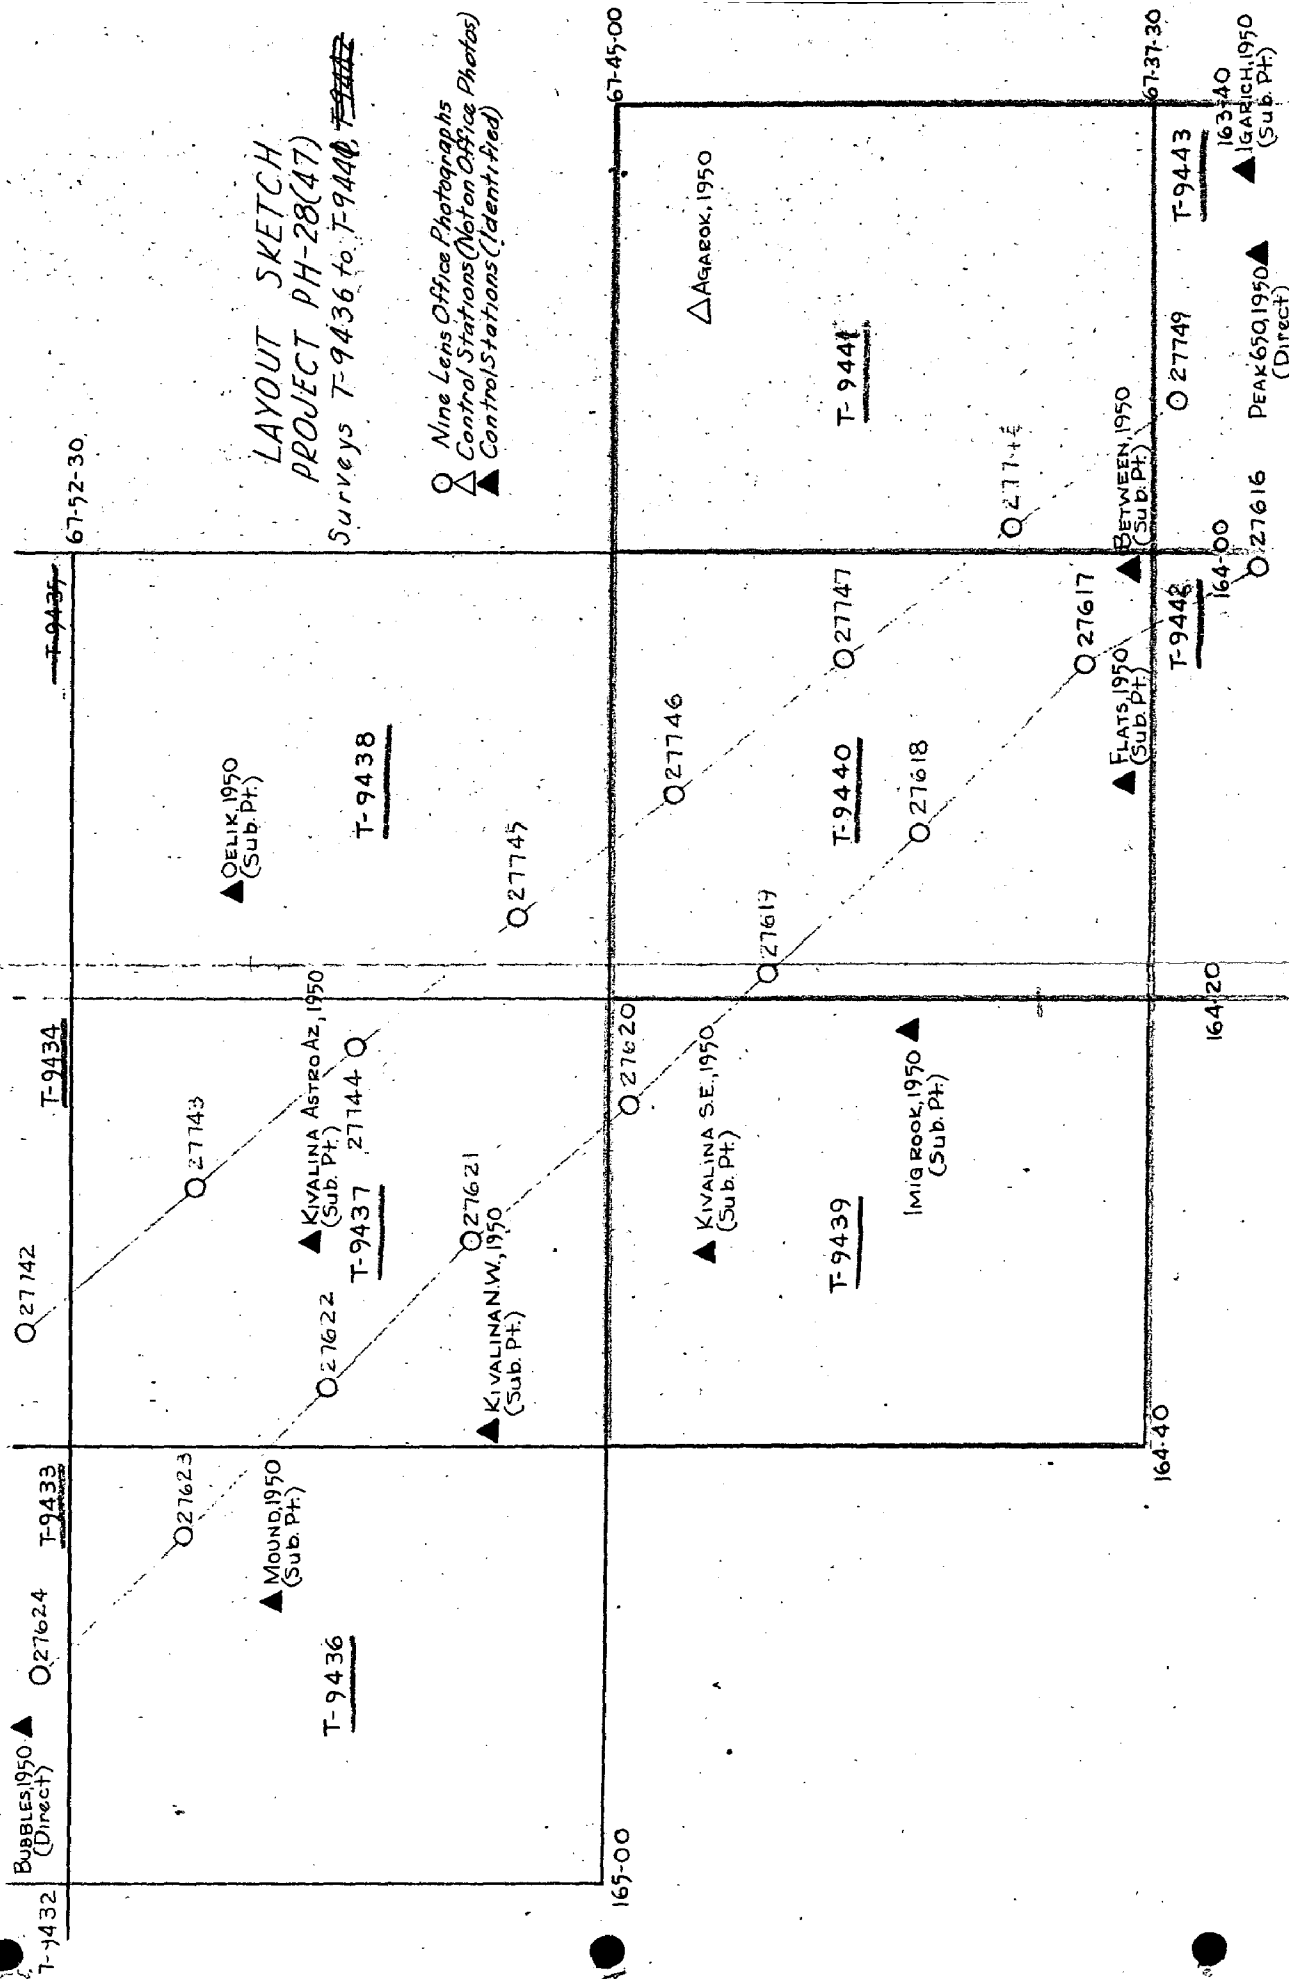
A sketch showing the layout of these surveys and the distribution of photograph centers and control is attached to this report.

Surveys T-9442 thru T-9447

○ Nine Lens Office Photographs  
△ Control Stations (Not on Office Photos)  
▲ Control Stations (Identified)
