U. S. COAST AND GEODETIC SURVEY

DESCRIPTIVE REPORT

Type of Survey Topographic

Locality Cape Krusenstern

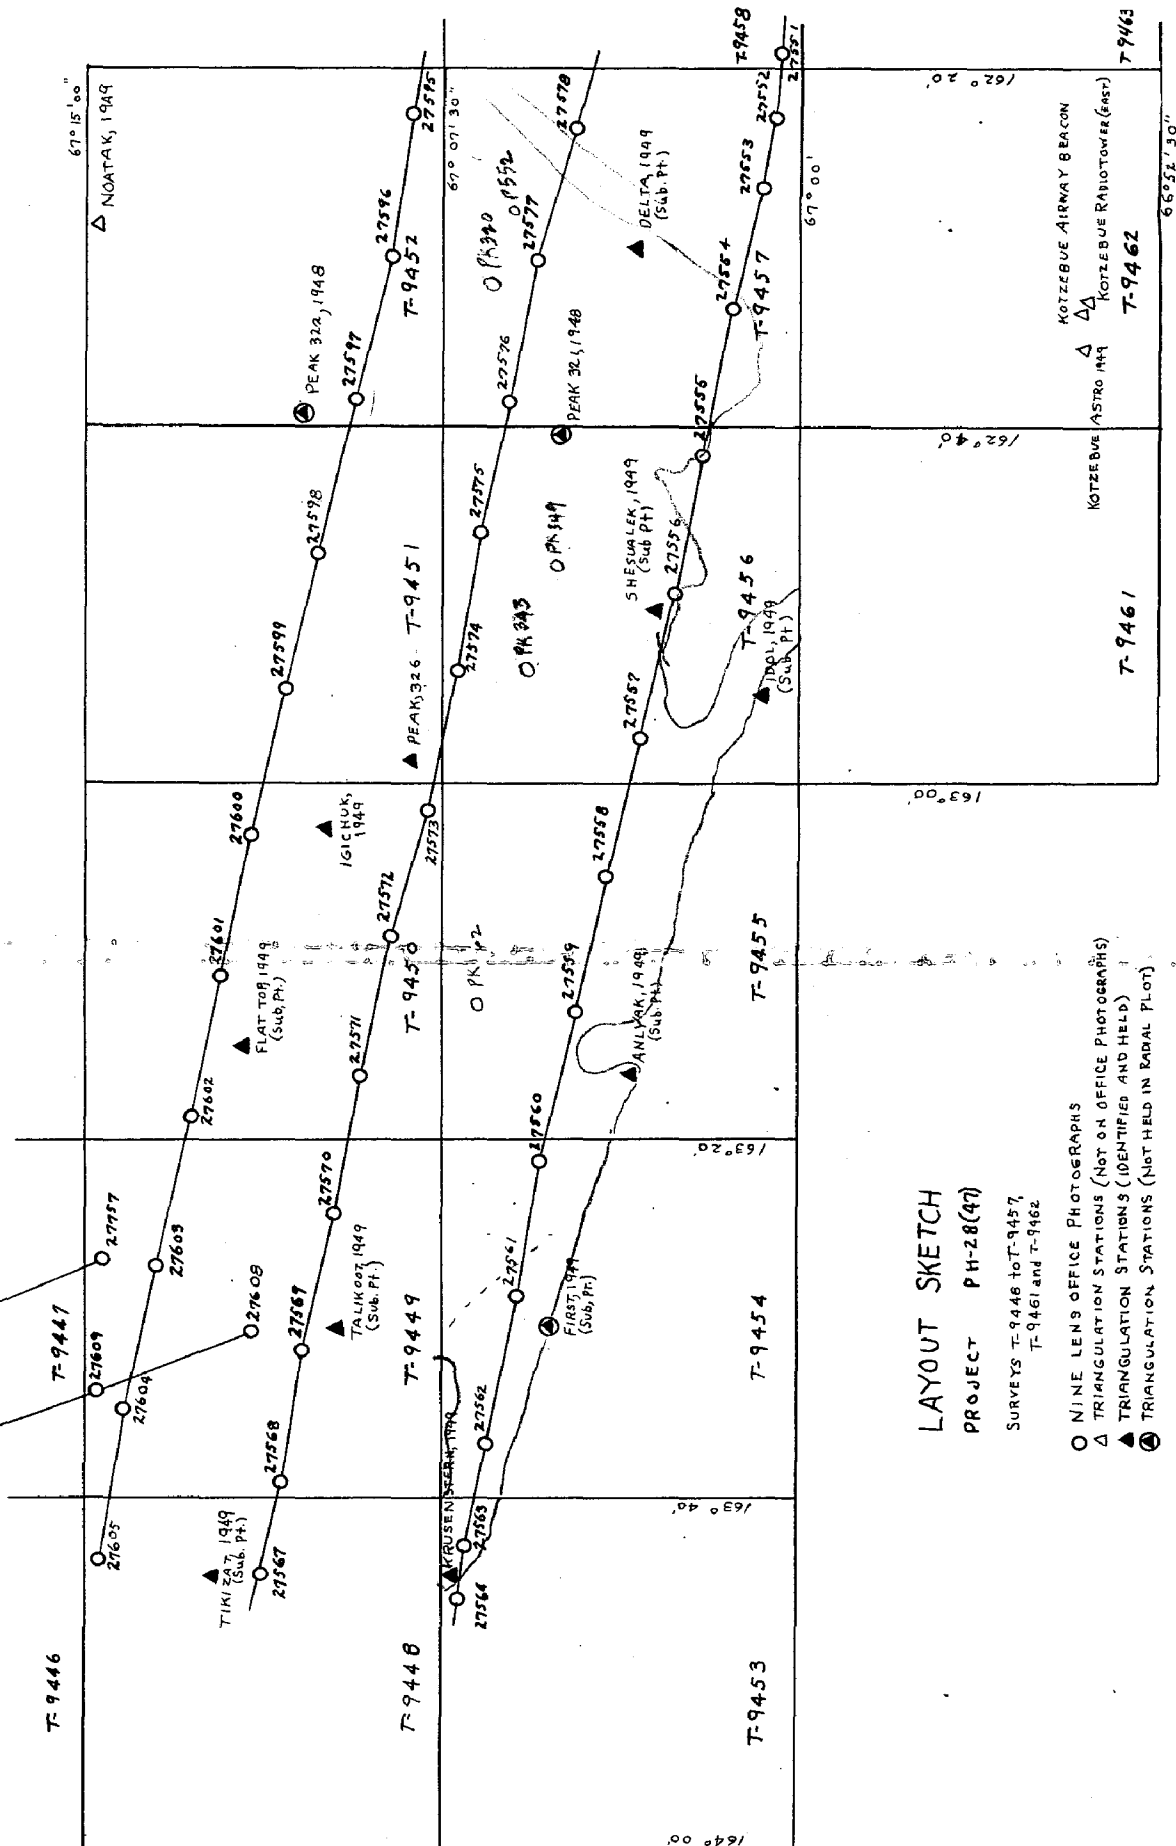
LAYOUT SKETCH

A sketch showing the layout of the these surveys and the distribution of control and photograph centers is attached to this report.

SURVEYS T-9446 to T-9457,
T-9461 and T-9462

- NINE LENS OFFICE PHOTOGRAPHS
- △ TRIANGULATION STATIONS (NOT ON OFFICE PHOTOGRAPHS)
- ▲ TRIANGULATION STATIONS (IDENTIFIED AND HELD)
- ⊙ TRIANGULATION STATIONS (NOT HELD IN RADIAL PLOT)

Contours and cultural features were delineated simultaneously on the Reading Plotter, model A and B. Model A was employed on the western end of the strip of quadrangles (see diagram, page 5), working eastward, while model B started on the east end and worked westward to their meeting point near the middle of T-9455. The entire land area of all five quads of this report has been delineated in this mapping operation.
