DESCRIPTIVE REPORT

Type of Survey Topographic

T-9461

General locality Kotzebue Sound

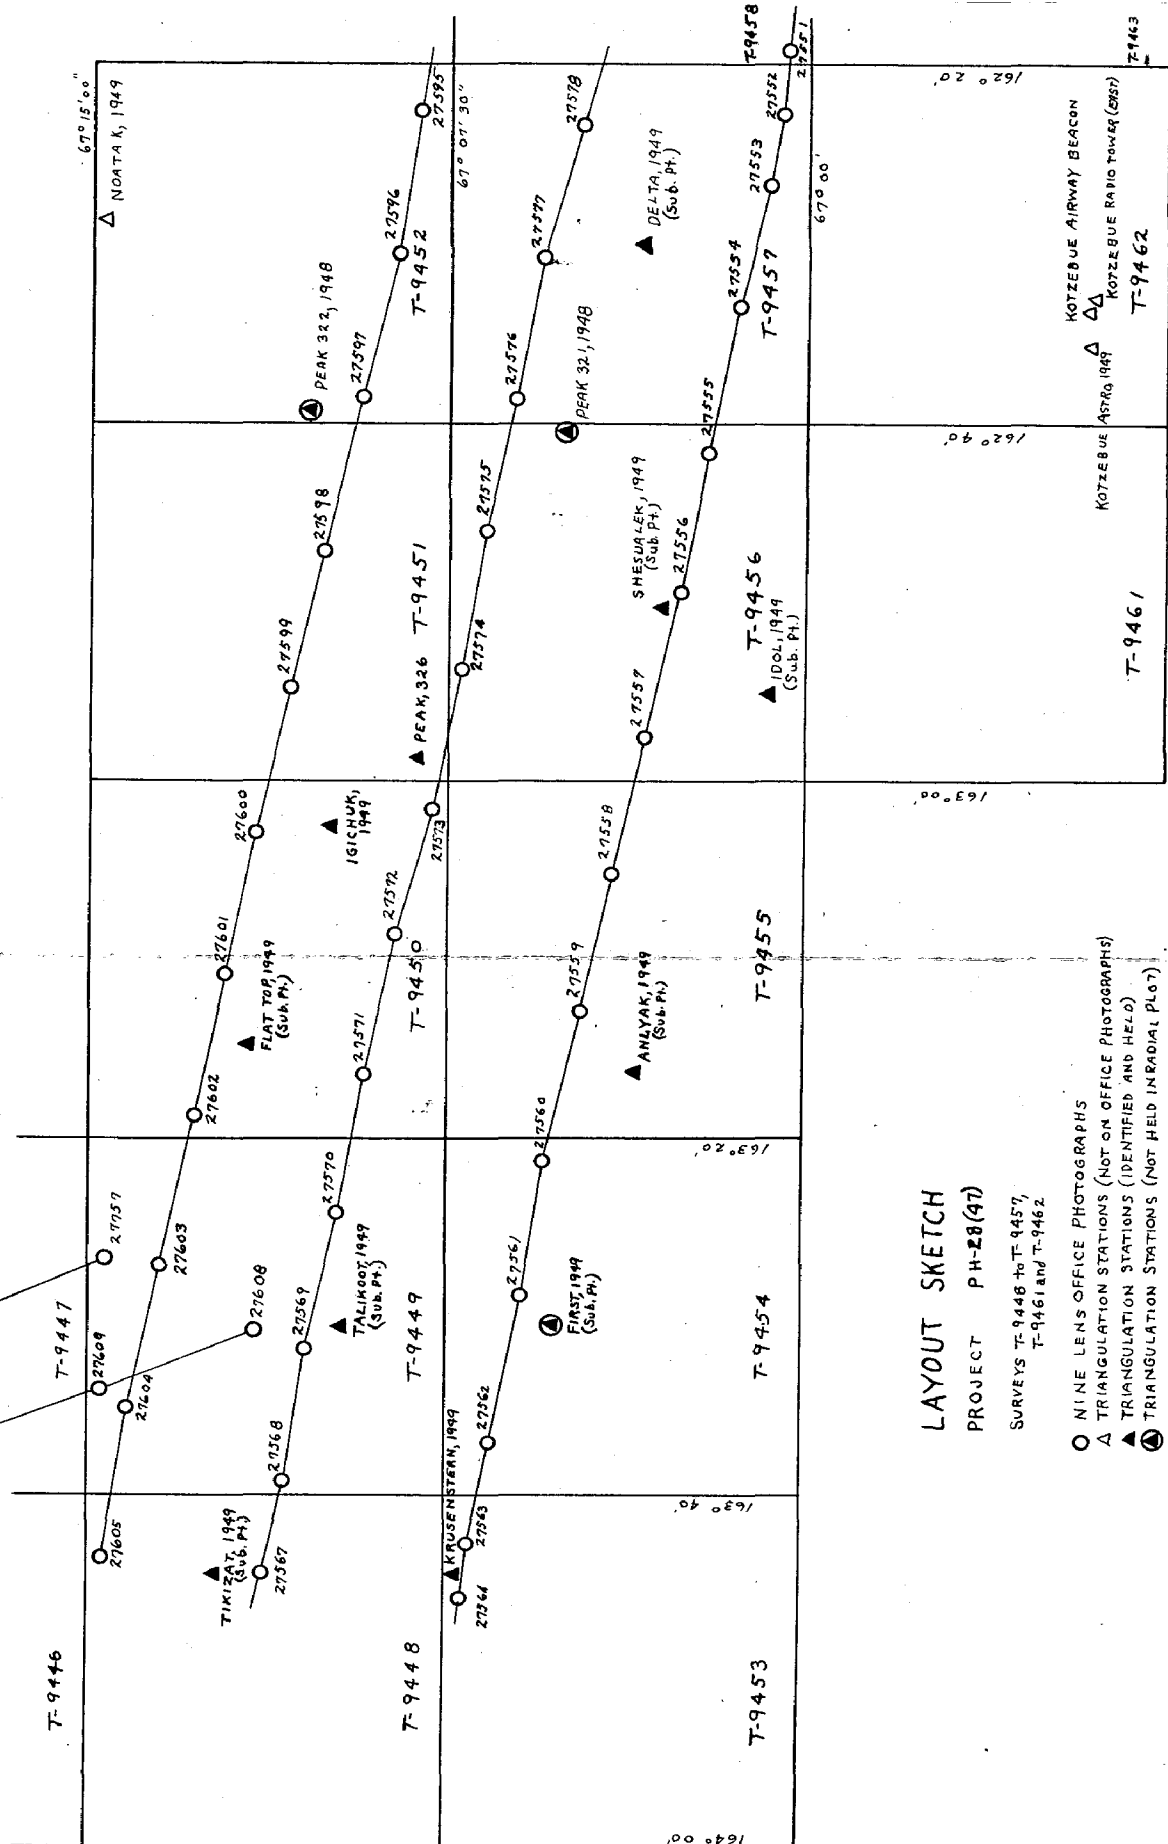
LAYOUT SKETCH

PROJECT PH-28(47)

SURVEYS T-9448 to T-9457,
T-9461 and T-9462

- NINE LENS OFFICE PHOTOGRAPHS
- △ TRIANGULATION STATIONS (NOT ON OFFICE PHOTOGRAPHS)
- ▲ TRIANGULATION STATIONS (IDENTIFIED AND HELD)
- TRIANGULATION STATIONS (NOT HELD IN RADIAL PLOT)

A sketch showing the layout of the these surveys and the distribution of control and photograph centers is attached to this report.
