DESCRIPTIVE REPORT

T-9479, 9480

General locality Kotzebue Sound

# TOPOGRAPHIC MAPPING PROJECT PH-28

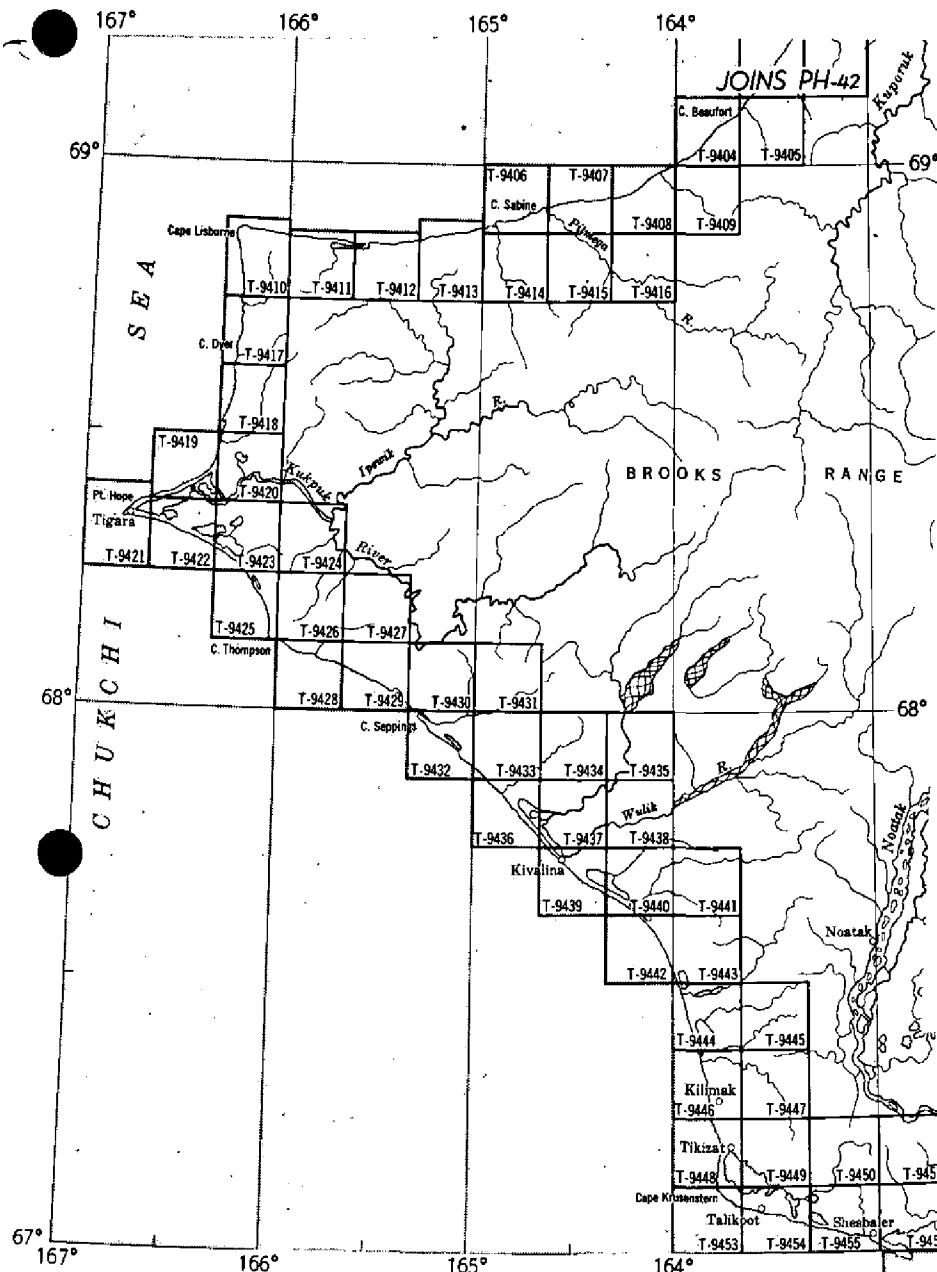
Page 5

Compiled at 1:20,000 scale, from 1:20,000 scale nine-lens photographs taken July, 1950 and June, 1951. For additional nine-lens photography refer to: Air-photo Index A-38 (1:20,000 scale, taken September 1947) Air-photo Index B-3 (1:28,000 scale taken Sept. 1947) Air-photo Index B-13 (1:20,000 scale, taken September 1947 and August 1948)

Junctions exist as shown on page 5; all are in agreement.

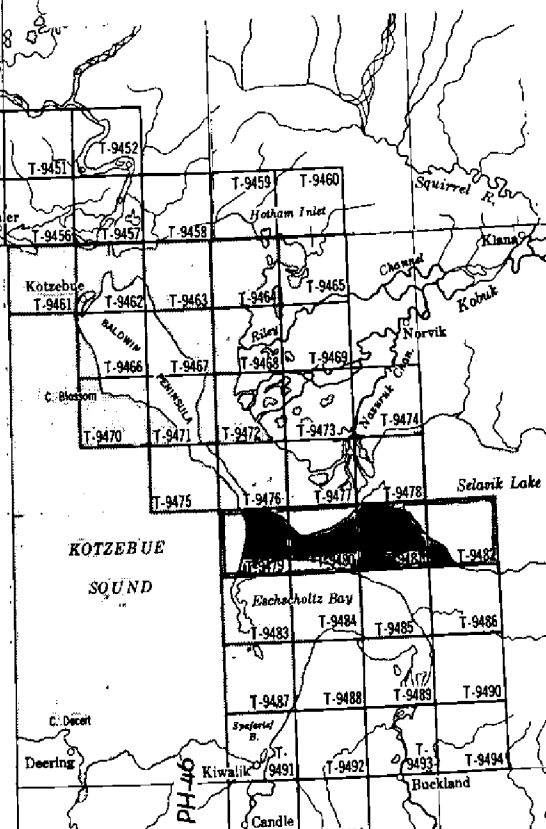
A sketch, showing the layout of surveys in this plot and the distribution of control and photograph centers, is attached to this report.
