Form 504 U. S. DEPARTMENT OF COMMERCE COAST AND GEODETIC SURVEY  <b>DESCRIPTIVE REPORT</b>	
Type of Survey	SHORELINE
Field No.	Office No. T-9826
<b>LOCALITY</b>	
State	ALASKA
General locality	PRINCE WILLIAM SOUND
Locality	MASKED BAY
<u>1950-54</u> <b>CHIEF OF PARTY</b> Field: G. A. Nelson Office: L. W. Swanson	
<b>LIBRARY &amp; ARCHIVES</b>	
DATE

T - 9826

Prince William Sound, Alaska

This shoreline manuscript, scale 1:10,000, is one of 43 maps that comprise Project PH-152, which is in the western part of Prince William Sound. T-9826 includes the north end of Chenega Island and part of Dangerous Passage and Masked Bay.

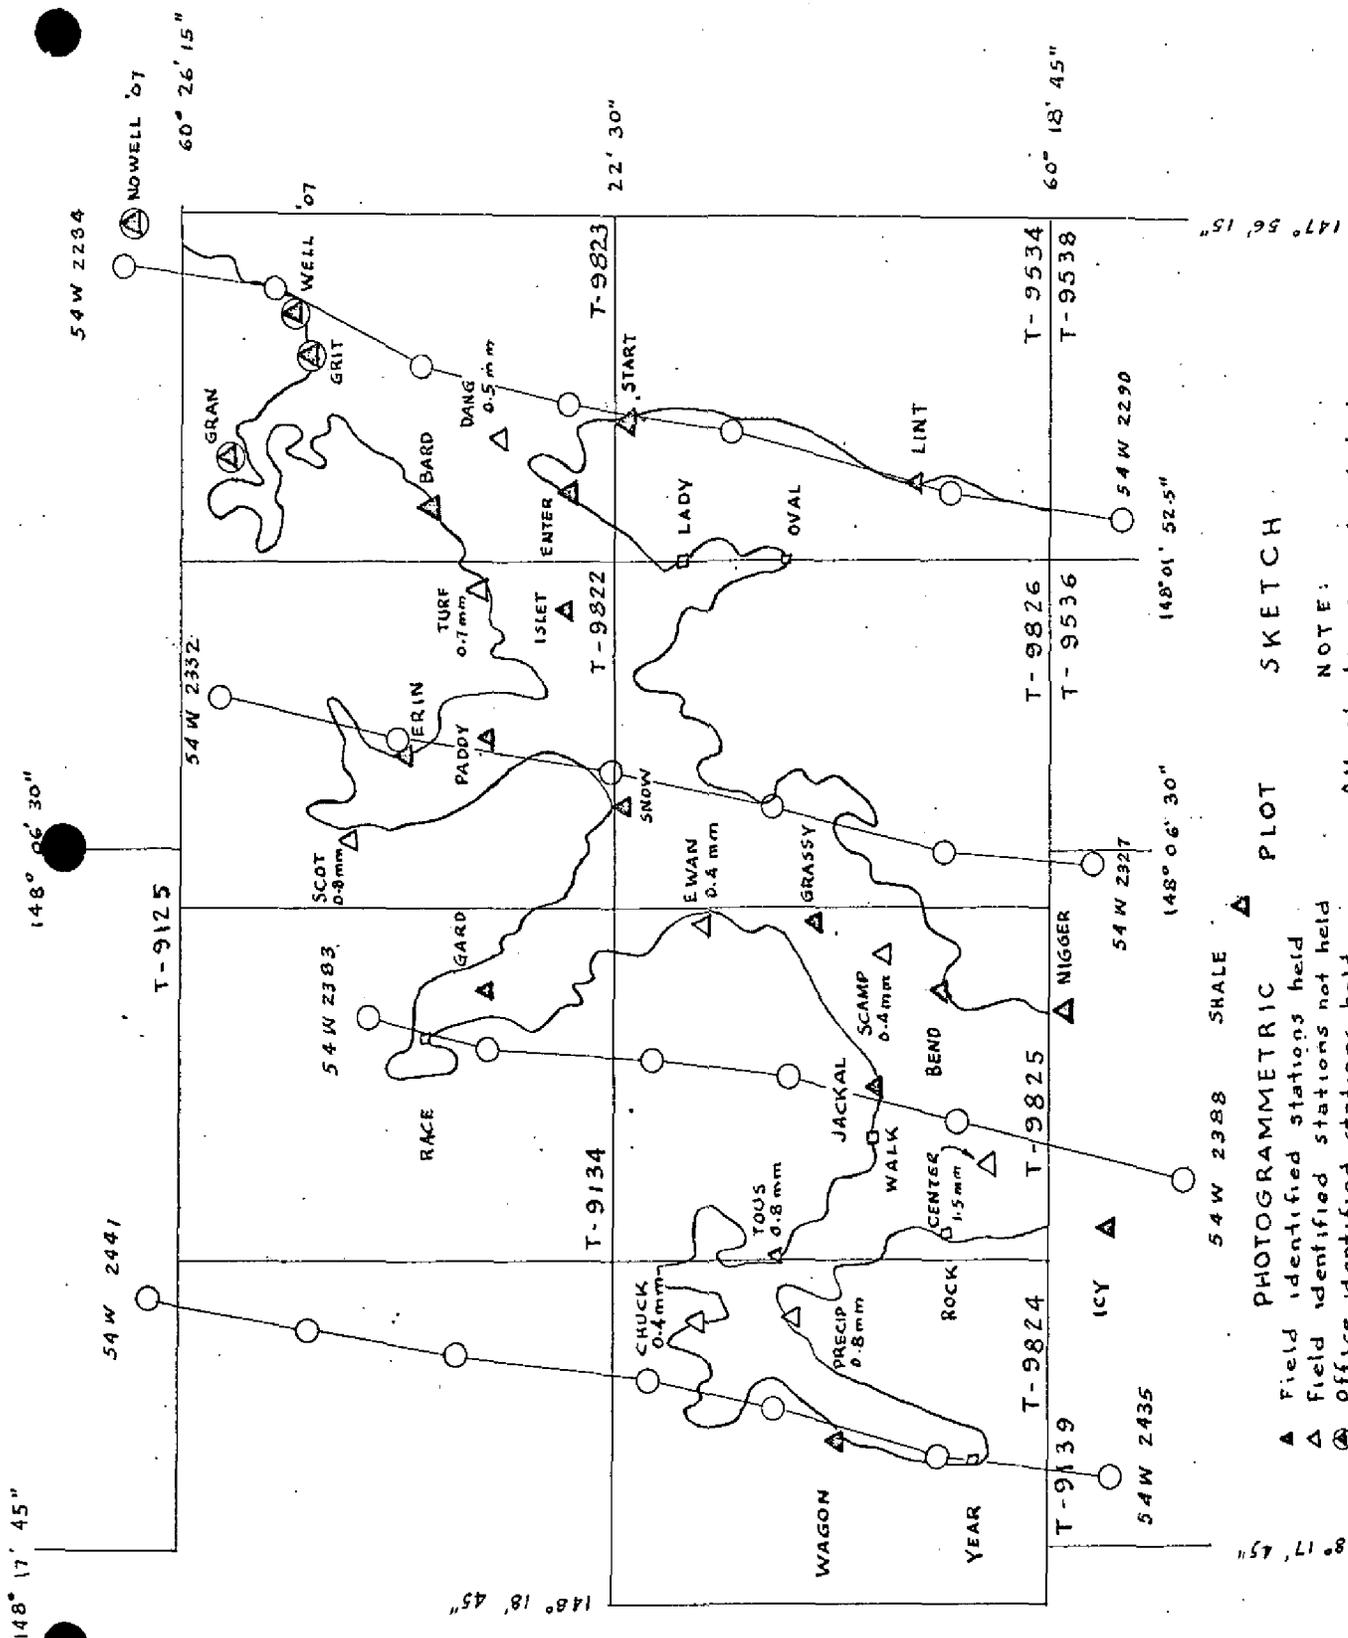
PHOTOGRAMMETRIC PLOT SKETCH

The control throughout most of the area was adequate. Of the 29 stations used, 20 of them held. (within 0.3mm). Three of them were held within 0.4mm. Those stations missed by larger amounts were SCOT (0.8mm N.E.) TURF (0.7mm N. W.) PRECIP (0.8mm N.E.) TOUS (0.8mm N) CENTER (1.5mm N.W.). All of these stations which were missed by large amounts were field-identified as questionable except CENTER 1933 which was due to erroneous identification on the field photograph. Plot positions for station BANG, 0.5mm difference and CHUCK, 0.4 mm. difference were formed by only two radials. Discrepancies thus are unchecked. Station CHUCK could easily have been misidentified by this amount.

- ▲ Field identified stations held
- △ Field identified stations not held
- ⊙ Office identified stations held
- ⊚ Office identified stations not held
- Topographic stations located by plot

This radial plot comprises seven manuscripts covering the area of Dangerous Passage and including the northern part of Chenega Island. The surveys included are T-9134, T-9822 thru T-9826 and T-9534.

The plot was begun on T-9825 which was thought to be strongest controlled, junctioning with positions and control on T-9139. The plot was continued up Dangerous Passage with the best controlled templates. The weaker controlled templates were then added and the plot was re-adjusted to fit control and improve pass point intersections.

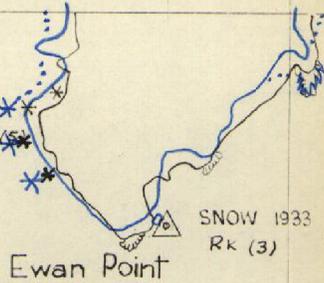
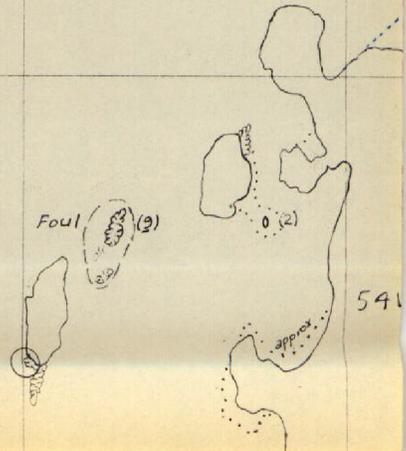
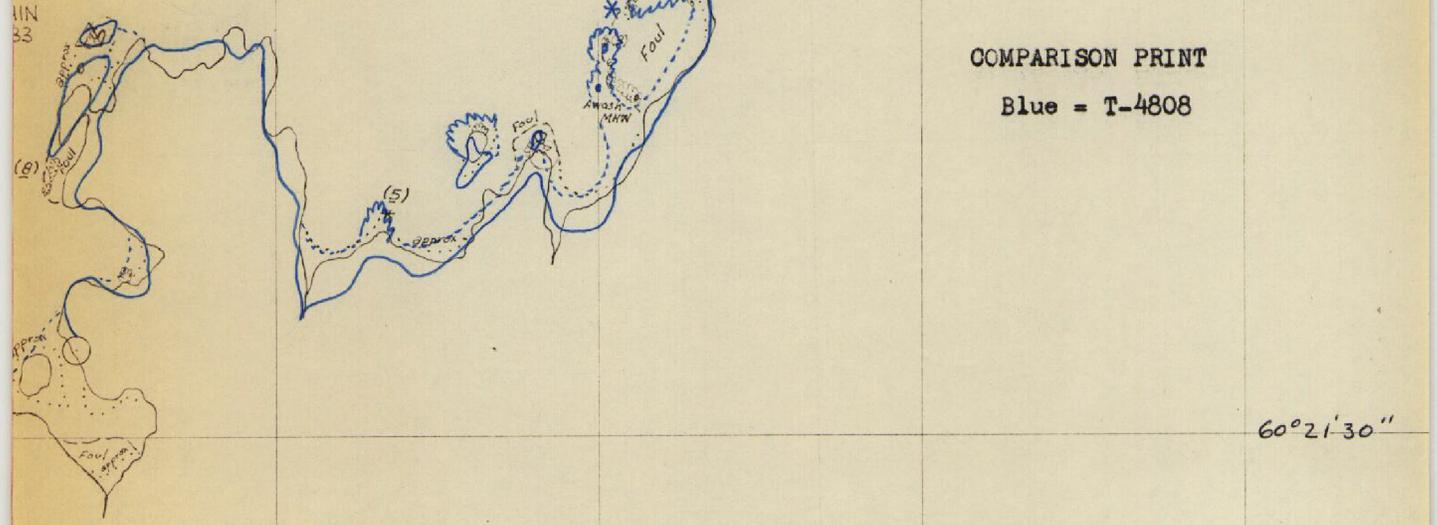
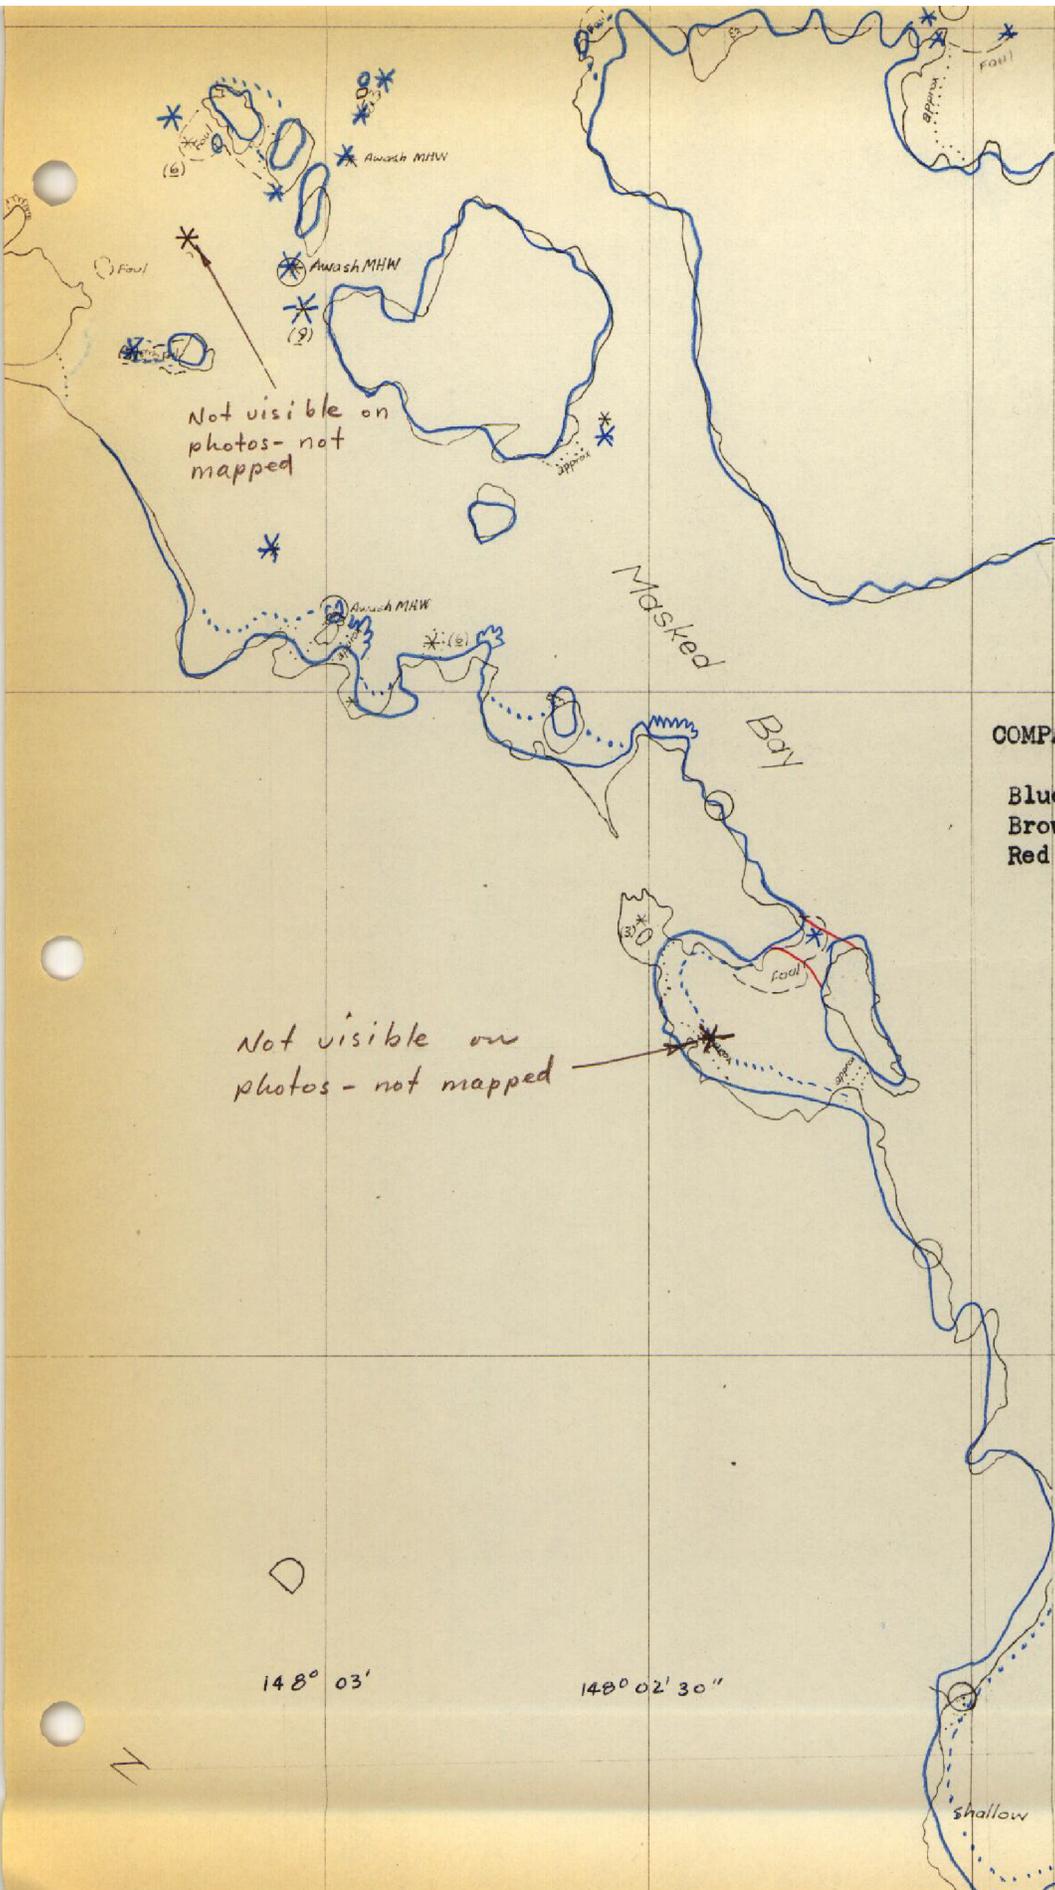
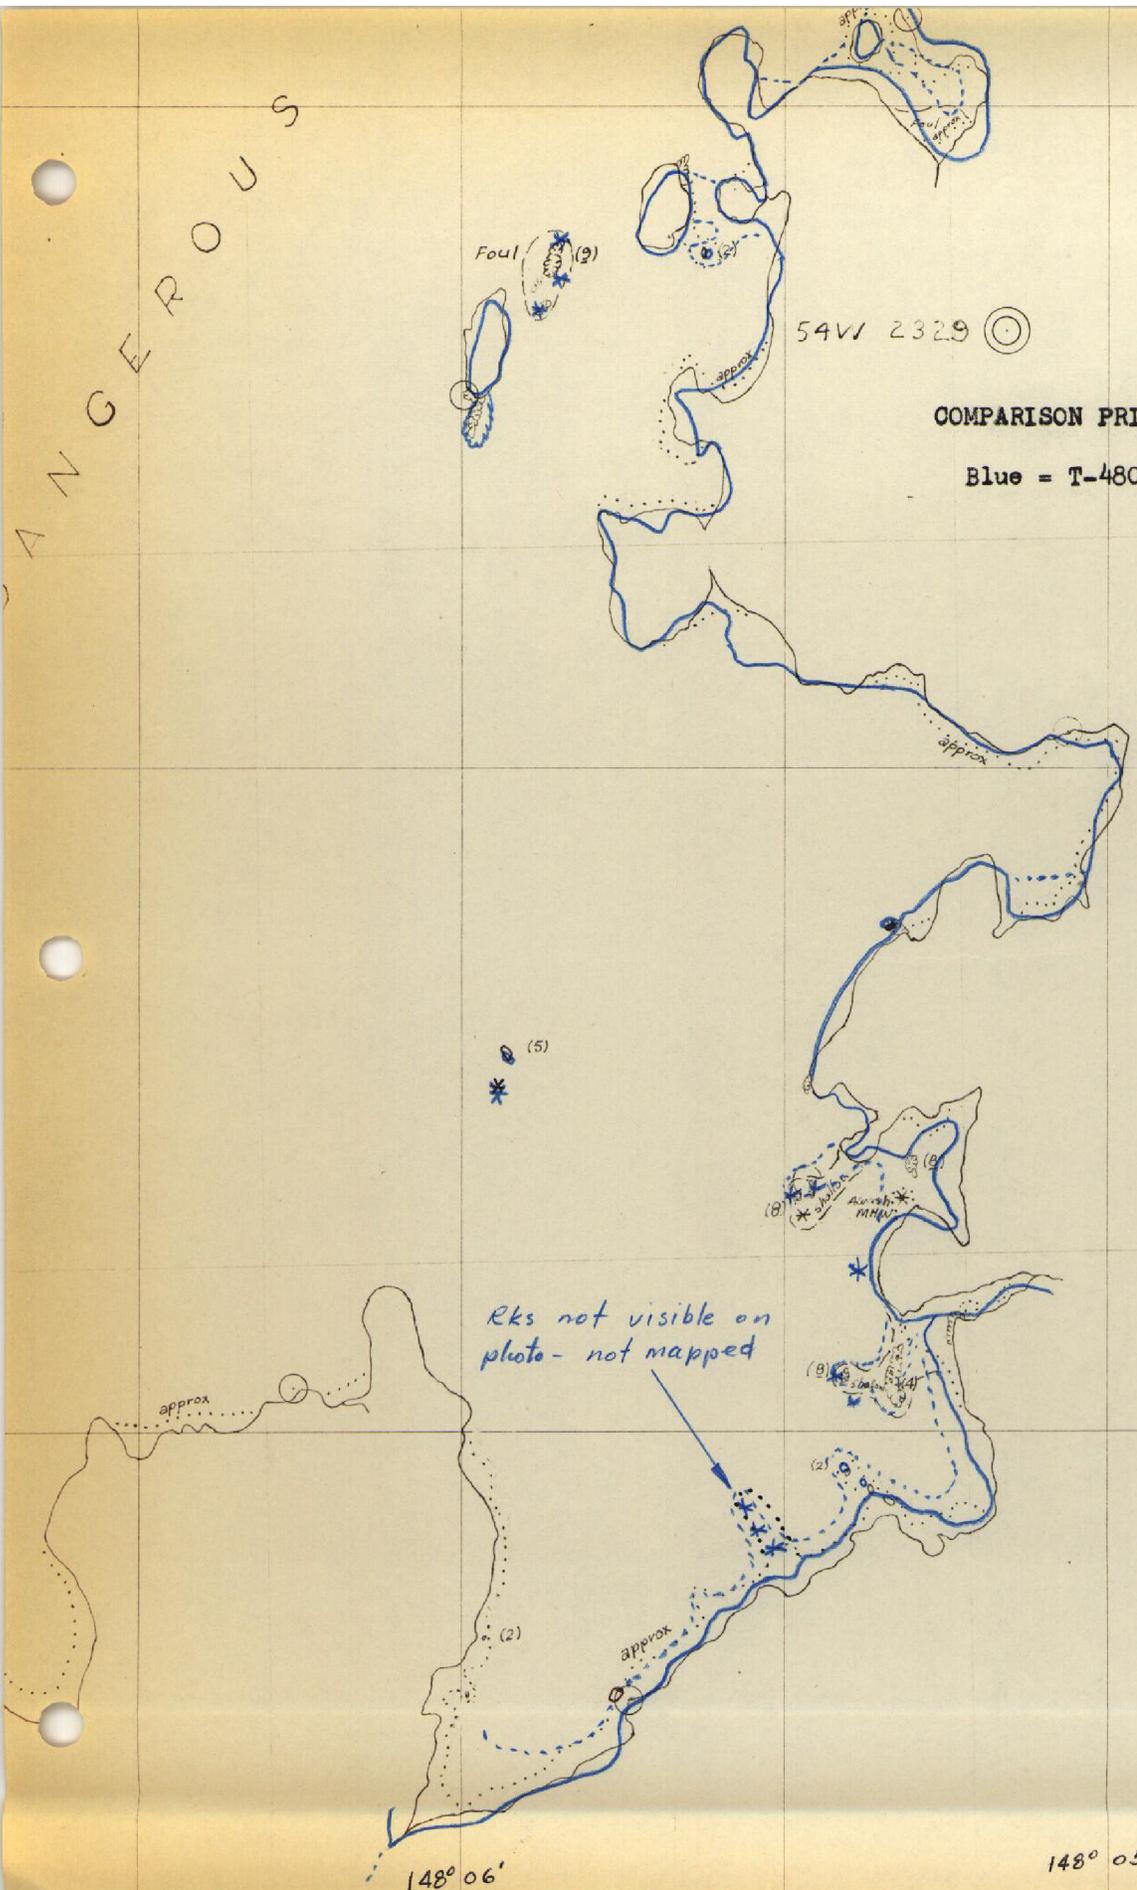
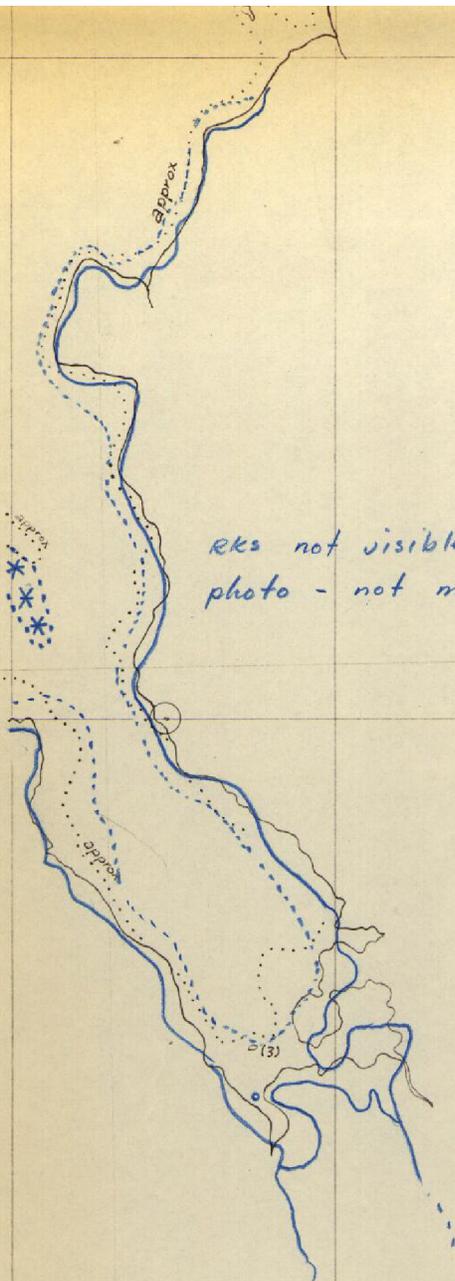
COMPARISON PRINT

Blue = T-4808

Not visible on photos -  
not mapped

- Blue = T-4808
- Brown = SEWARD (B-3)
- Red = Chart 8515

Rks not visible on photo - not mapped

RRs not visible on photo - not mapped.

An ozalid comparison print, (pages 25 through 30), with differences noted in Items 62 through 65, is bound with the original of this report.

A comparison was made with Survey T-4808, scale 1:20,000, dated May - June 1933, using triangulation common to both maps and one projection intersection to control the comparison. The number of stations was adequate for this comparison. Differences between T-4808 and T-9826 are shown in blue on the comparison print.

The general trend of the shoreline is about the same. Most rock positions compare favorably.

A visual comparison was made with U.S.G.S. Quadrangle SEWARD (B-3), ALASKA, scale 1:63,360, dated 1950. Differences are noted on the comparison print in brown.

A visual comparison was made with Chart 8515, scale 1:80,000, 10th edition, dated October 25, 1969. One difference at latitude  $60^{\circ}21.8'$ , longitude  $148^{\circ}02.2'$  is shown in red on the comparison print.
