## DESCRIPTIVE REPORT

Type of Survey PLANIMETRICField No. \_\_\_\_\_ Office No. T-9946

State OREGONGeneral locality NETARTS BAYLocality NETARTS BAY1955Fred Natella, ~~Chief of Party~~ CHIEF OF PARTY  
Division of Photogrammetry, Washington, D. C.  
Alfred C. Holmes, Director, A. M. C.

# PLANIMETRIC PROJECT PH-157 NETARTS BAY, OREGON

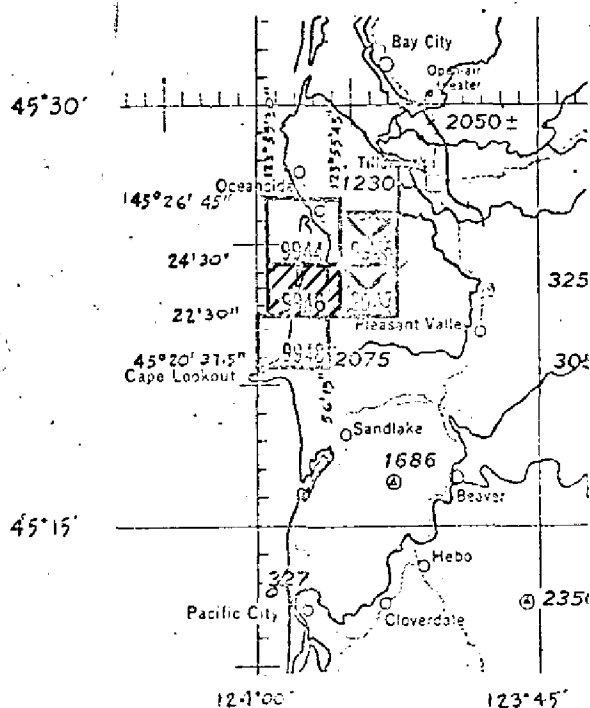
This 1:5,000 scale planimetric manuscript is the center one of three maps that comprise Project PH-157, Netarts Bay, Oregon. Originally, five maps were planned, but the two easterly maps, T-9945 and T-9947, were cancelled. The east and west neatlines of T-9946 were moved one half minute to the east at the time of final review, in order that the east side of Netarts Bay would be within the map limit and not in the east margin.

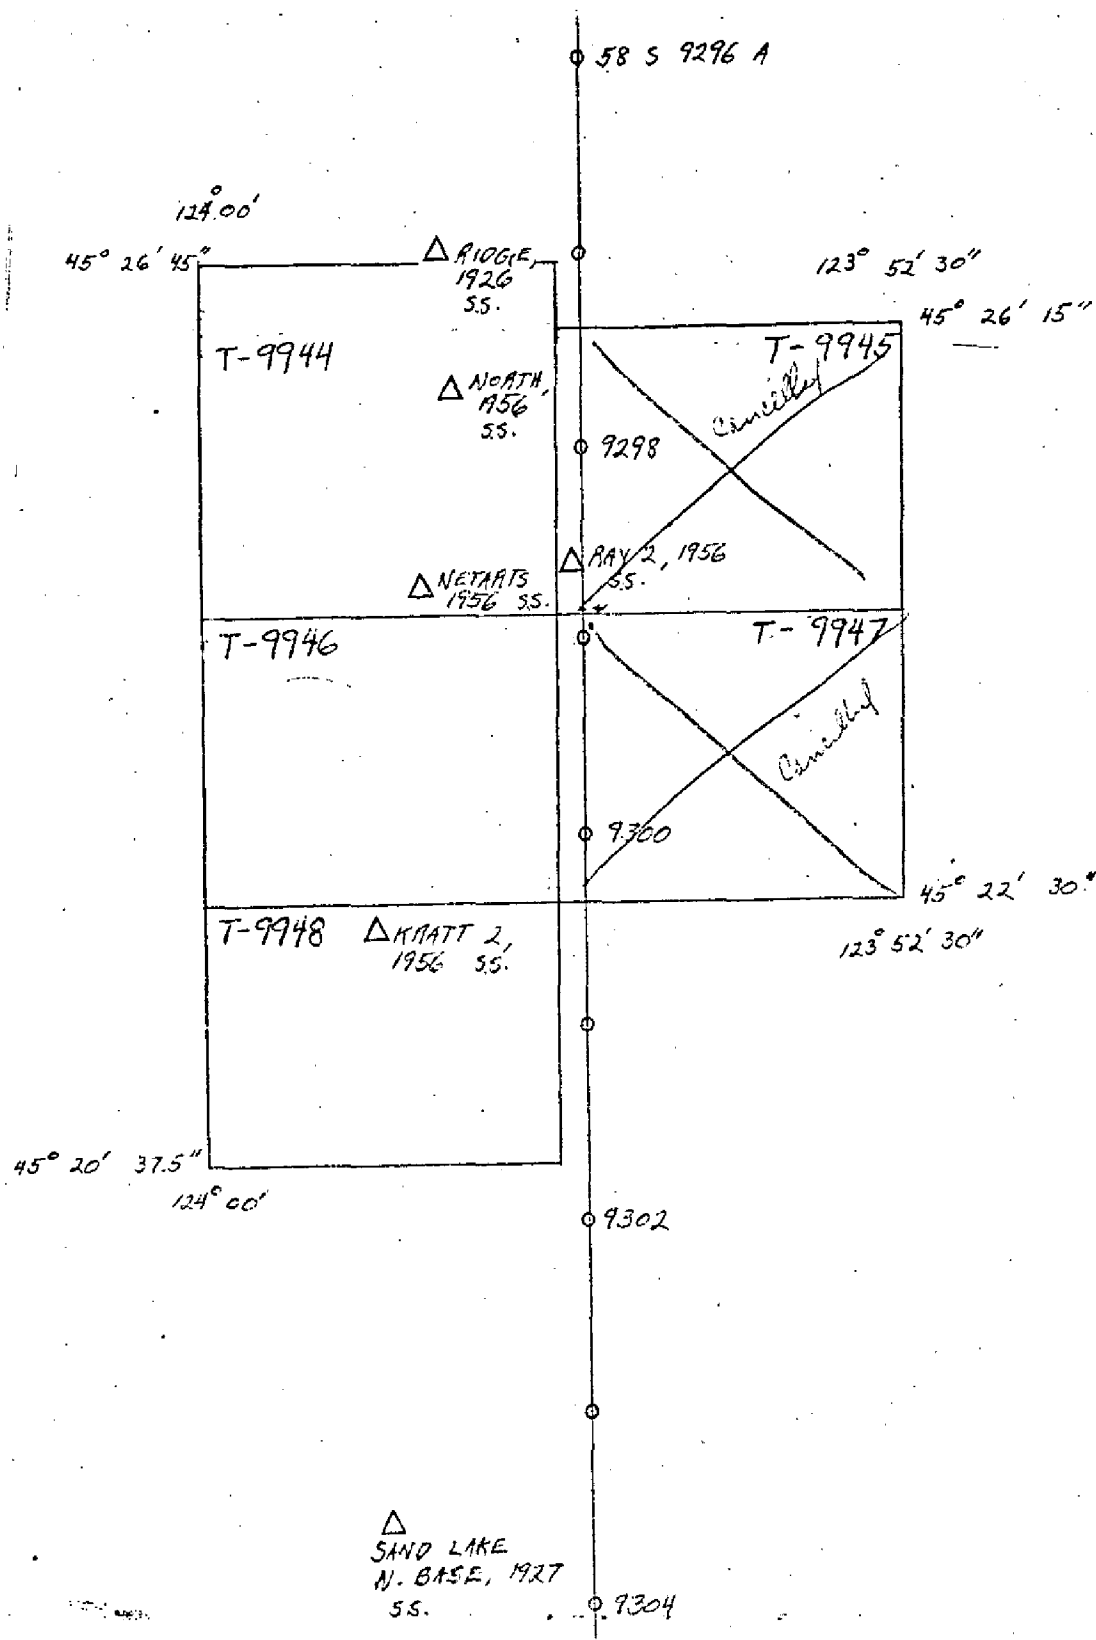
NETARTS BAY, OREGON PROJECT PH-6157

This new stereoplanigraph bridge was done to furnish pass points to control the compilation of planimetric detail by Kelsh plotter. East-West flights which were available were not included for bridging because the flights lacked sufficient control to assure accuracy to the eastern limit of the project layout. Because of this and the paucity of planimetric detail in this area, the project layout will be revised to extend only to the limit of compilation from this single flight of photographs. Photographs used in this stereo-bridge were numbered 58S9296A through 9304 and are at a scale of 1:30,000.
