| DESCRIPTIVE REPORT | |
| Type of Survey ..... Coastal Zone Map | |
| Job No. ..PH-7113..... | Map No. TP-00432..... |
| Locality ..Turkey Point..... | |

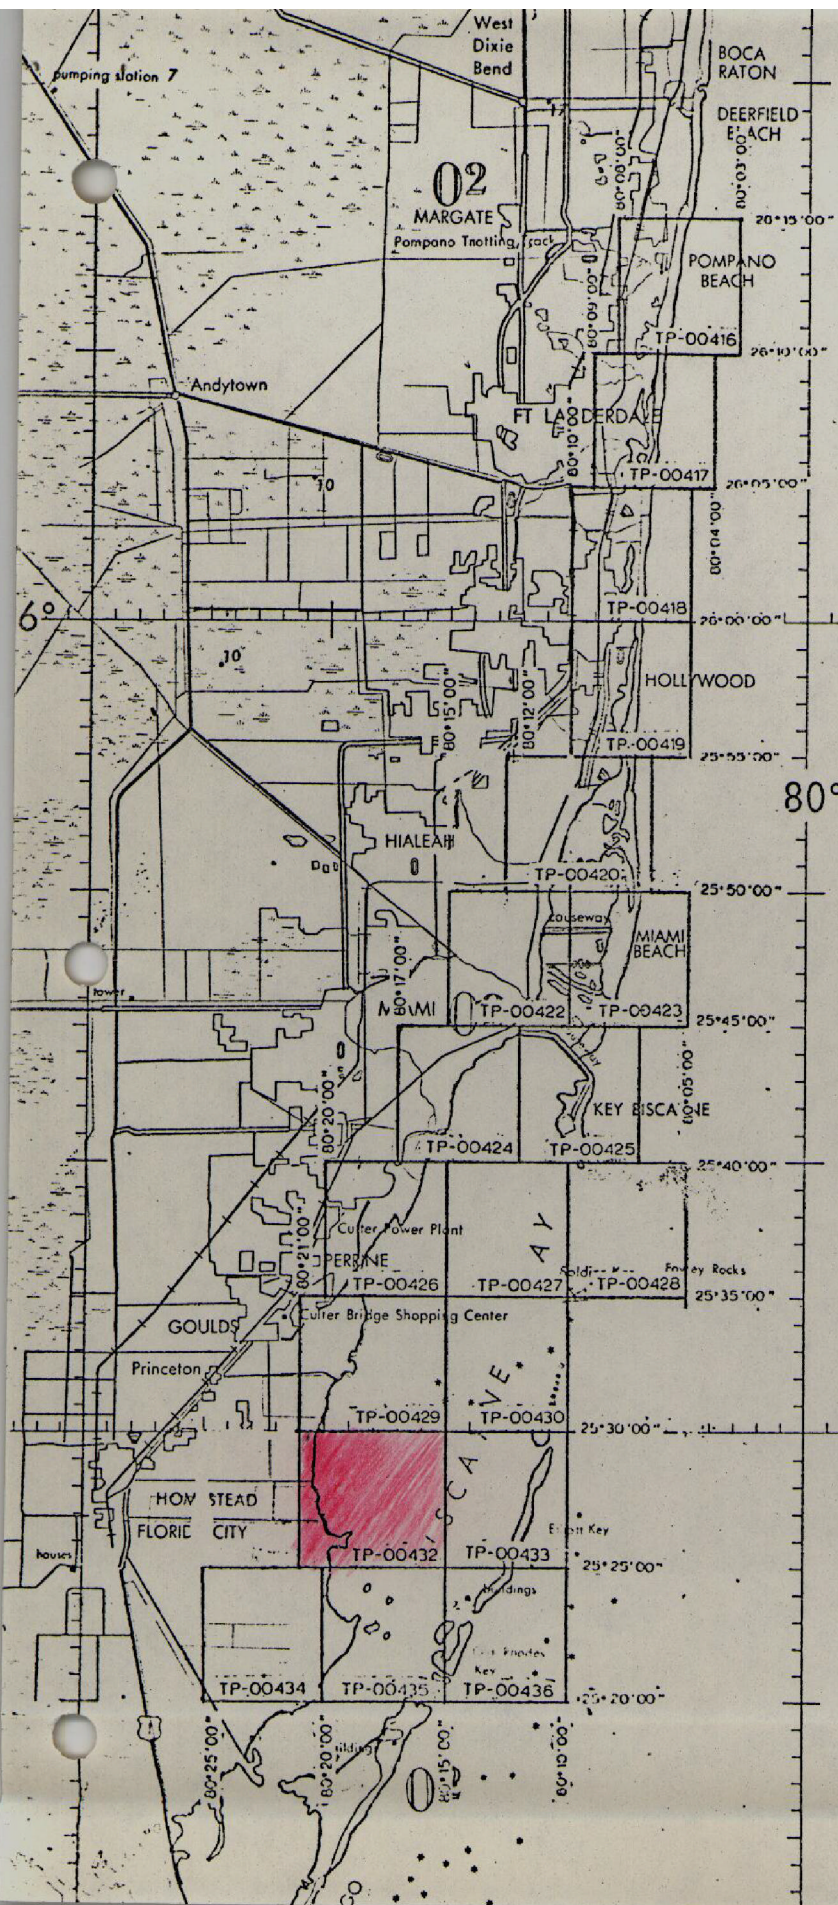
JOB PH-7113  
HILLSBORO INLET to CARD SOUND  
FLORIDA  
SHORELINE MAPPING  
SCALE 1:10,000

A layout for Job PH-7113 (revised since the aerotriangulation operation) will show the location of individual maps. A copy of this layout is included in this Descriptive Report.

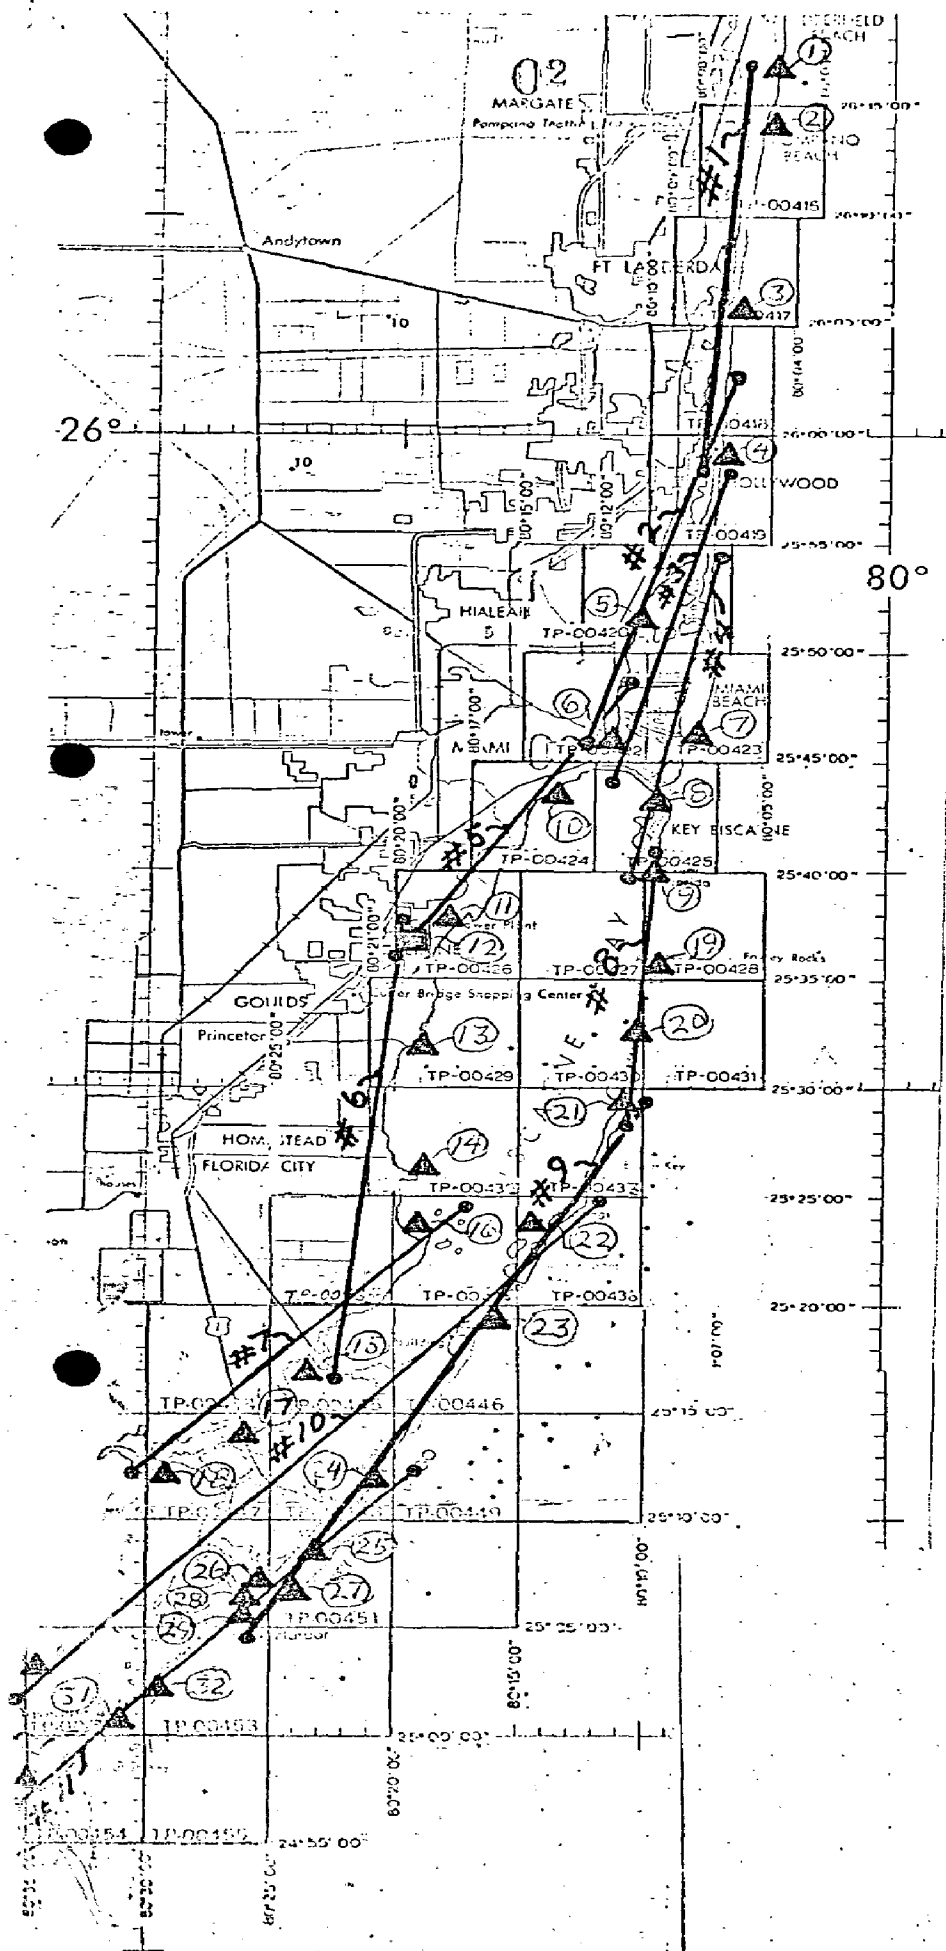
CONTROL STATIONS  
USED IN THE  
ADJUSTMENTS

CONTROL STATIONS

Image points were located to rectify photographs for orthophoto, nautical, and small craft charts. All points were drilled by the PUG method. Closure to control has been noted on the read-outs. A sketch is attached which shows the control used in the strip and block adjustments. All points were plotted on the Florida East Zone Plane Coordinate System using the Coradomat Plotter or the Calcomp Plotter.

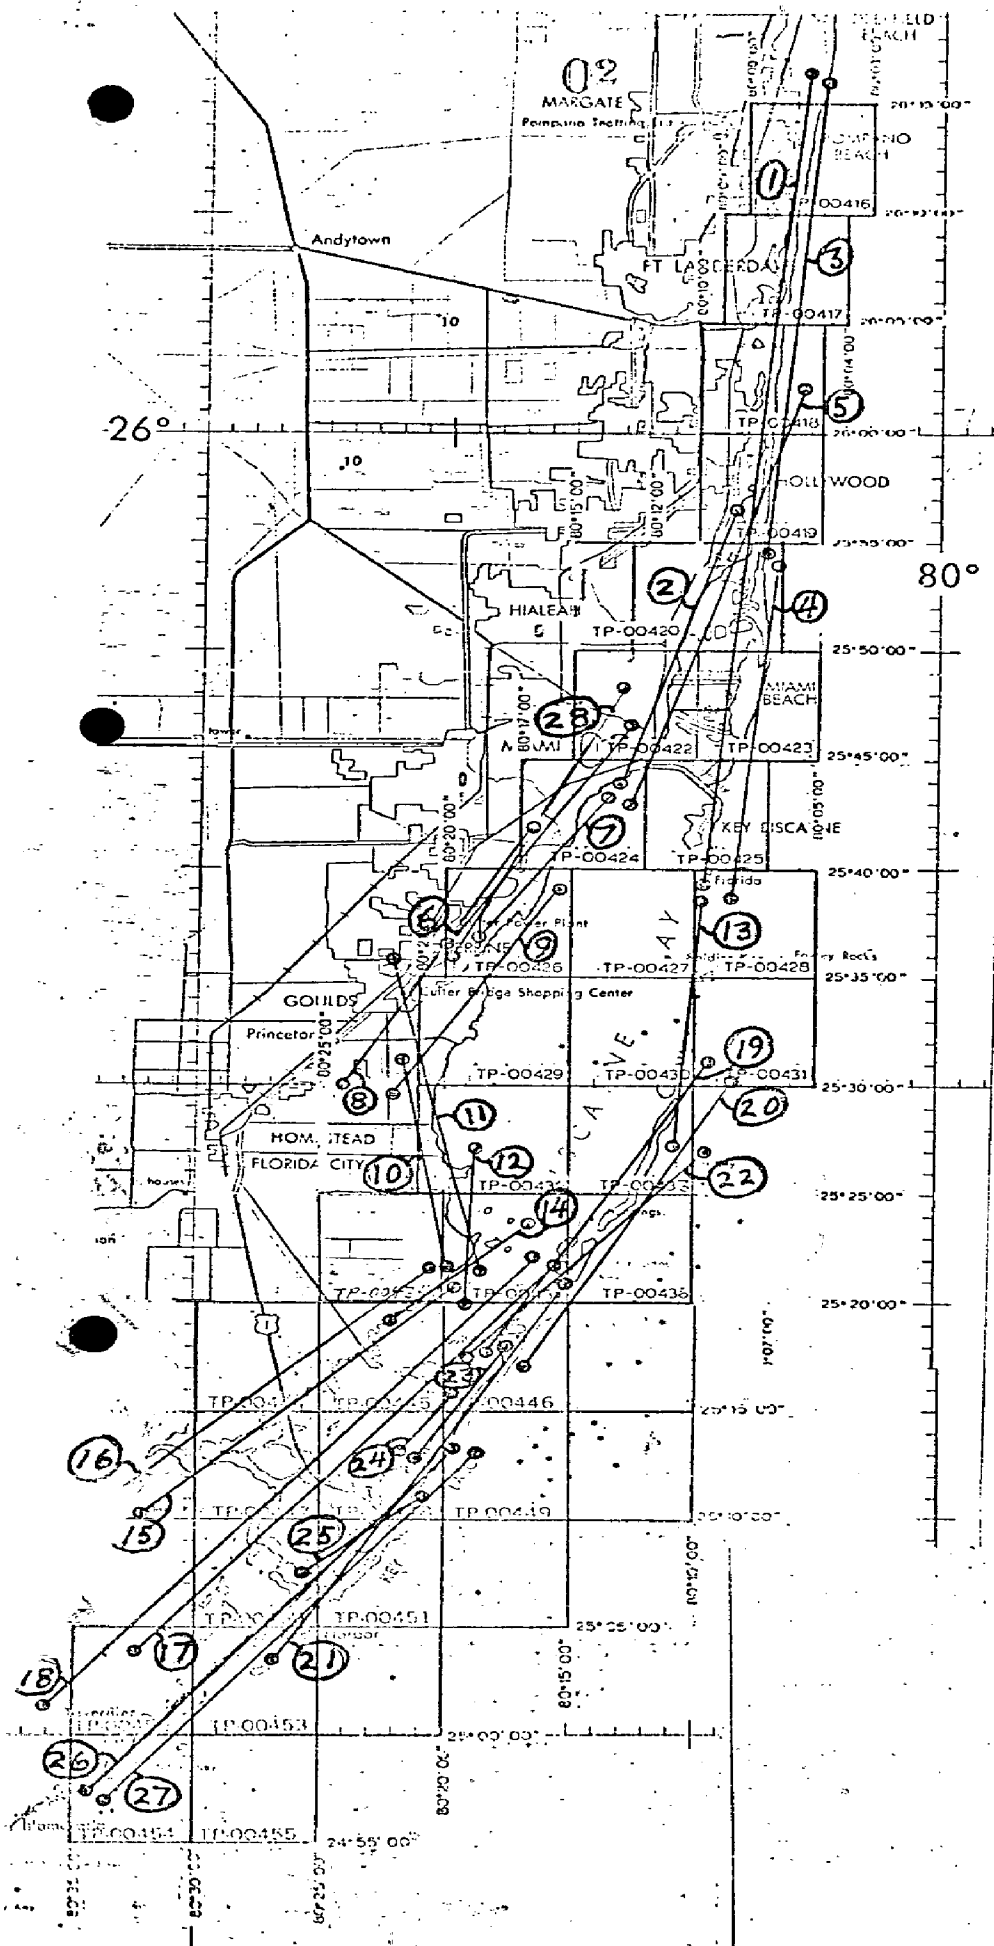
JOB PH-7113  
AND  
JOB PH-7119

## INFRA-RED CONTACT PRINTS

1. 71K 5632R - 5660R MLW
2. 71K 5662R - 5672R MLW
3. 71K 5750R - 5766R MHW
4. 71K 5795R - 5806R MHW
5. 71K 5815R - 5829R MHW
6. 71L 8501R - 8509R MLW
7. 71L 8512R - 8520R MLW
8. 71L 8571R - 8580R MHW
9. 71L 8523R - 8530R MLW
10. 71L 8783R - 8791R MHW
11. 71L 8584R - 8593R MHW
12. 71L 8532R - 8537R MLW
13. 71L 9067R - 9080R MLW
14. 71L 8337R - 8341R MHW
15. 72K 6287R - 6298R MHW
16. 72K 6572R - 6584R MLW
17. 72K 6546R - 6563R MLW
18. 72K 6311R - 6330R MHW
19. 71L 8544R - 8559R MLW
20. 71L 8648R - 8662R MLW
21. 72K 6480R - 6499R MHW
22. 71L 8697R - 8705R MHW
23. 72K 6344R - 6350R MLW
24. 72K 6253R - 6255R MLW
25. 72K 6420R - 6423R MHW
26. 72K 6501R - 6515R MHW
27. 72K 6368R - 6382R MLW
28. 71K 5847R - 5856R MHW

Ratio points were located on twenty-eight (28) strips of infrared contact prints. Additional ratio points were located on contact prints which have a large portion of water coverage so that they could be individually enlarged to scale. A sketch showing the location of the infrared photographs is attached.
