DESCRIPTIVE REPORT

Type of Survey ... Coastal Boundary

Job No. PH-7119 Map No. TP-00447

Locality ... Shell Key

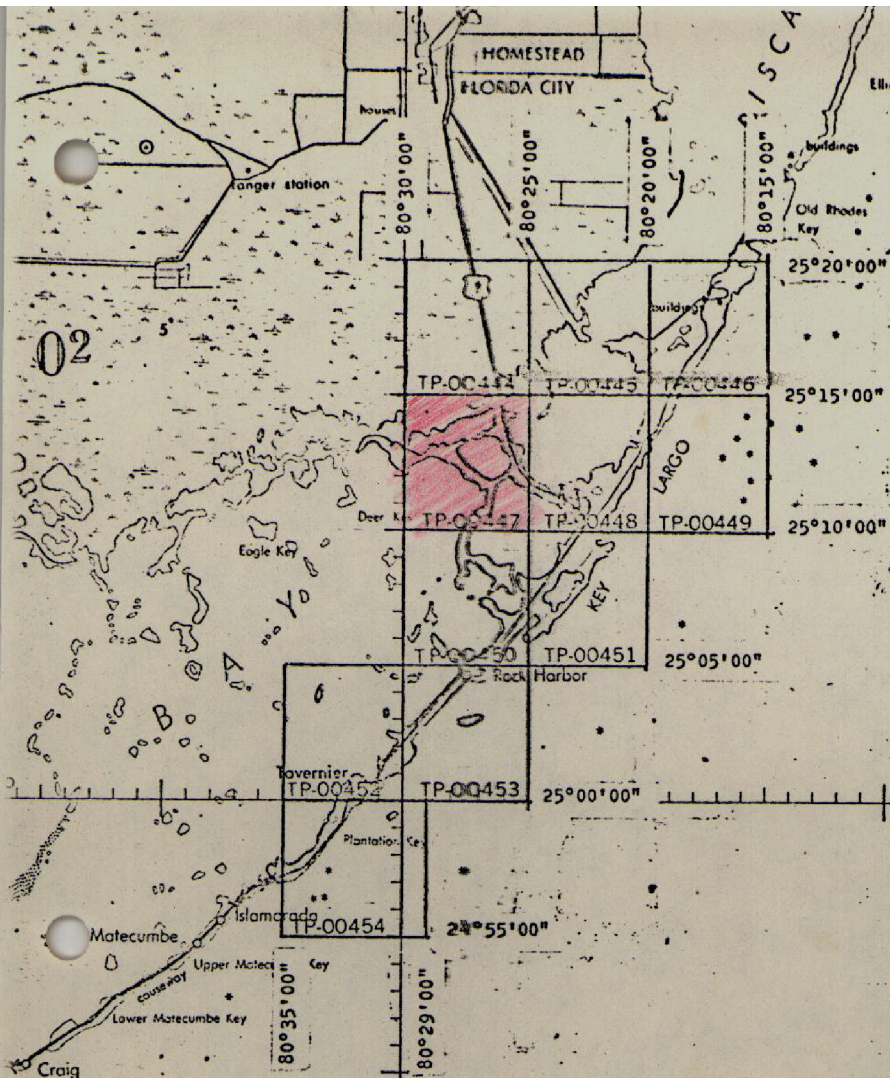
JOB PH-7119
 CARD SOUND to PLANTATION KEY
 FLORIDA
 SHORELINE MAPPING
 SCALE 1:10000

A layout of Job PH-7119 (revised since the aerotriangulation operation) will show the location of the individual maps. A copy of this layout is included in this Descriptive Report.

Sheet No.	Sq. Miles
TP-00444	2
TP-00445	8
TP-00446	6
<u>TP-00447</u>	10
TP-00448	8
TP-00449	2
TP-00450	8
TP-00451	4
TP-00452	4
TP-00453	6
TP-00454	5
Total	63

Coastal Zone Map TP- 00447 is one of eleven (11), 1:10,000 scale (shoreline type) maps in Job PH-7119. These maps will not be published. Interior detail is limited to a narrow zone of planimetry usually back to and including the first road.

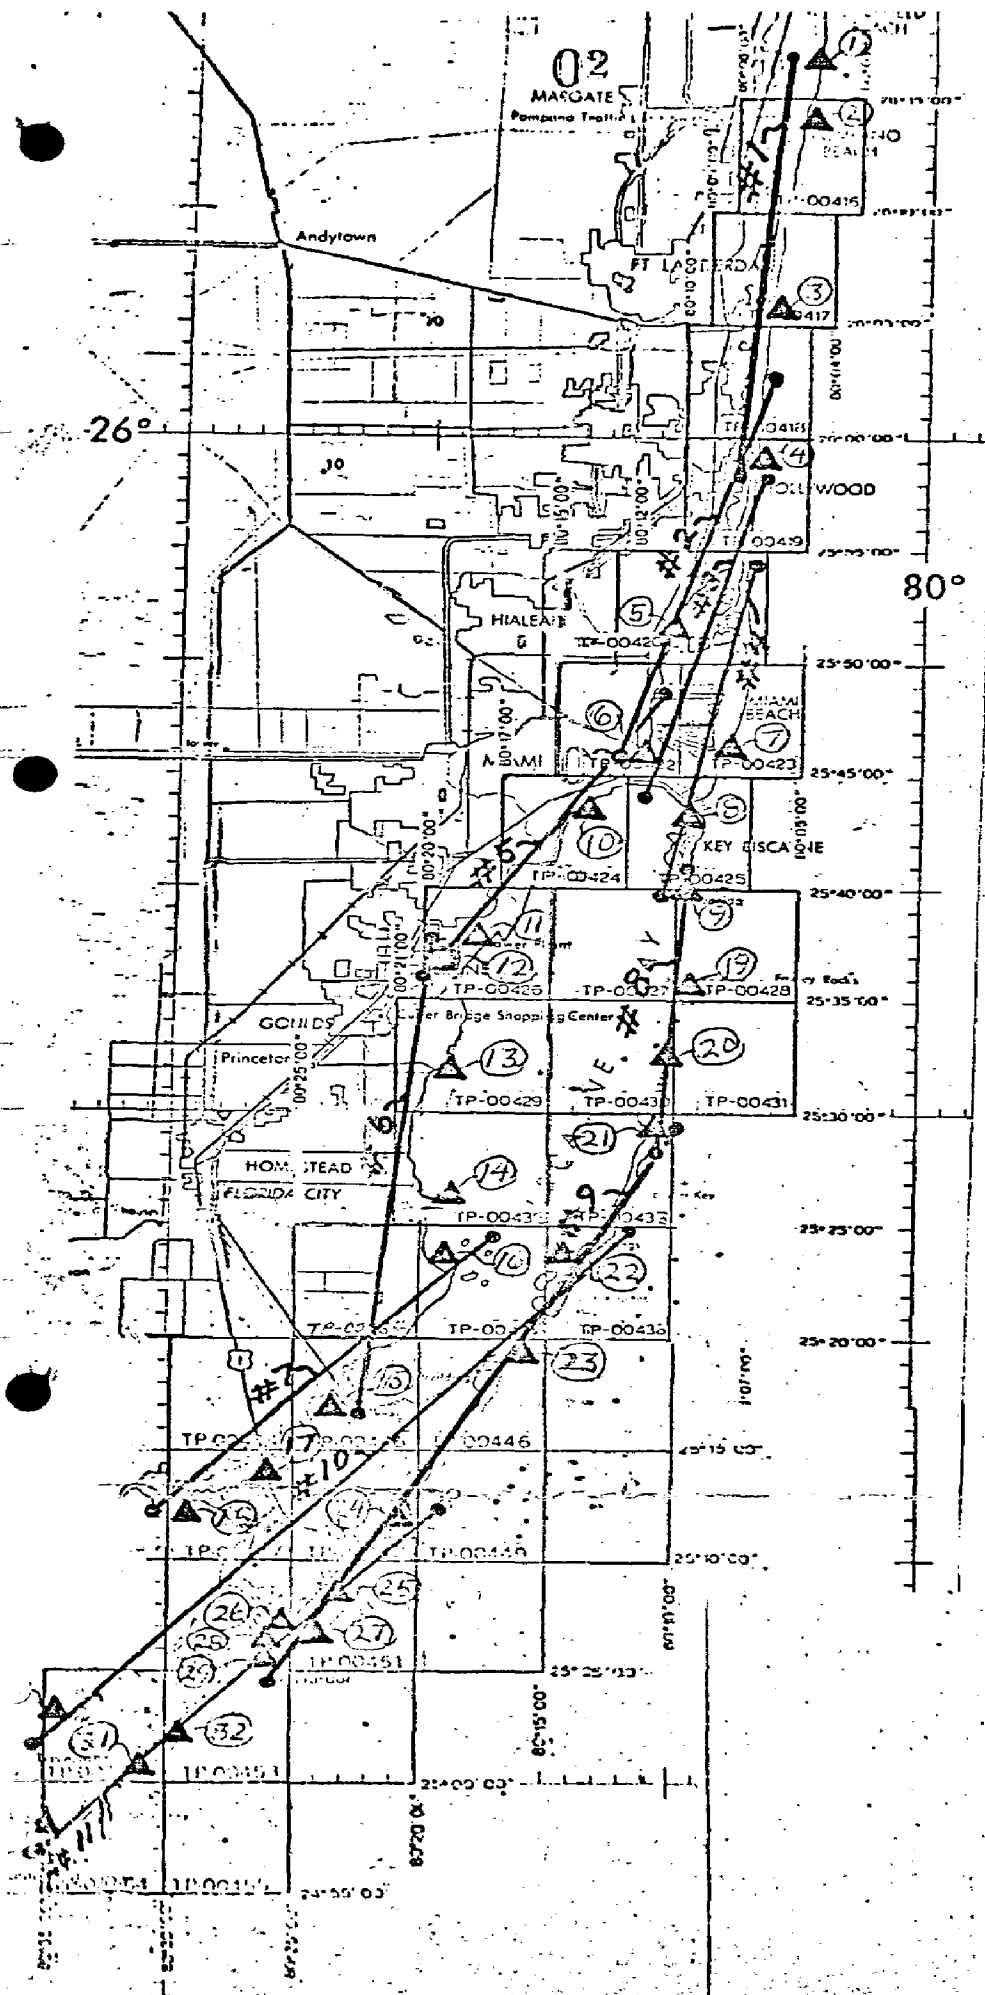
CONTROL STATIONS
USED IN THE
ADJUSTMENTS

Image points were located to rectify photographs for orthophoto, nautical, and small craft charts. All points were drilled by the PUG method. Closure to control has been noted on the read-outs. A sketch is attached which shows the control used in the strip and block adjustments. All points were plotted on the Florida East Zone Plane Coordinate System using the Coradomat Plotter or the Calcomp Plotter.

A listing of closures to control is included on an attached sheet of control stations. The station with the largest residual is Narrow Point 1854, with 1.808 feet in X and 1.267 feet in Y.
