| DESCRIPTIVE REPORT | |
| Map No.<br>TP-00977 | Edition No.<br>1 |
| Type of Survey<br>Shoreline | |
| Locality<br>Port Tampa to Gadsden Point | |

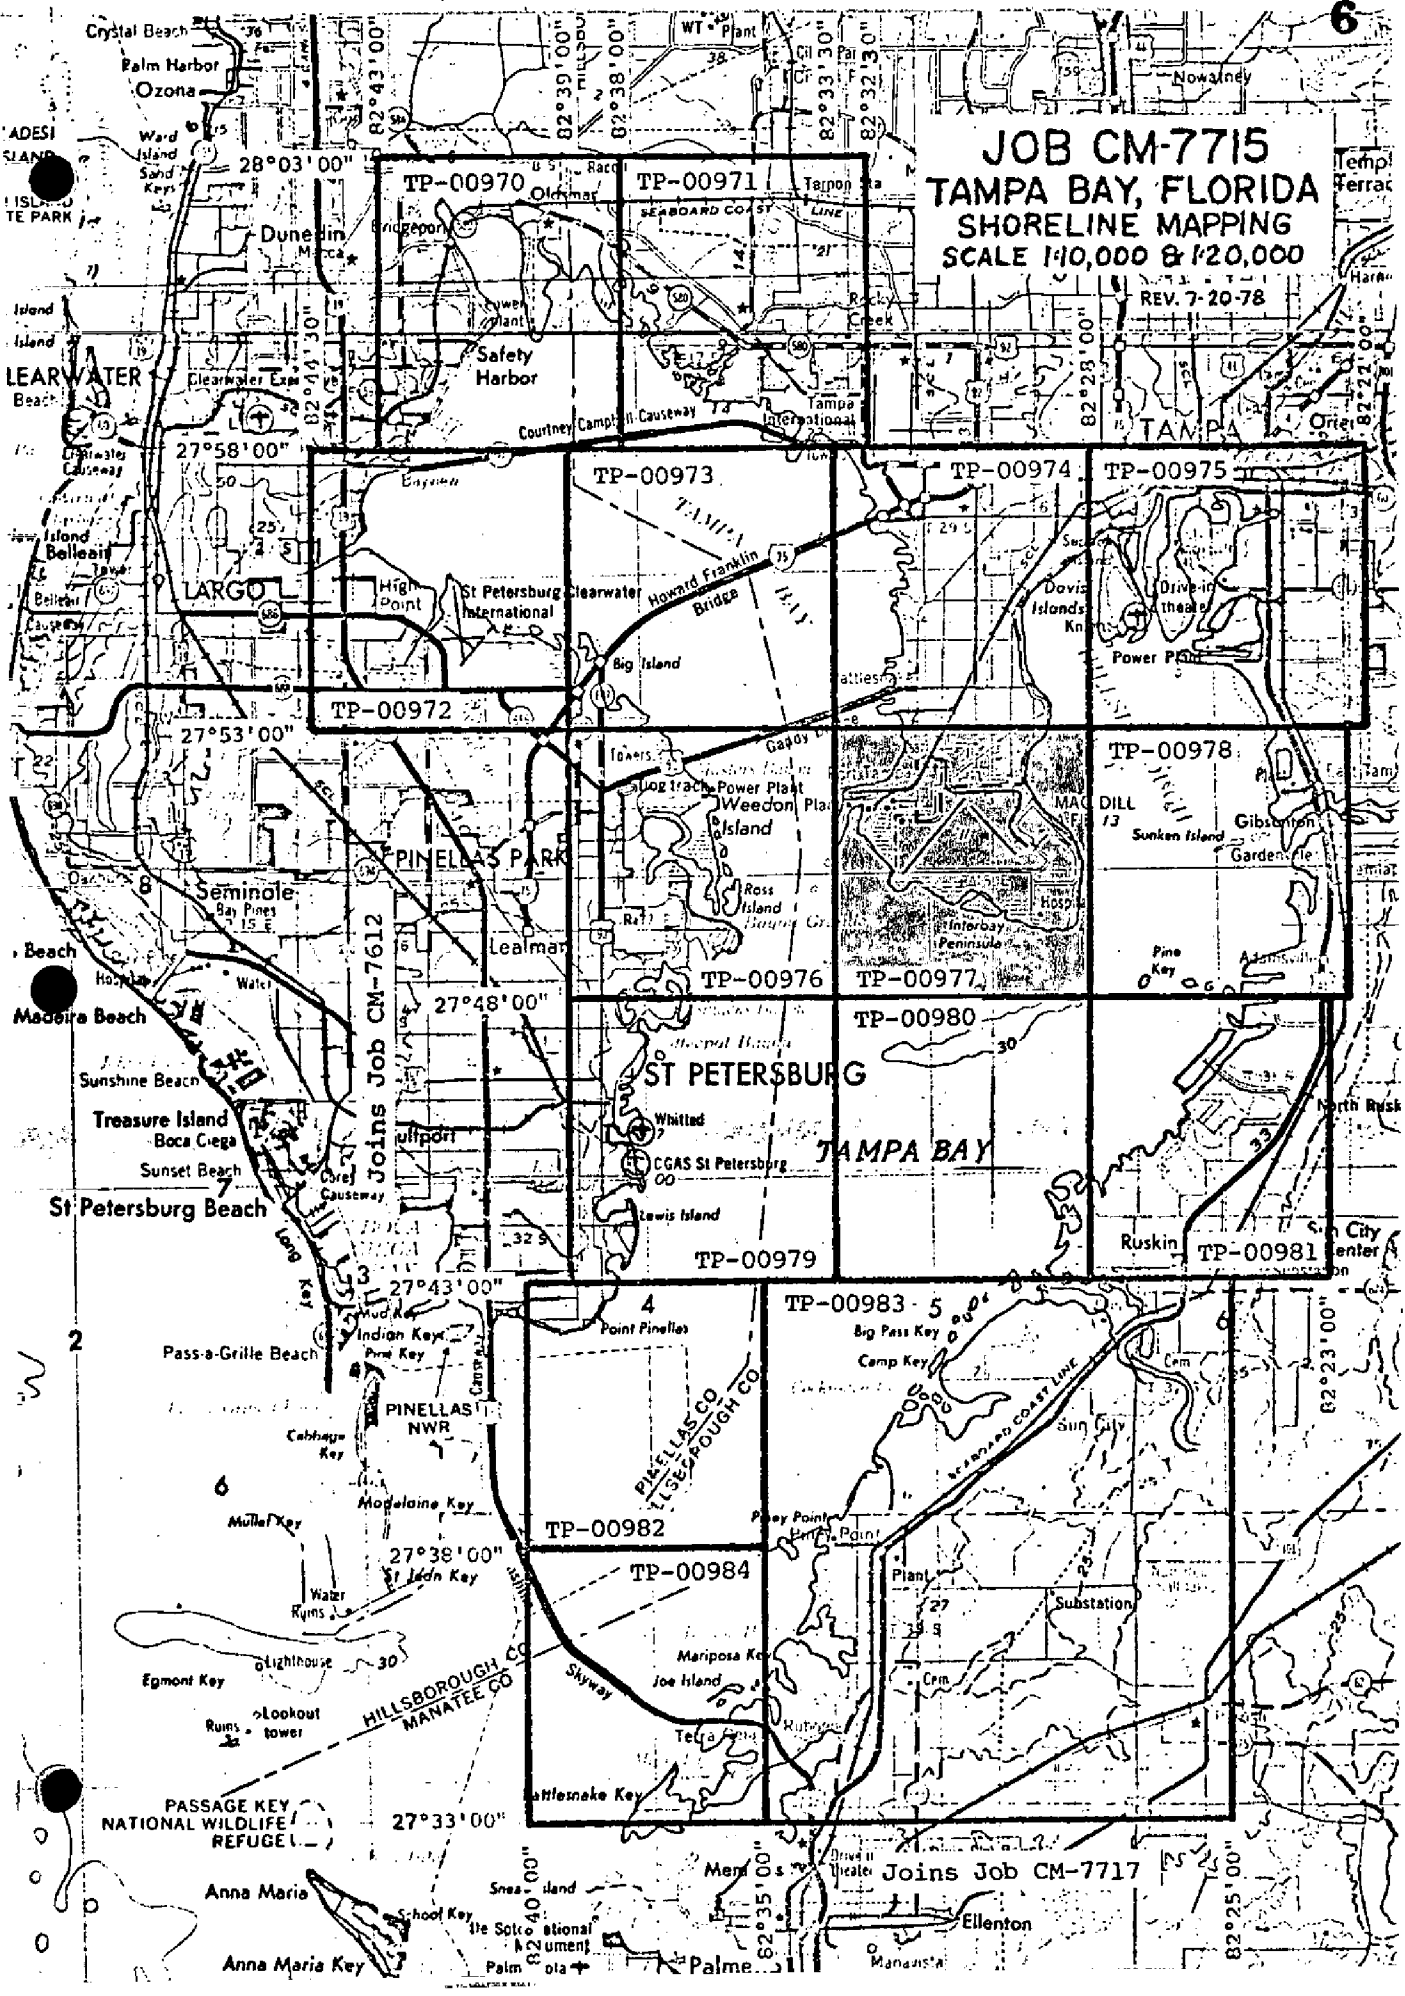
**JOB CM-7715**  
**TAMPA BAY, FLORIDA**  
**SHORELINE MAPPING**  
**SCALE 1:10,000 & 1:20,000**

The layout for CM-7715 will show the location of the individual maps from Rattlesnake Key to Oldsmar, Florida. A copy of the layout is included in this Descriptive Report.
