Form 504	
U. S. DEPARTMENT OF COMMERCE	
COAST AND GEODETIC SURVEY	
DESCRIPTIVE REPORT	
Type of Survey	Chart Topography
Field No.	Office No. T-13217
LOCALITY	
State	Oregon-Washington
General locality	Columbia River
Locality	Umatilla
<del>1968</del> 1967-69	
CHIEF OF PARTY	
V. Ralph Sobieralski, Chief Photogrammetry Division	
LIBRARY & ARCHIVES	
DATE

T - 13217

PH-6718

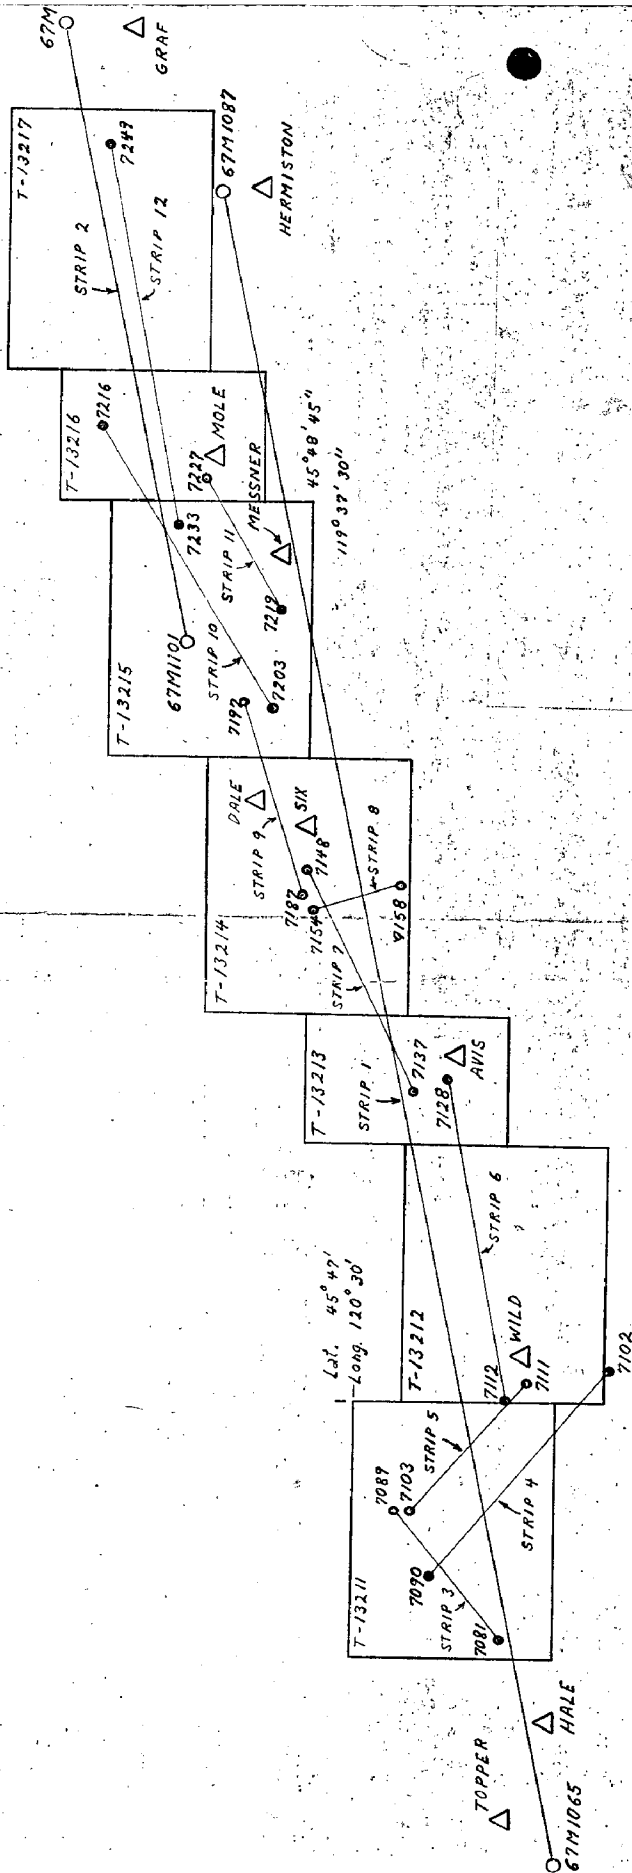
AEROTRIANGULATION SKETCH  
 JOHN DAY POOL  
 COLUMBIA RIVER  
 OREGON - WASHINGTON  
 MAY, 1968

- 1:60,000 panchromatic
- 1:20,000 color
- △ horizontal control
