| DESCRIPTIVE REPORT |
| Type of Survey <u>Shoreline (Photogrammetric)</u><br>T-10426 thru T-10428<br>Field No. <u>Ph-63</u> Office No. <u>T-10430 thru T-10432</u> |
| LOCALITY<br>State <u>Oregon and Washington</u><br>General locality <u>Columbia River</u><br>Locality <u>McNary Dam Reservoir from</u><br><u>Umatilla to Juniper Canyon</u><br><u>1954-56</u> |

These six surveys are part of Shoreline Project PH-63 (27020). The project, consisting of eighteen manuscripts, covers that part of the Columbia River and adjoining land area from McNary Dam to Pasco in Washington. It was initiated to support hydrographic surveys for the construction of new nautical charts. Subject surveys represent the southern portion of the project and extend from McNary Dam eastward to Juniper Canyon.

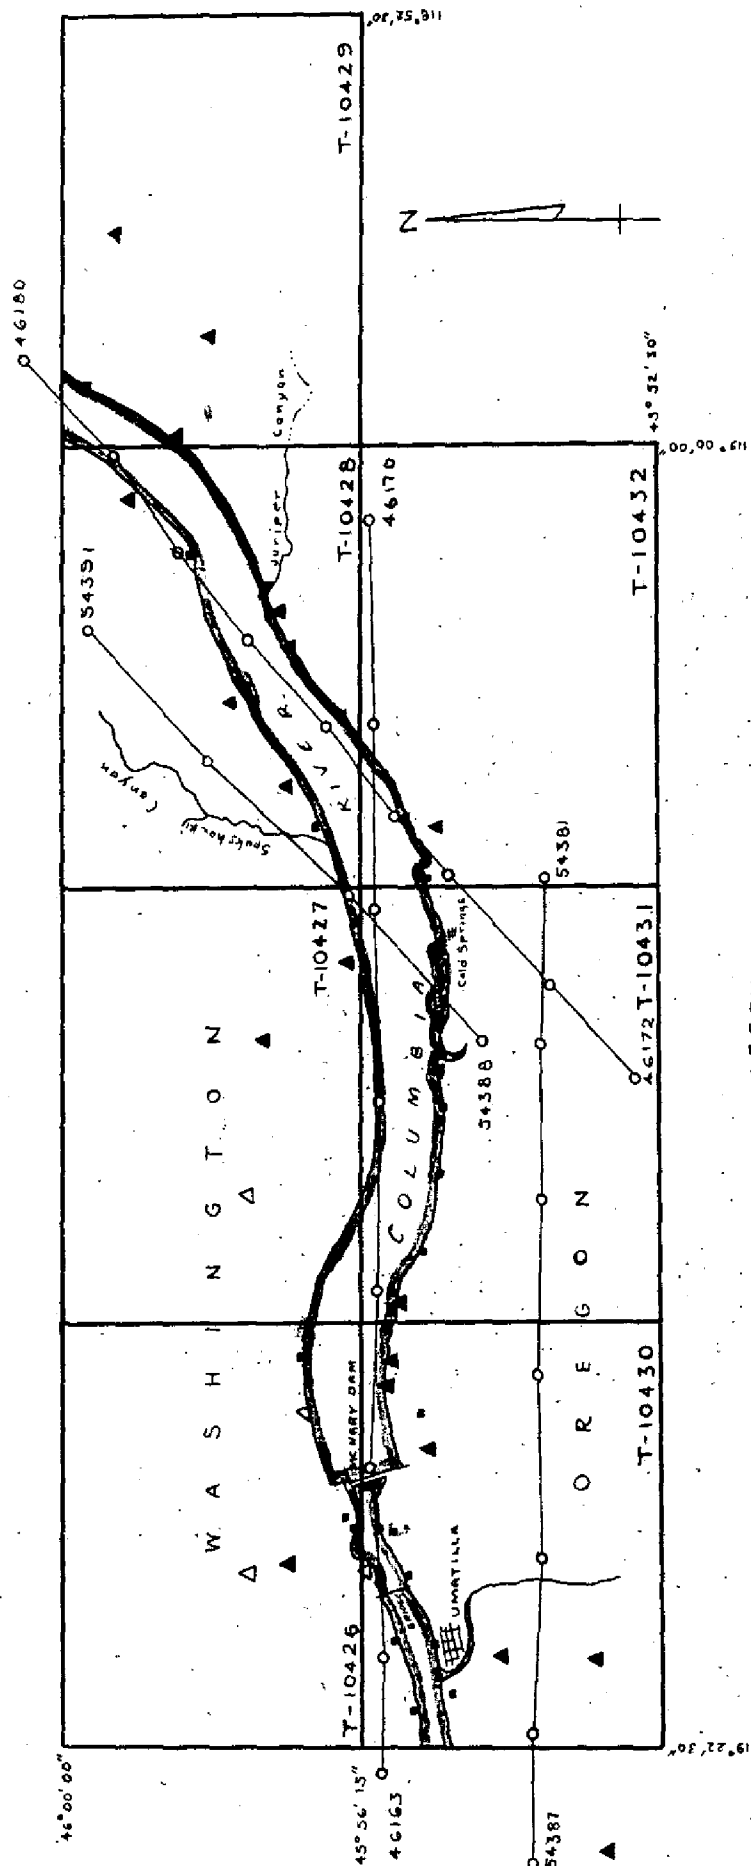
SKETCH SHOWING AREA OF PHOTOGRAMMETRIC PLOT  
 MCNARY DAM POOL-PROJECT 27020  
 RADIAL PLOT "A"  
 SCALE 1:163,000 (Approx.)

This radial plot covers the shorelines of the Columbia River in Oregon and Washington to an interior depth of about three miles, from a point two miles downstream from Umatilla, Oregon, to a point about one mile upstream from Juniper, Oregon. It comprises map manuscripts T-10426 thru T-10432.
