FORM C&GS-504	
U.S. DEPARTMENT OF COMMERCE ENVIRONMENTAL SCIENCE SERVICES ADMINISTRATION COAST AND GEODETIC SURVEY	
DESCRIPTIVE REPORT	
Type of Survey	SHORELINE
Field No.	Office No. T-10682
LOCALITY	
State	ALASKA
General locality	IPHIGENIA BAY
Locality	CORONATION ISLAND
1955 - 60	
CHIEF OF PARTY E. W. Richards, Chief of Field Party William F. Deane, Baltimore District Officer Alfred C. Holmes, Director, A. M. O.	
LIBRARY & ARCHIVES	
DATE

DESCRIPTIVE REPORT T-10682

This shoreline manuscript, scale 1:10,000, is one of 45 maps planned for Project PH-5702, which includes the south half of Kuiu Island, Spanish Islands, and Coronation Island, in Southeast Alaska. Only 33 maps were compiled. T-10682 includes part of the southeast side of Coronation Island.

PHOTOGRAMMETRIC PLOT REPORT
Project Ph-5702

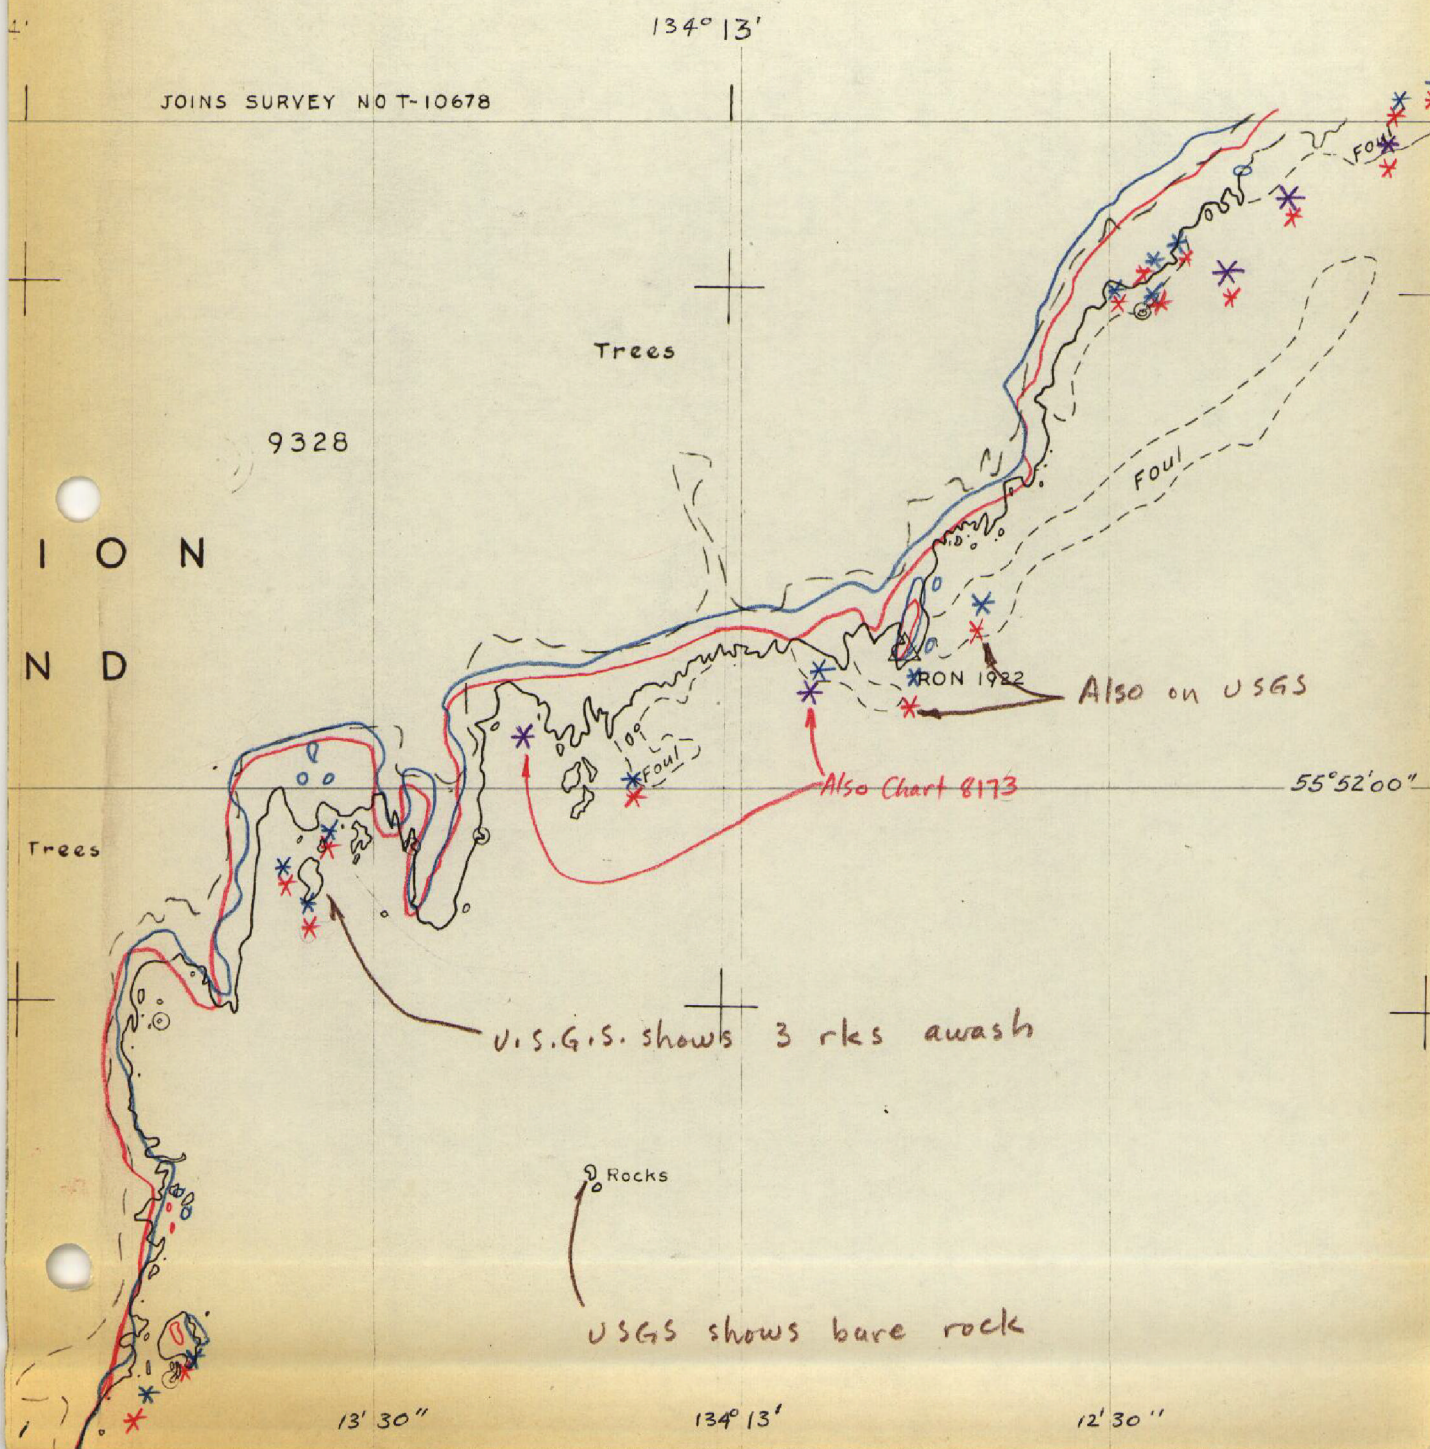
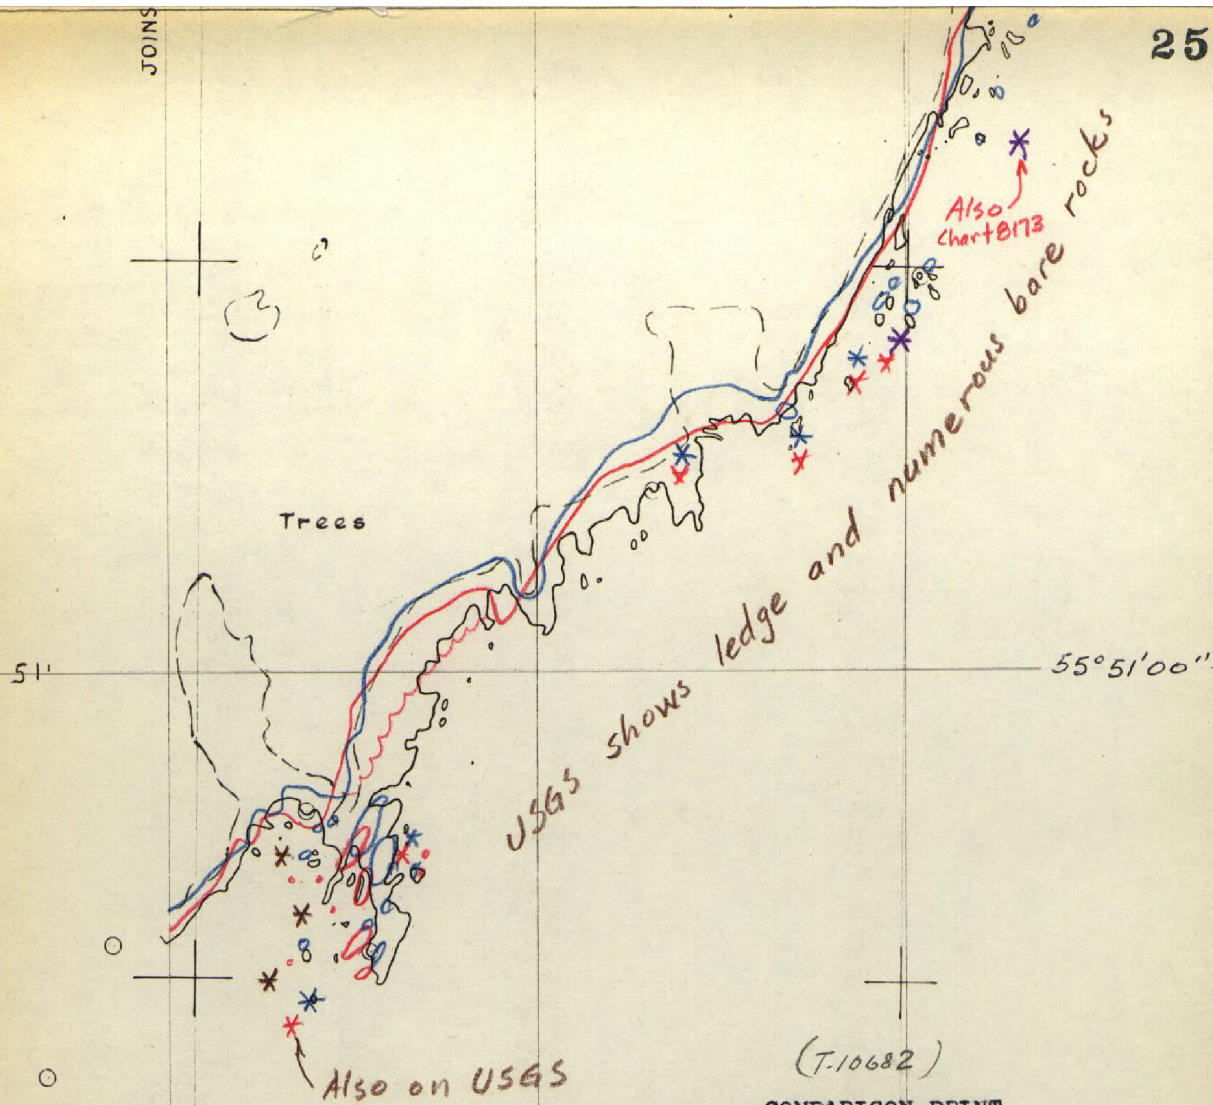
COMPARISON PRINT

Blue = T-4054
 Brown = USGS CRAIG (D-7 & D-8)
 Purple = H-8112
 Red = Chart 8173

An ozalid comparison print, pages 24 through 25, with differences noted in Items 62 through 65 is bound with the original of this report.

A comparison was made with Survey No. 4054, scale 1:20,000, dated 1923. Differences between this survey and T-10682 are shown in blue on the comparison print.

A visual comparison was made with U.S.G.S. Quadrangle CRAIG (D-7 and D-8), ALASKA, scale 1:63,360, dated 1948. Significant differences between this map and T-10682 are noted in brown on the comparison print.

A comparison was made with Survey H-8112, scale 1:20,000, dated 1960. No shoreline differences were noted, as T-10682 was the base map for the shoreline that was compared. Seven rocks awash that were not visible on the photographs are shown in purple on the comparison print.

A visual comparison was made with Chart 8173, scale 1:40,000, 5th edition, dated August 30, 1969. Differences between this chart and T-10682 are shown in red on the comparison print.
