DESCRIPTIVE REPORT

Type of Survey	SHORELINE
	Office No. T-11698
<u> </u>	LOCALITY
State	VIRGINIA
General locality	NORTHAMPTON COUNTY
	MAN AND BOY MARSH
,	•
	19 59 -62
W. E. Randall,	CHIEF OF PARTY Thief of Field Party Baltimore District Office Baltimore District Office
	RARY & ARCHIVES
DATF) JUL 1975

DESCRIPTIVE REPORT T-11698

This 1:10,000 scale shoreline manuscript is one of 43 maps that comprise Project PH-5907, Cape Charles to Assateague, Virginia. The project diagram on page 5 indicates the location of this map in the project.

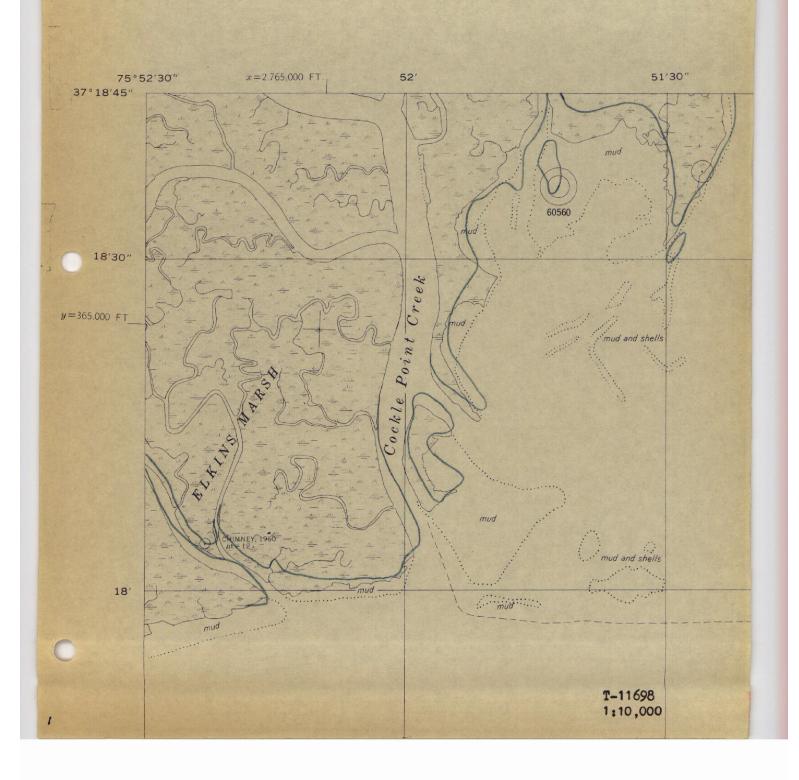
COMPARISON PRINT

An ozalid comparison print, showing differences noted in Par. 62, is bound with the original of this report.

A comparison was made with USGS Quadrangle COBB ISLAND, VA, 1:24,000 scale, dated 1942. Differences noted were the same as noted on T-8178 and were shown on the comparison print with the same blue line.

Blue = T-8178 & USGS
