DESCRIPTIVE REPORT

Type of Survey Shoreline
Job No. PH-6013 Map No. *
Classification No. 111 Editions No
* T-12040, T-12045, T-12046, T-12049
LOCALITY
State
General Locality Cook Inlet
Locality Kenai
· · · · · · · · · · · · · · · · · · ·
1960 TO 19
REGISTRY IN ARCHIVES
DATE

lst Editions: Maps T-12040, T-12045, T-12046, T-12049 Shoreline Mapping-1:20,000 Scale

These maps are a part of Job PH-6013, which is comprised of 45 maps covering the northern portion of Cook Inlet, Alaska.

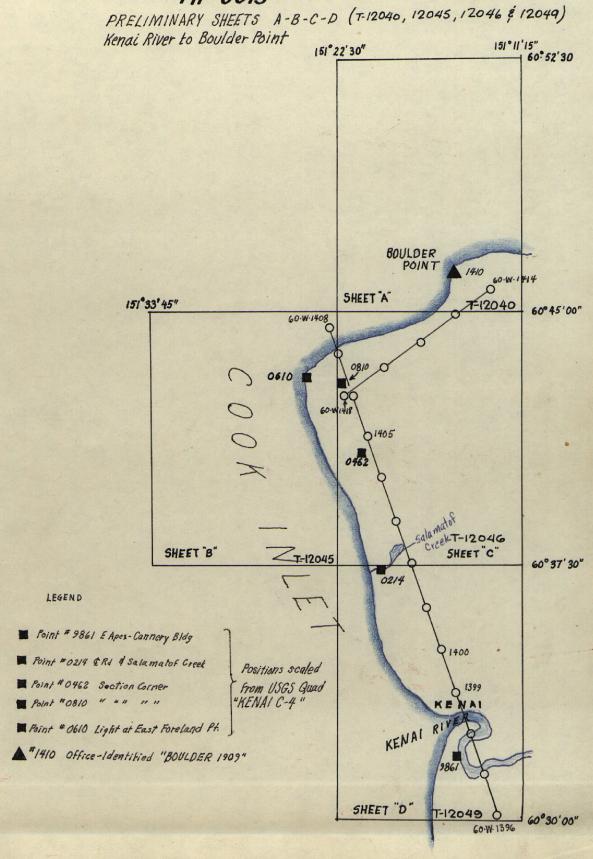
12046 & 12049)

Preliminary manuscripts T-12040, T-12045, T-12046, and T-12049, 1:20,000 scale, cover the area described above and are bounded by Latitude 60°30'00" north to 60°52'30" and Longitude 151°11'15" west to 151°33'45", see attached sketch.

Class V manuscripts

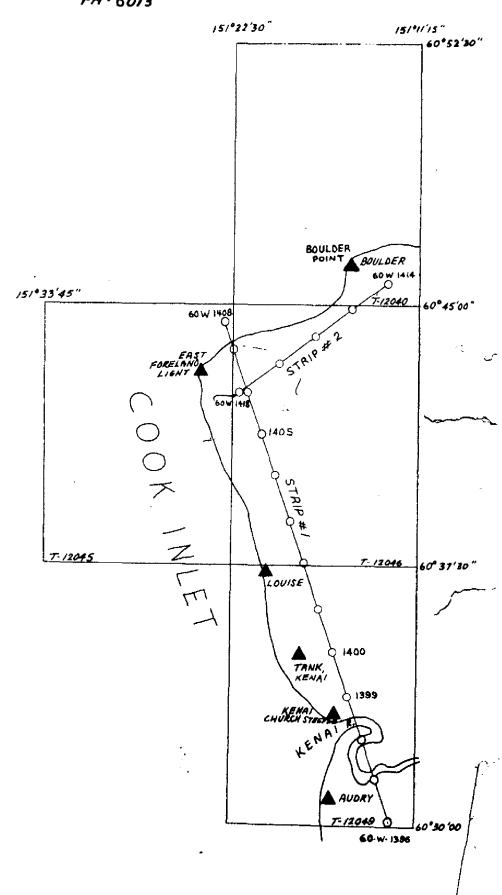
COOK INLET, ALASKA

Strip No. 1 comprises photographs 60W1396 through 1408 and Strip No. 2 comprises photographs 60W1414 through 1418. The adjustment of Strip No. 1 indicated a large error (approx. 70 ft.) in the identification of Station "Audry". Thus the strip was adjusted to three control stations with one as a check. Close agreement in tie points of Strip No. 2 was affected. Strip No. 2 consisted of 4 models which was controlled with two stations.

Sketch and Form M-2388-12.
