Form 504	
U. S. DEPARTMENT OF COMMERCE	
COAST AND GEODETIC SURVEY	
DESCRIPTIVE REPORT	
Type of Survey <u>SHORELINE (Photogrammetric)</u>	
Field No. _____	Office No. <u>T-12619</u>
LOCALITY	
State <u>SOUTH CAROLINA</u>	
General locality <u>CHARLESTON, S. C. TO SAVANNAH, GA.</u>	
Locality <u>PORT ROYAL SOUND</u>	
<u>19 64-65</u>	
CHIEF OF PARTY	
Joseph K. Wilson, Chief, Photo Party 6420	
Allen L. Powell, Director, A.M.C.	
LIBRARY & ARCHIVES	
DATE _____

T -12619

PROJECT 21420 (PH-6407)

SUMMARY TO ACCOMPANY  
DESCRIPTIVE REPORT T-12619

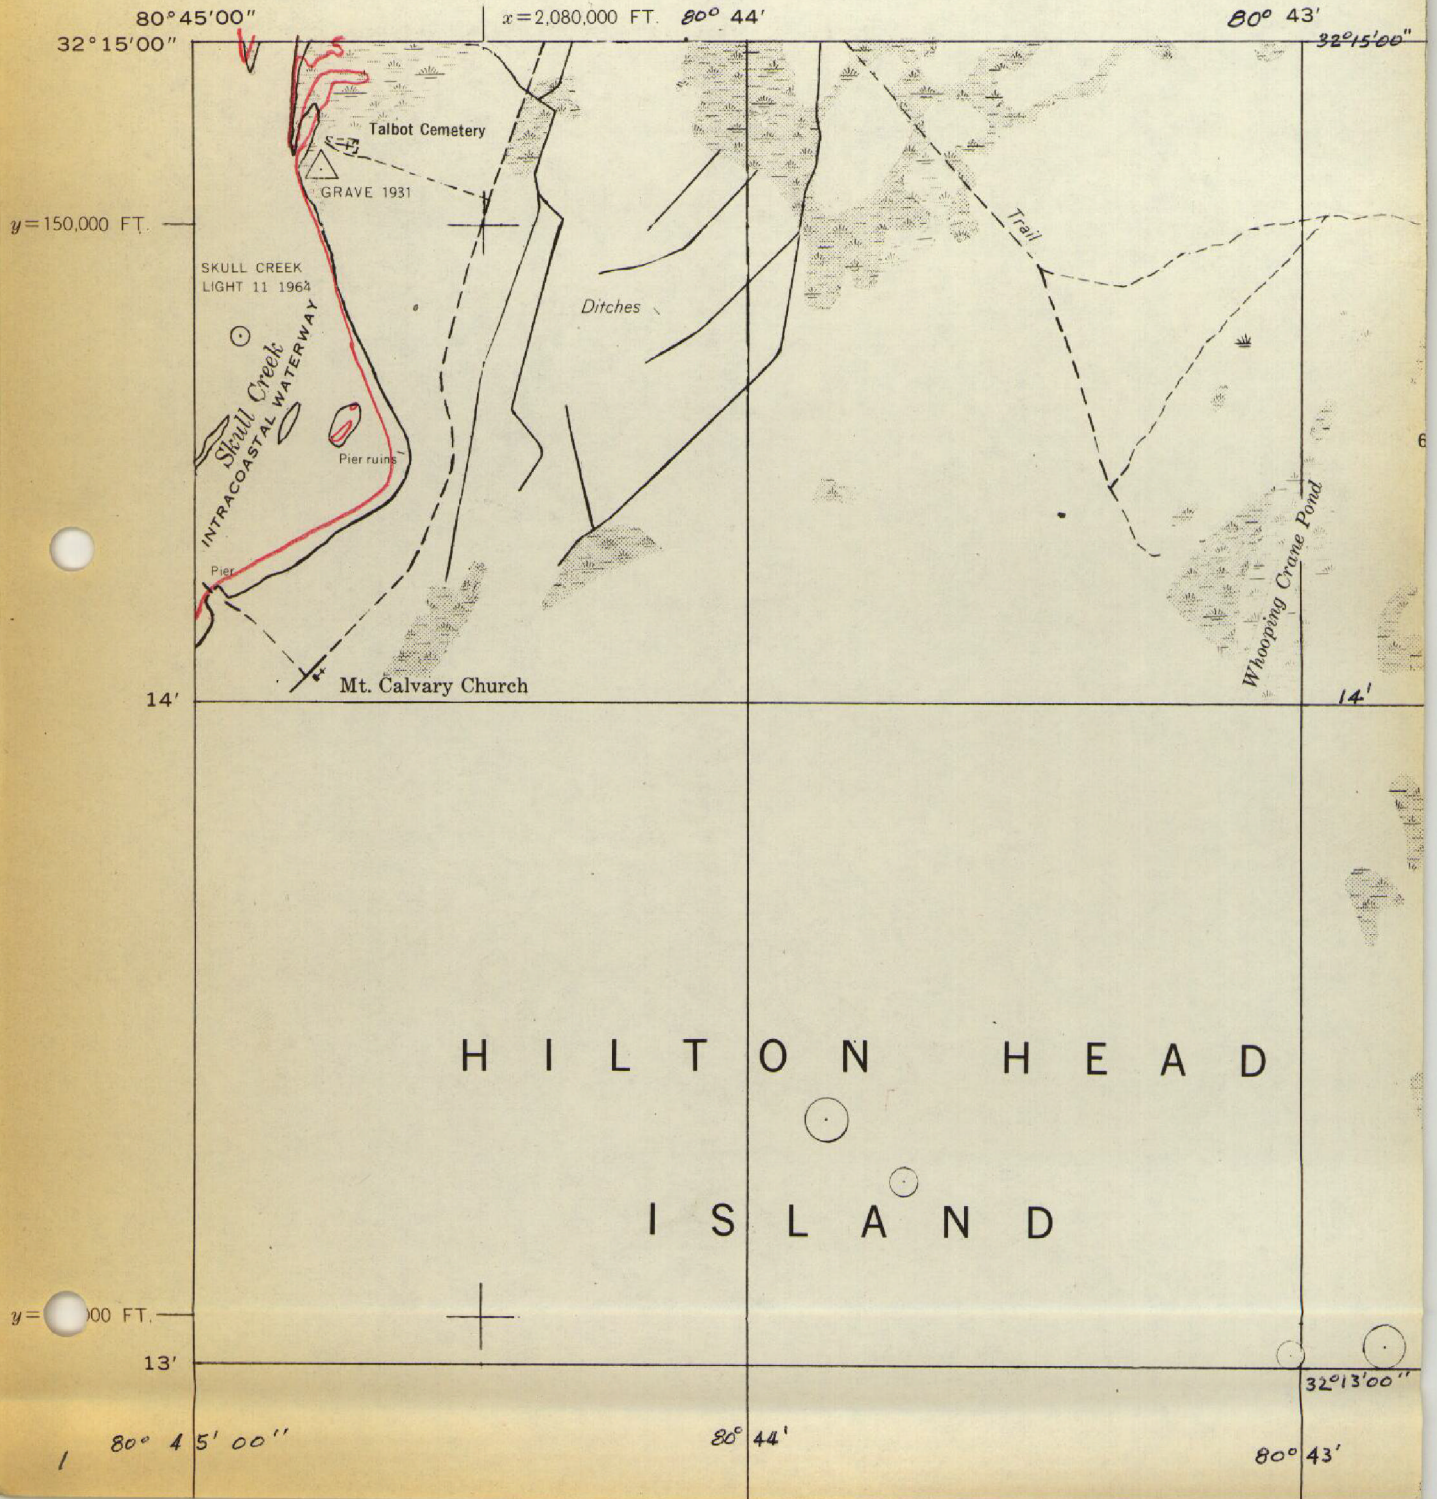
An ozalid comparison print, pages 26 through 30, with differences noted in Items 62, 63, and 65, is bound with the original of this report.

A comparison was made with Survey T-5135, scale 1:20,000, compiled from aerial photographs taken in 1933. Differences between this survey and T-12619 are shown in blue on the comparison print.

A comparison was made with U.S.G.S. Quadrangle HILTON HEAD, S.C., scale 1:24,000, dated 1956. Differences between this map and T-12619 are shown in brown on the comparison print.

There are discrepancies of as much as 0.6 mm (120 meters) in the shoreline bordering the Atlantic Ocean. See Comparison Print.

A comparison was made with Chart 571, scale 1:40,000, 16th edition, dated October 31, 1970. Differences between this chart and T-12619 are shown in red on the comparison print.
