DESCRIPTIVE REPORT

Type of Survey SHORELINE (Photogrammetric)
Field No. Office No. T-12810
LOCALITY
State SOUTH CAROLINA
General locality CHARLESTON, S. C. TO SAVANNAH, GA
Locality SCARBOROUGH HEAD
1964_65
CHIEF OF PARTY Joseph K. Wilson, Chief, Photo Party 6420 Allen L. Powell, Director, A. M. C.
LIBRARY & ARCHIVES

DESCRIPTIVE REPORT T-12810

This shoreline manuscript, scale 1:10,000, is one of 18 maps that comprise Project PH-6407, Charleston, South Carolina to Savannah, Georgia. The sketch on page 5 of this report shows the location of T-12810 in the project.

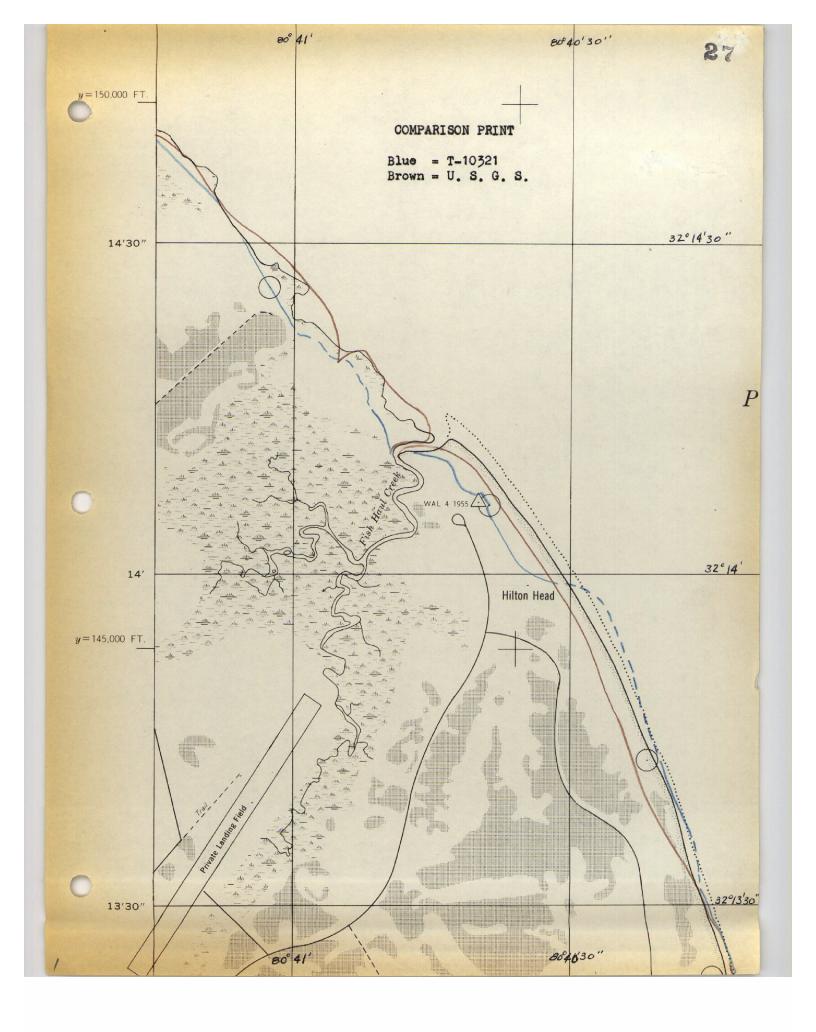
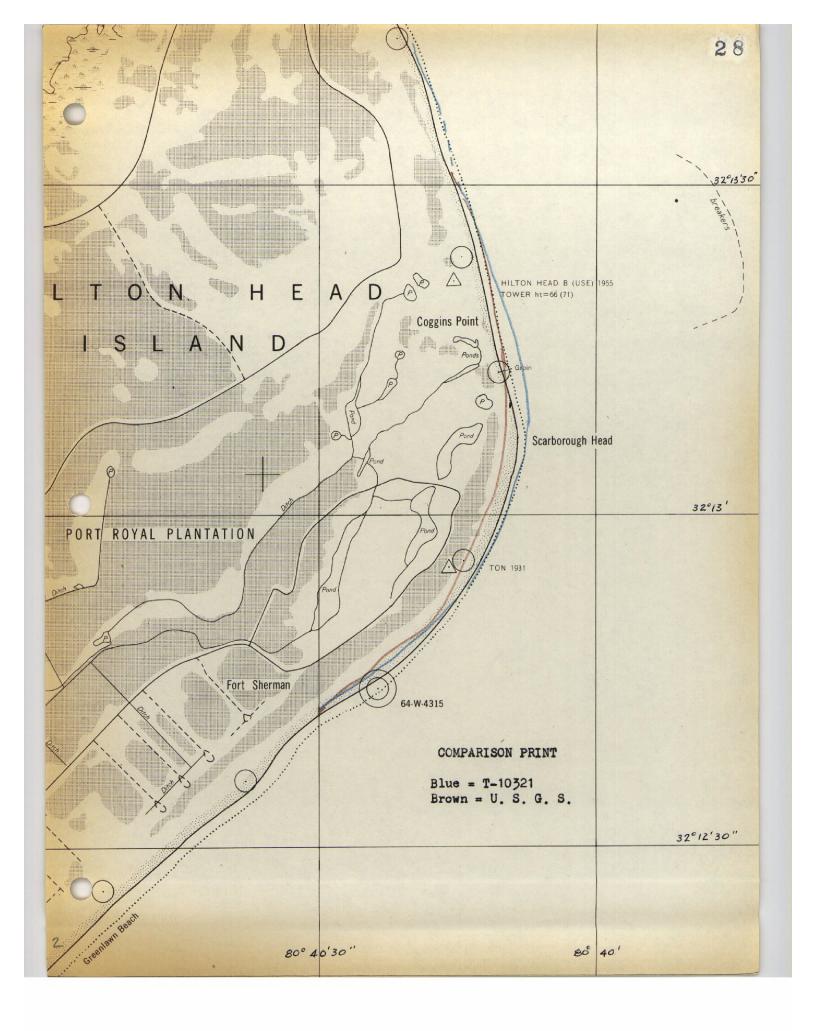
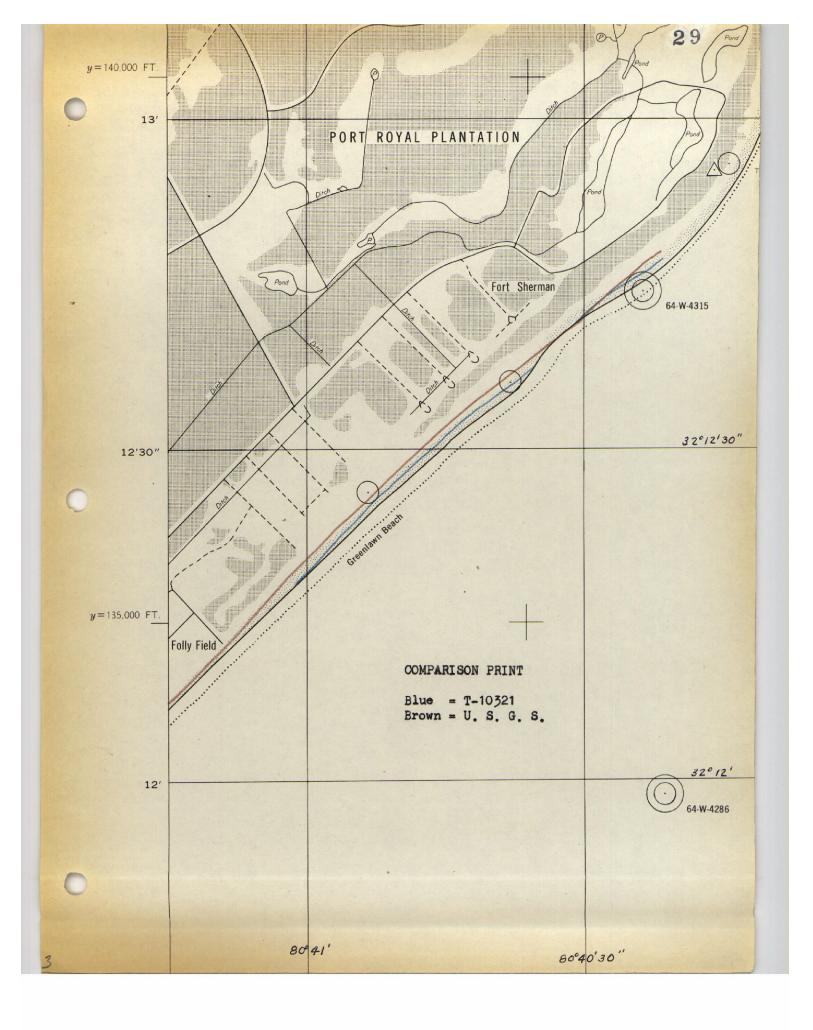
An ozalid comparison print, pages 27 through 29, with differences noted in Items 62 and 63, is bound with the original of this report.

A comparison was made with Survey T-10321, scale 1:10,000, dated 1955. Differences between this survey and T-12810 are shown in blue on the comparison print.

A comparison was made with U.S.G.S. Quadrangle HILTON HEAD, S. C. , scale 1:24,000, dated 1956. Shoreline differences between this map and T-12810 are shown in brown on the comparison print.

Only shoreline differences were shown on the comparison print. Roads in the area and the airstrip have been relocated.

The general trend of the shoreline is the same although there are differences of as much as 100 meters in placement.
