## DESCRIPTIVE REPORT

State *Oregon*General locality *Cape Arago to*Locality *Yaquina Head*1928

DESCRIPTIVE REPORT TO ACCOMPANY

A, B, C, D, E, F, G, H, I and J.  
4411 4412 4413 4414 4415 4416 4417 4418 4419 4420

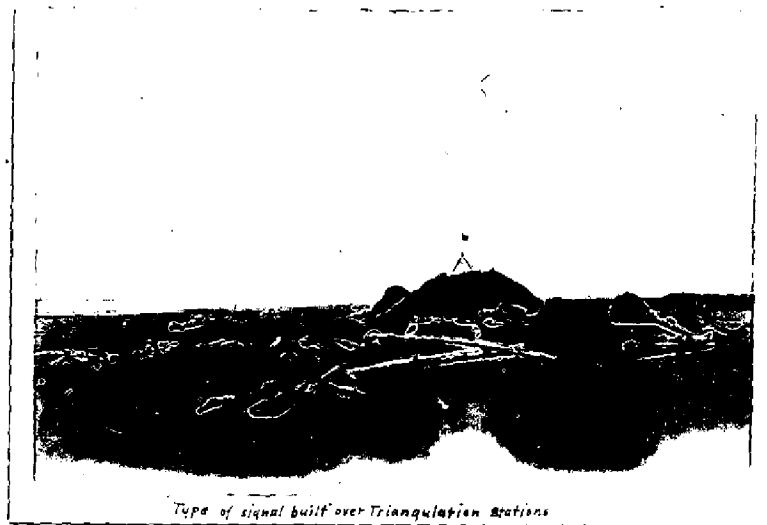
Signals were erected over all triangulation stations where they were suitably located for hydrographic signals, and other hydrographic signals were erected and located about 850 meters apart throughout the survey. Natural objects and buildings were used where ever possible.

*Type of signal built over Triangulation Stations*

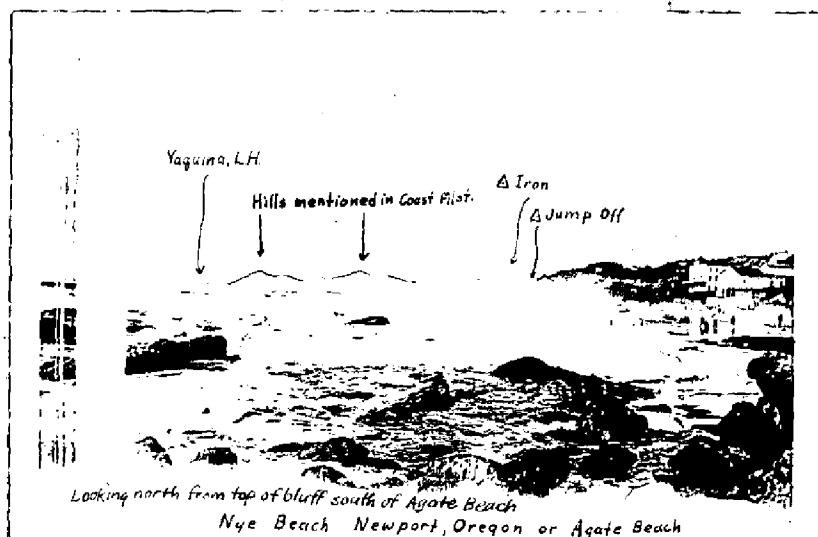
The southern shore of Yaquina Head is very rocky and precipitous. There is one point however where it was possible to make a whaleboat landing at high water. This part of the coast is sheltered from a northeast storm. The Yaquina L. H. keeper said that years ago sailing vessels ran in south of the head to anchor and be sheltered from the north or northwest.

Yaquina Head, showing the two large hills mentioned in the Coast Pilot, shows on this picture.

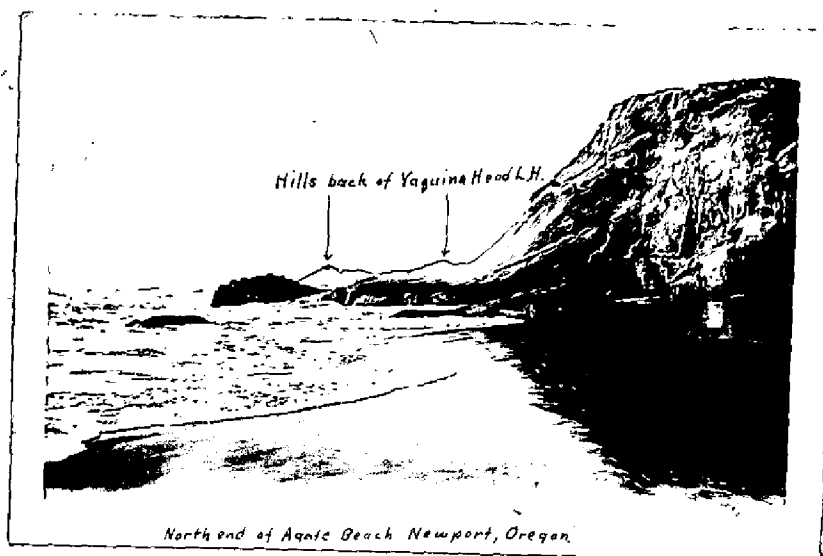
Nye Beach and Agate Beach are two names for the same beach. The low bluffs in this section are of soft sandstone and are being eroded quite rapidly.

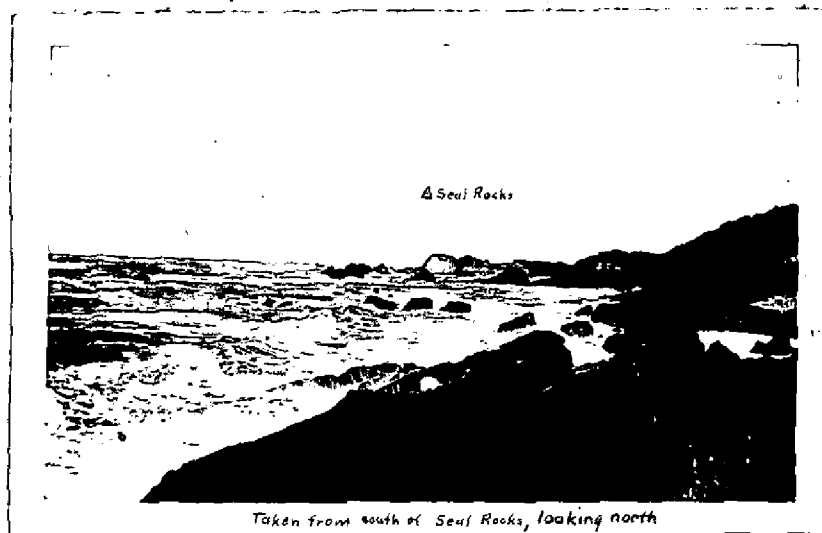
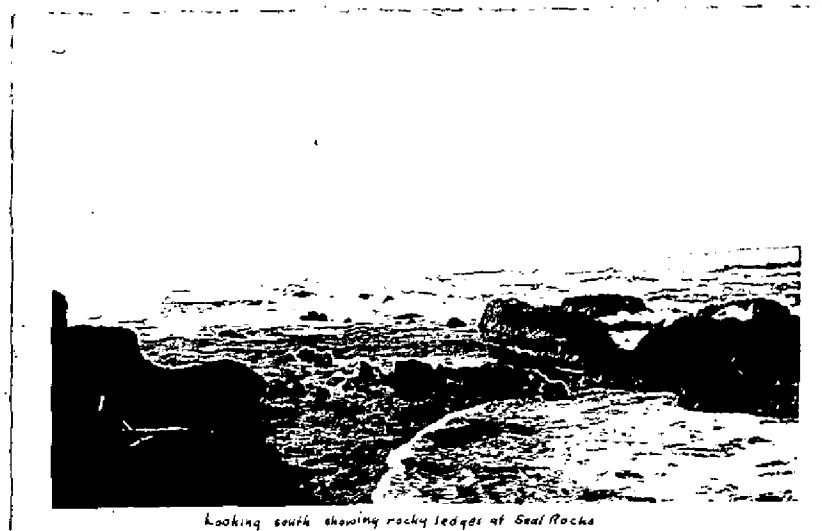
Seal Rocks are made up of several ledges of very hard rock running approximately north and south. These ledges are about one and one half miles long and extend offshore about one half mile.

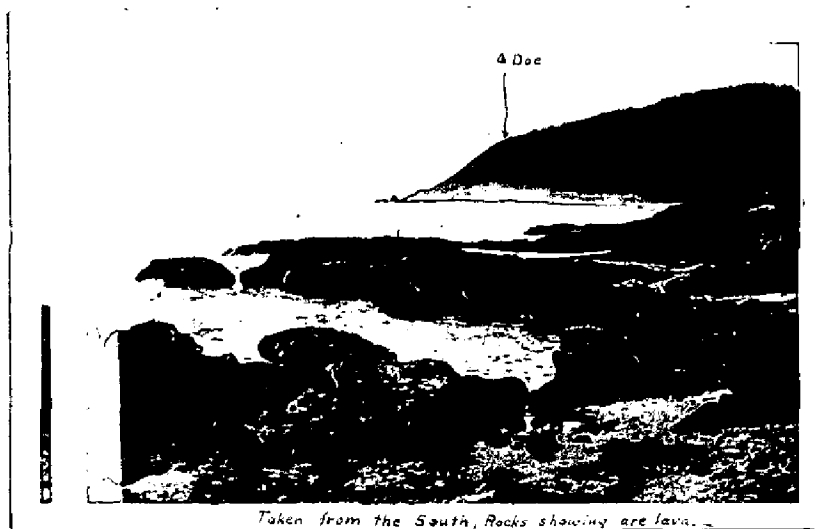
From the northern limits of the sheet south to a point south of Rocky Knoll the coast is very rough and rugged. The rocky ledges are all black igneous rock, very hard and are being eroded very slowly. There are a few short stretches of sand beach between these sheets of hard rock. There is a layer of stratified and cemented gravel and sand on top of the igneous deposit, which forms a high bluff along this part of the coast. There are many agates of all colors and sizes found in the loose gravel along the narrow stretch of beach. They come from the old cemented gravel bed which the surf is wearing away.

*Taken from the South, Rocks showing are lava.*

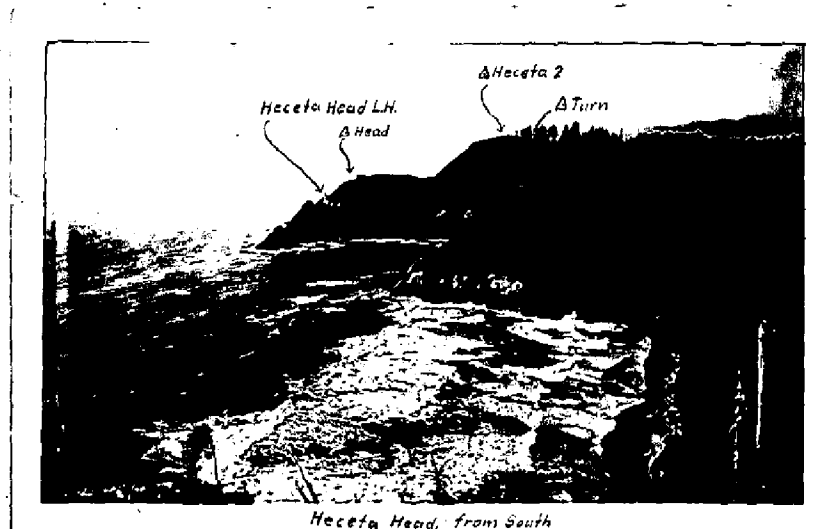
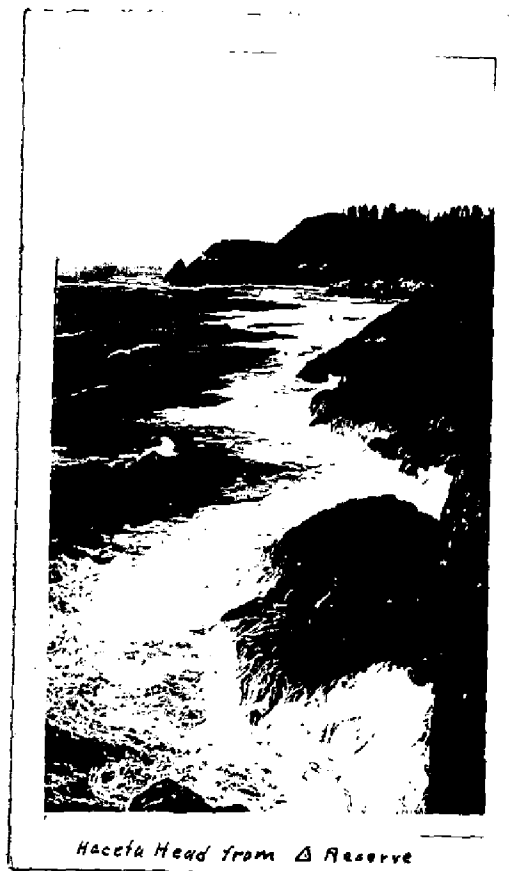
Heceta Head is all heavily wooded. The old highway or trail winds around over the top of the head and is almost impassible for automobiles. The preliminary survey for the Roosevelt Highway over the head has been made. The head is a formation of hard black igneous rock and is being eroded very slowly.

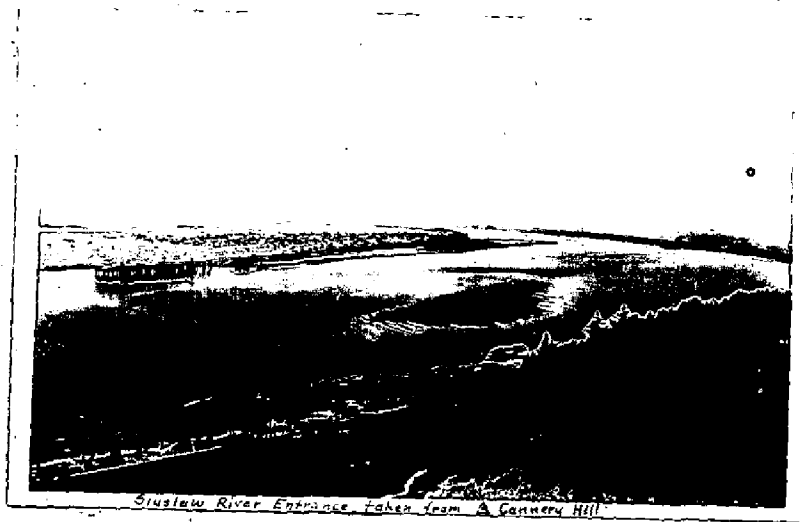
On the north side of the river there is a sandy bluff running almost due north and south. In front of this bluff is a wide area of sand which gets narrower to the north. The river curves sharply to the south from the entrance and so the bluff forms its north bank after crossing the sand area.

Siuslaw River Entrance, taken from Cannon Hill

The bluff is covered with a low evergreen growth. The trestle work over the jetties still remains.

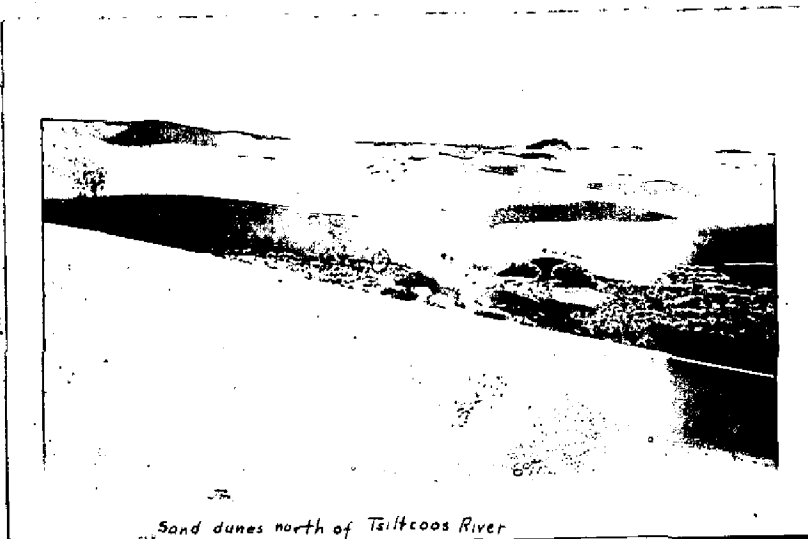
From the Siuslaw River to the Siltcoos River is an area of drifting sand dunes one mile to two miles wide. There are a few small groups of evergreen scattered over this area. There is a broad flat beach along this area.

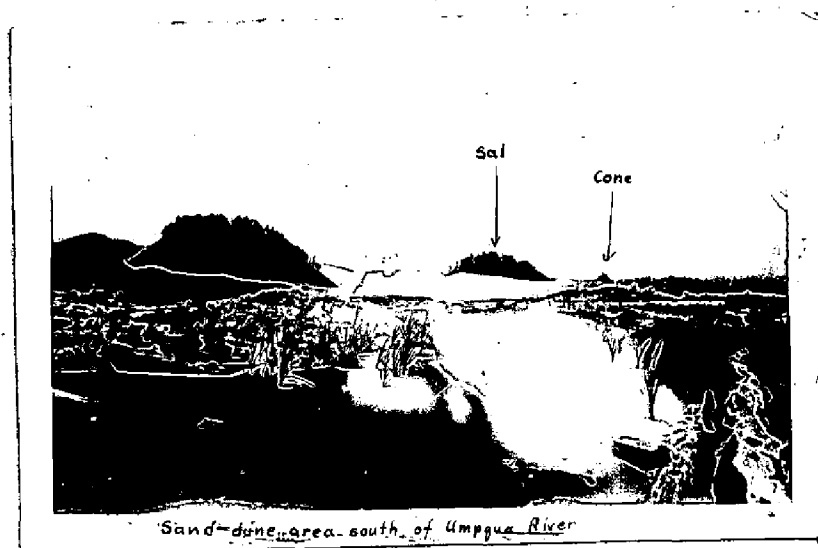
A broad sandy beach extends the entire length of this sheet and is backed by an area of sand dunes from one-half to one and one-half miles wide. There are a few scattered clumps of pine trees in this area.

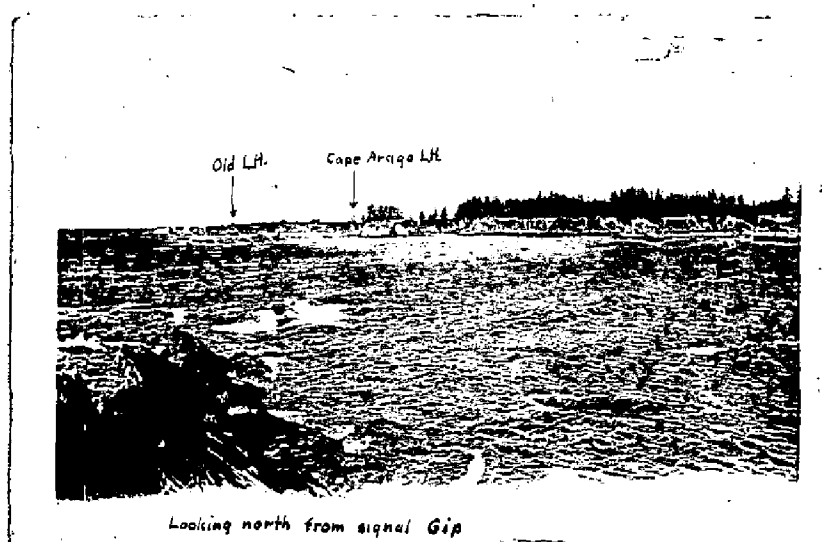
The rocks in this vicinity are very hard stratified sandstone and run in long straight ledges.
