U. S. COAST AND GEODETIC SURVEY

DESCRIPTIVE REPORT

Type of Survey TOPOGRAPHIC

Locality ANCHUTKA ISLAND

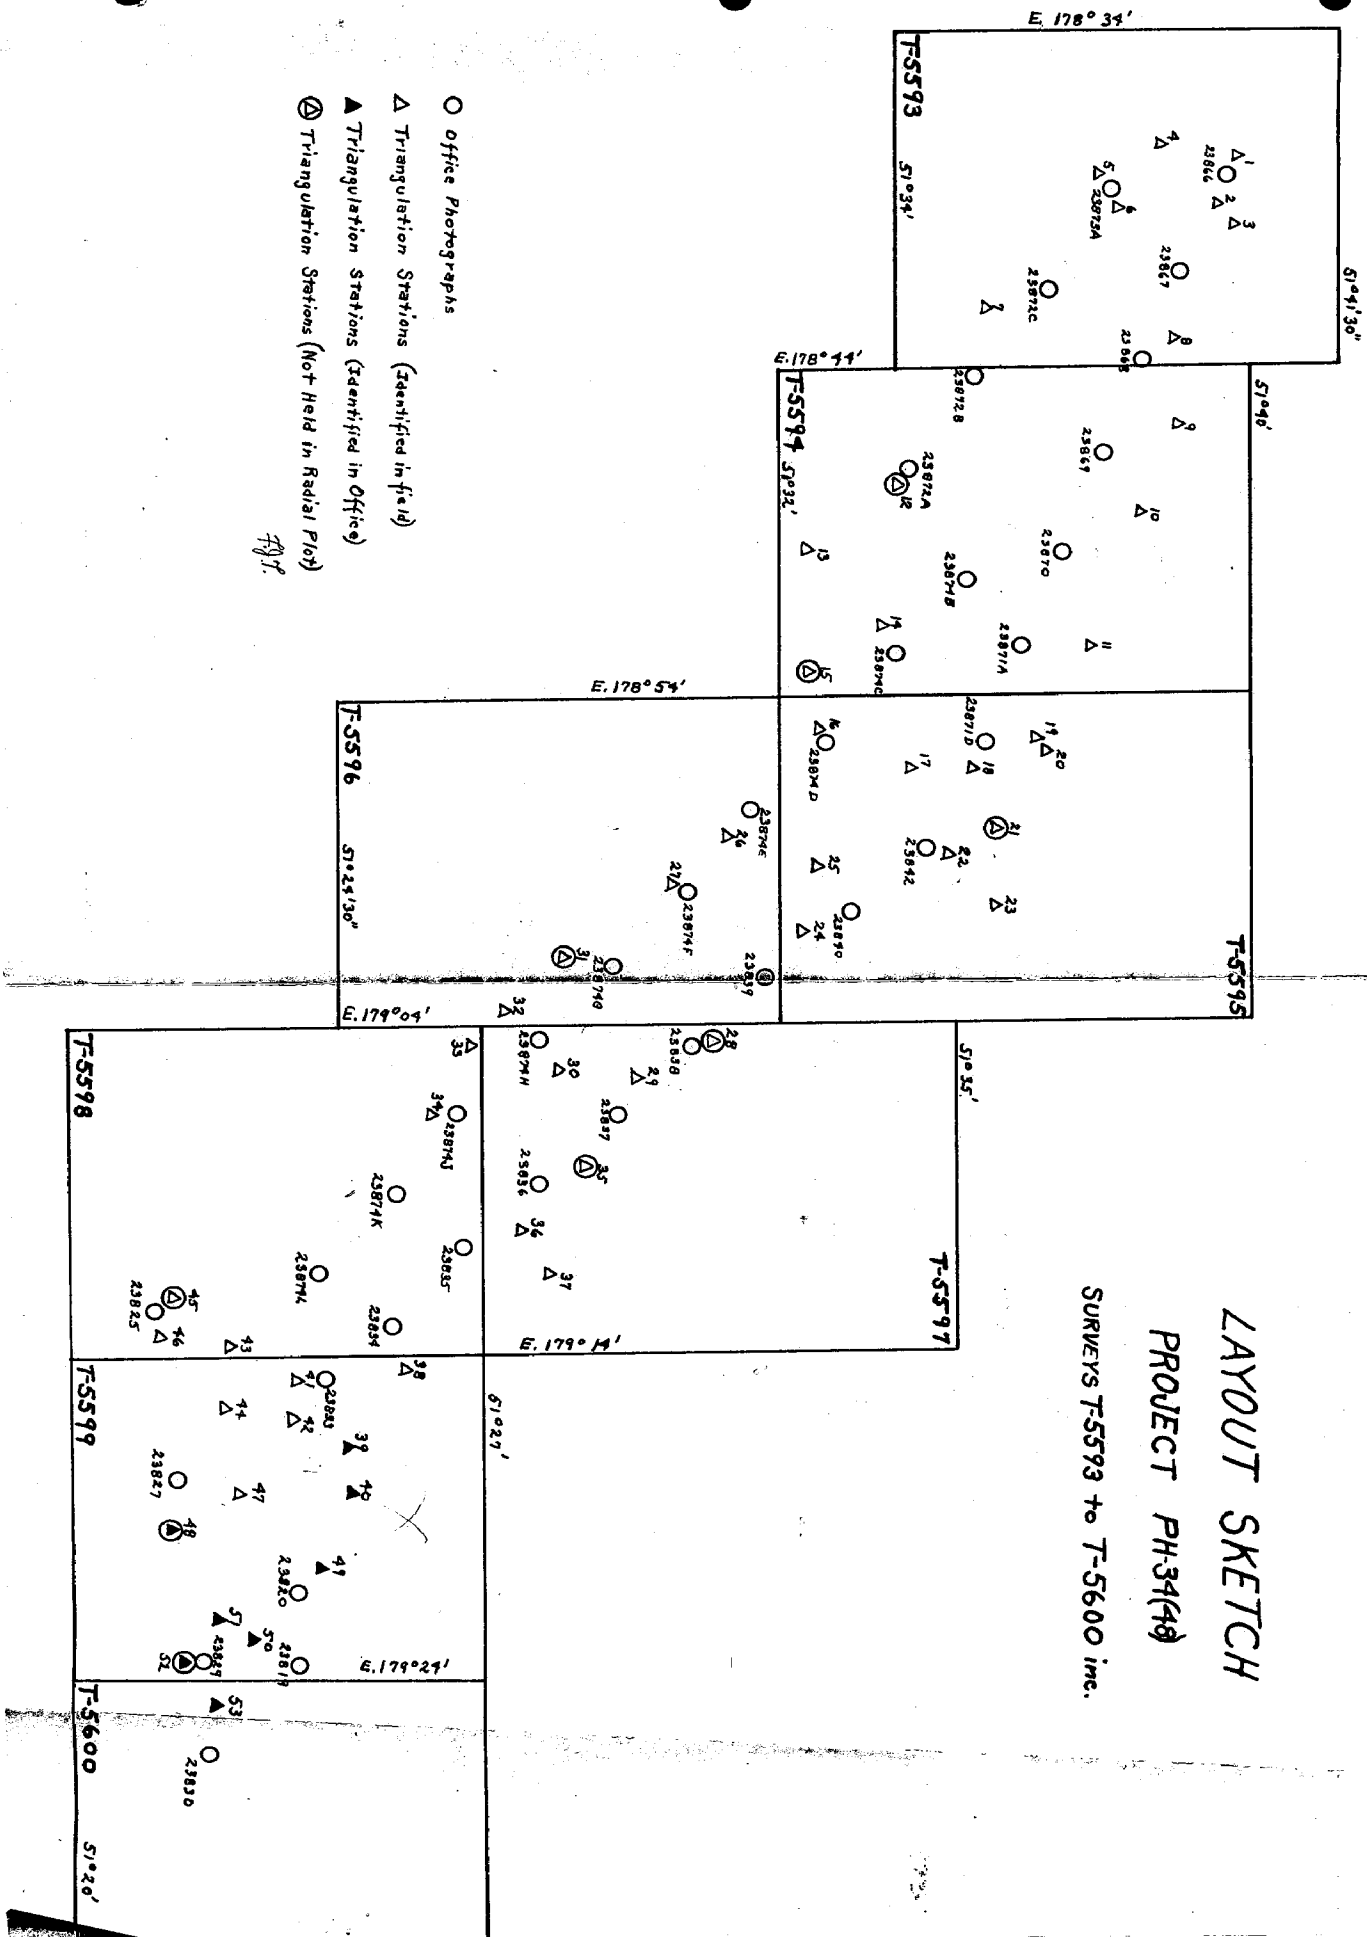
Fig. 1.

- Office Photographs
- △ Triangulation Stations (Identified in field)
- ▲ Triangulation Stations (Identified in Office)
- ⊙ Triangulation Stations (Not Held in Radial Plot)

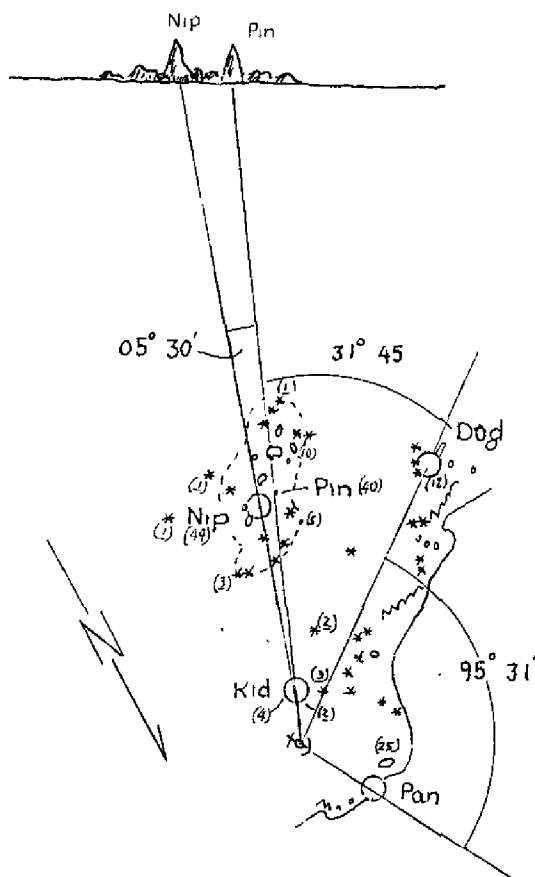
## ELEVATION OF RECOVERABLE H. and T. STATION NIP, 1945

Manuscript T-5599  
 Lat.  $51^{\circ} 21' \text{ N.}$   
 Long.  $179^{\circ} 20' \text{ E.}$   
 14:45, 28 May 1950

Sextant angles taken from anchored launch. Three point fix with check angle plotted on vinylite copy of map manuscript. Distance from launch position to NIP scaled. Vertical angle to top of pinnacle (NIP) read on and off the sextant circle.

Mean vertical angle  $01^{\circ} 13'.7$   
 Horizontal distance 640 m.
