DESCRIPTIVE REPORT

Type of Survey TOPOGRAPHIC

Field No. PH-3 (LR) Office No. T-5593 50
T-5600 incl.

Locality ANCHUTKA ISLAND

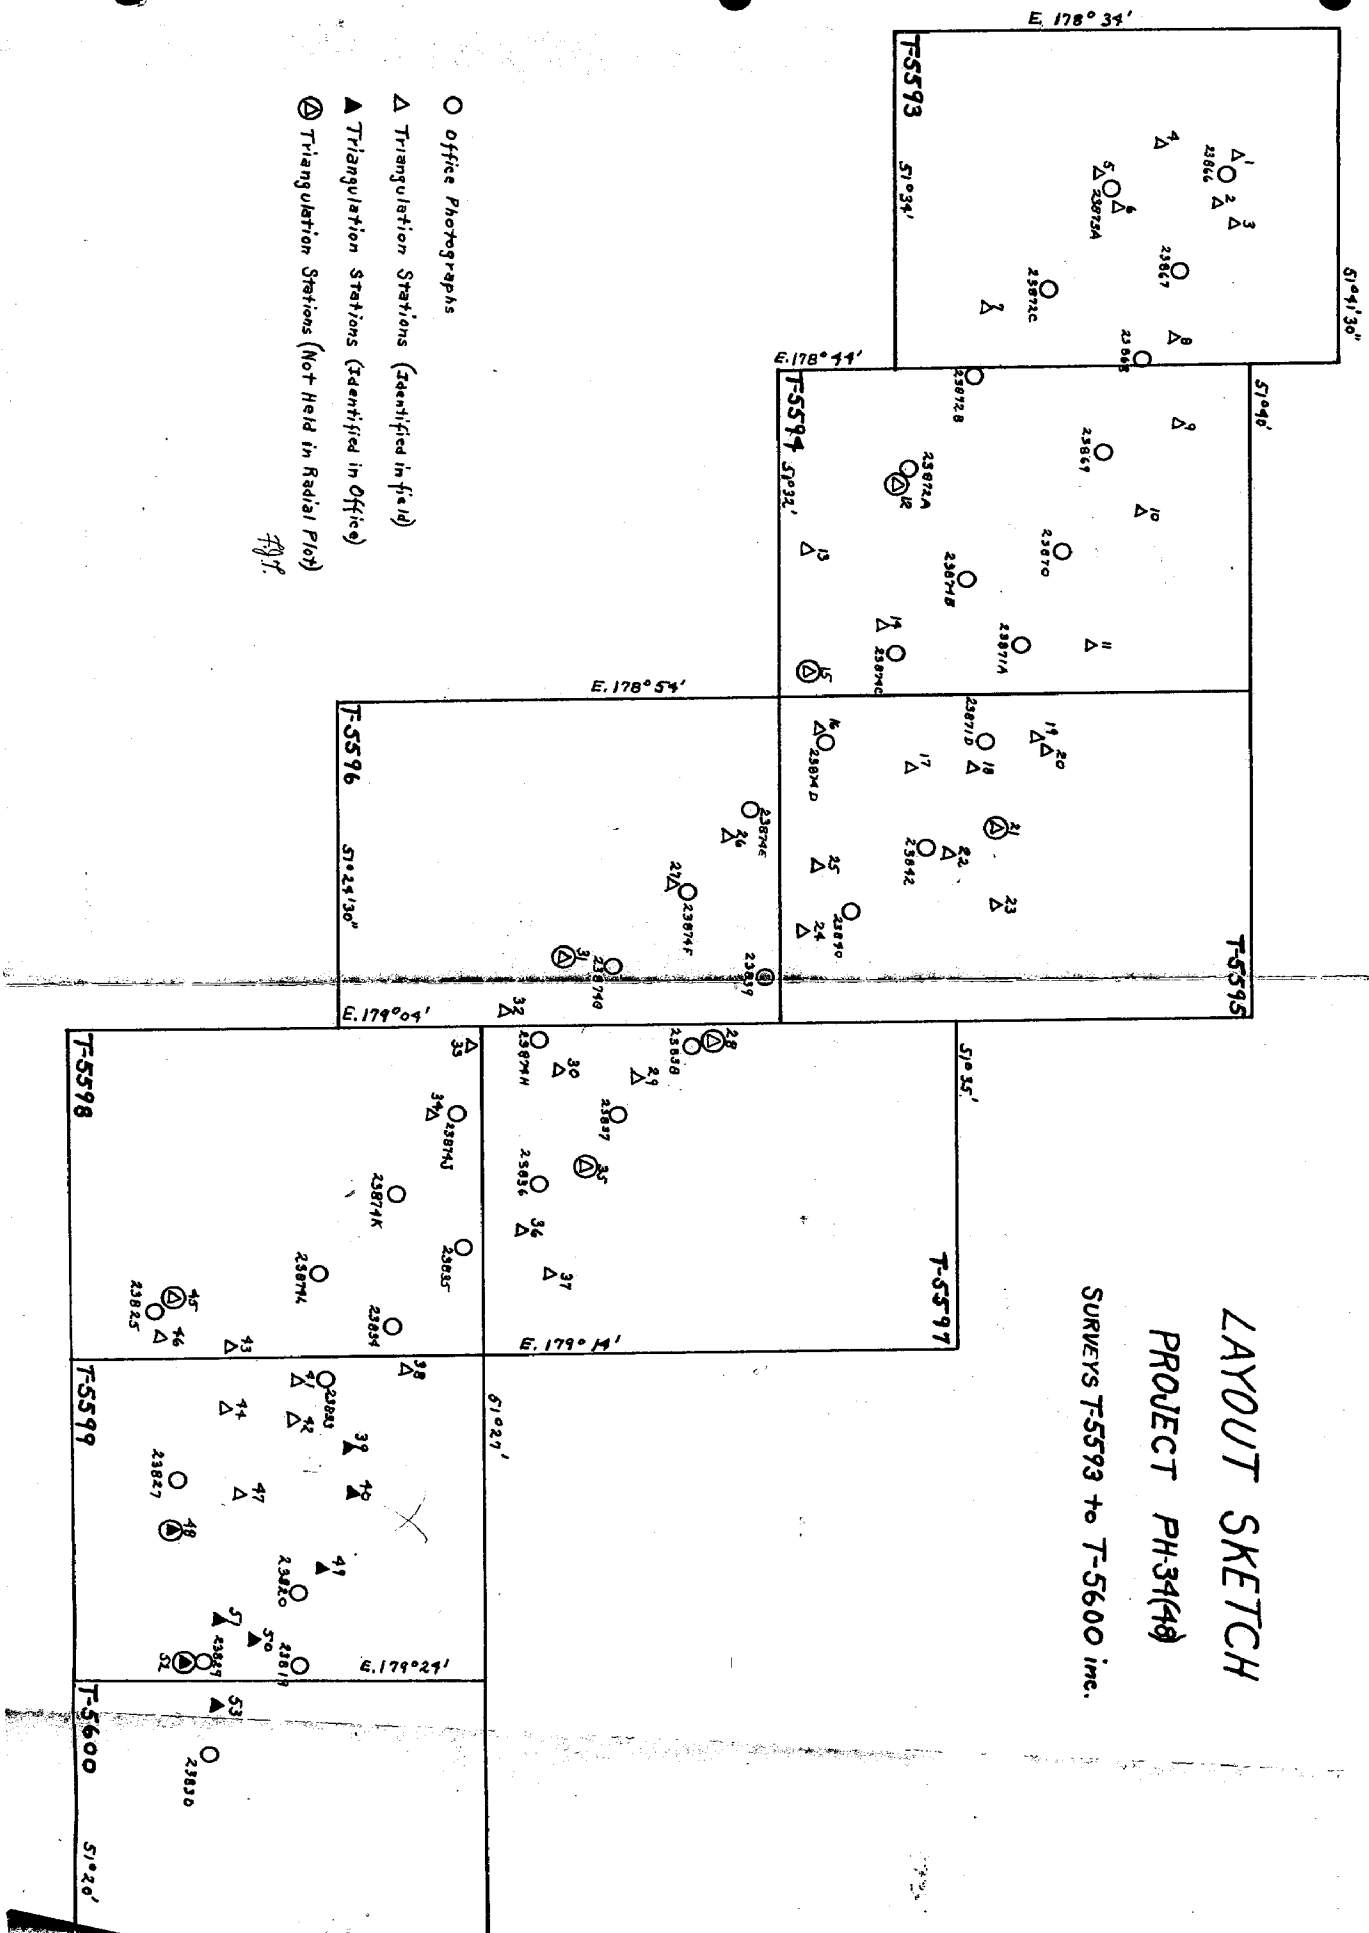
Fig. 1.

- Office Photographs
- △ Triangulation Stations (Identified in field)
- ▲ Triangulation Stations (Identified in Office)
- ⊙ Triangulation Stations (Not Held in Radial Plot)

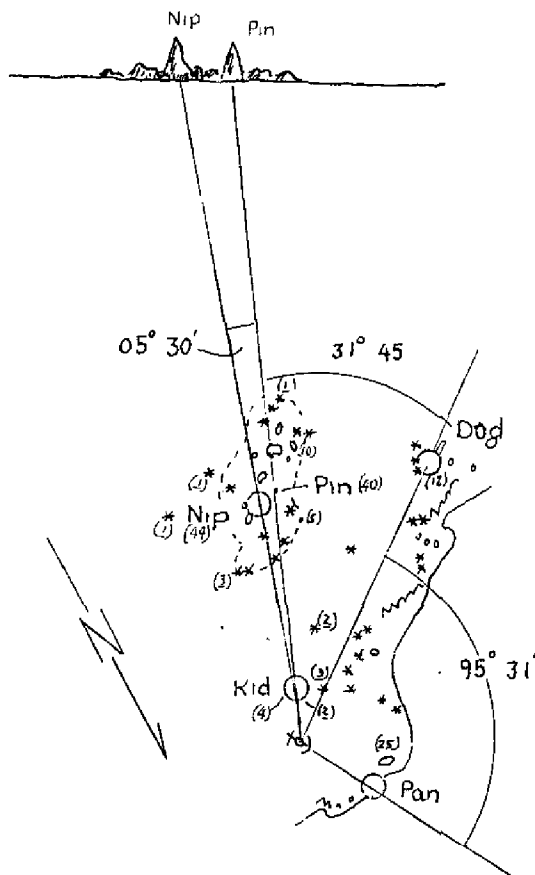
ELEVATION OF RECOVERABLE H. and T. STATION NIP, 1945

Manuscript T-5599
 Lat. $51^{\circ} 21' N$.
 Long. $179^{\circ} 20' E$.
 14:45, 28 May 1950

Sextant angles taken from anchored launch. Three point fix with check angle plotted on vinylite copy of map manuscript. Distance from launch position to NIP scaled. Vertical angle to top of pinnacle (NIP) read on and off the sextant circle.

Mean vertical angle $01^{\circ} 13'.7$
 Horizontal distance 640 m.
