DESCRIPTIVE REPORT

Type of SurveySnoreline
Job NoPH-71Q7 Мар NoTP-Q0412
Classification No. Final Edition No. 1
Field Edited Map
LOCALITY
State California
General Locality Dana Point to Point Vicente
Locality Crystal Cove
Locality (16076) Francisco
19 71 TO 19 74
REGISTRY IN ARCHIVES
DATE

Field Report Project PH-7107 Dana Point to Point Vicente, California Shoreline Mapping February - March 1971

PHOTOGRAMMETRIC PLOT REPORT Part 1 Dana Point to Point Vicente California Job PH-7107 November 1971

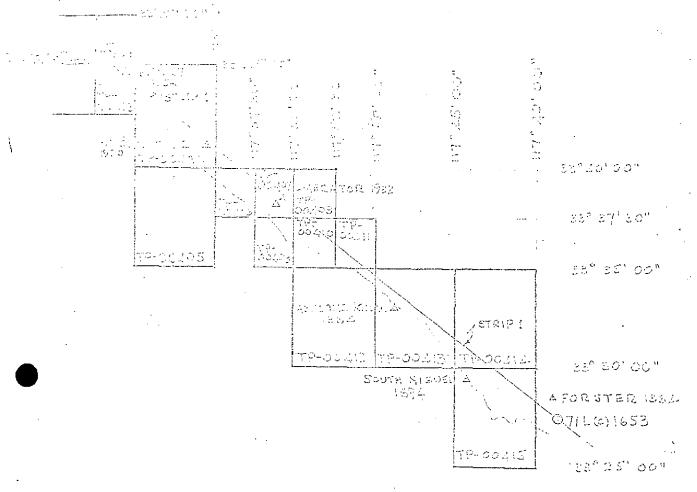
A CONTRIBL USED IN ADJUSTMENT O 1880,000 SCALE PROTECTAFEY

JOB PH - 7107

DANA POINT TO POINT VICENTE

Strip #1 (1:30,000 scale photography) was bridged using analytical aerotriangulation methods. Sketch #1 shows the flight line of the photography and the placement of the control used in the adjustment. Compilation points were located between Strip #1 and Strips #2, #3 and #4 (1:15,000 scale photography) to control the 1:5,000 scale compilation. Compilation points were also located between Strip #1 and Strip #5 (1:30,000 scale photography) where coverage from Strip #1 was not sufficient to control the 1:10,000 scale compilation. Sketch #2 shows the flight lines of the photography. Common points were located between Strip #1 and the 1:15,000 scale and 1:20,000 scale photography in order to determine the ratio scale for the hydro support photography. Natural objects such as tanks, stacks, etc. were located for hydro support parties during bridging. All data for ruling projections and plotting points for the compilation office were furnished to the Coradonat to be plotted on the California zone 6 coordinate system.
