| DESCRIPTIVE REPORT | |
| Type of Survey .... Coastal Boundary ..... | |
| Job No. .... PH-7119 ..... | Map No. TP-00452 ..... |
| Locality ... Butternut Key to Point ..... | |

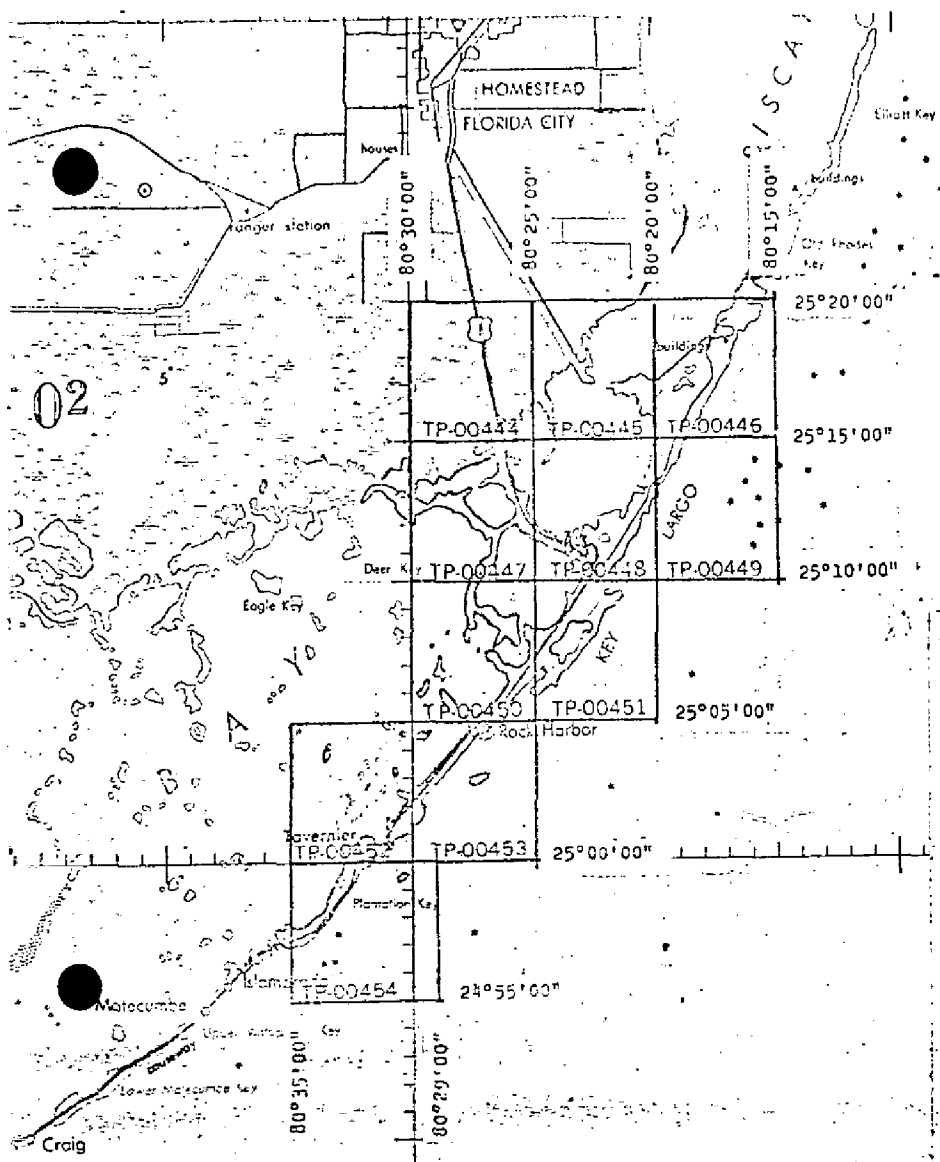
JOB PH-7119  
 CARD SOUND to PLANTATION KEY  
 FLORIDA  
 SHORELINE MAPPING  
 SCALE 1:10000

A layout of Job PH-7119 (revised since the aerotriangulation operation) will show the location of the individual maps. A copy of this layout is included in this Descriptive Report.

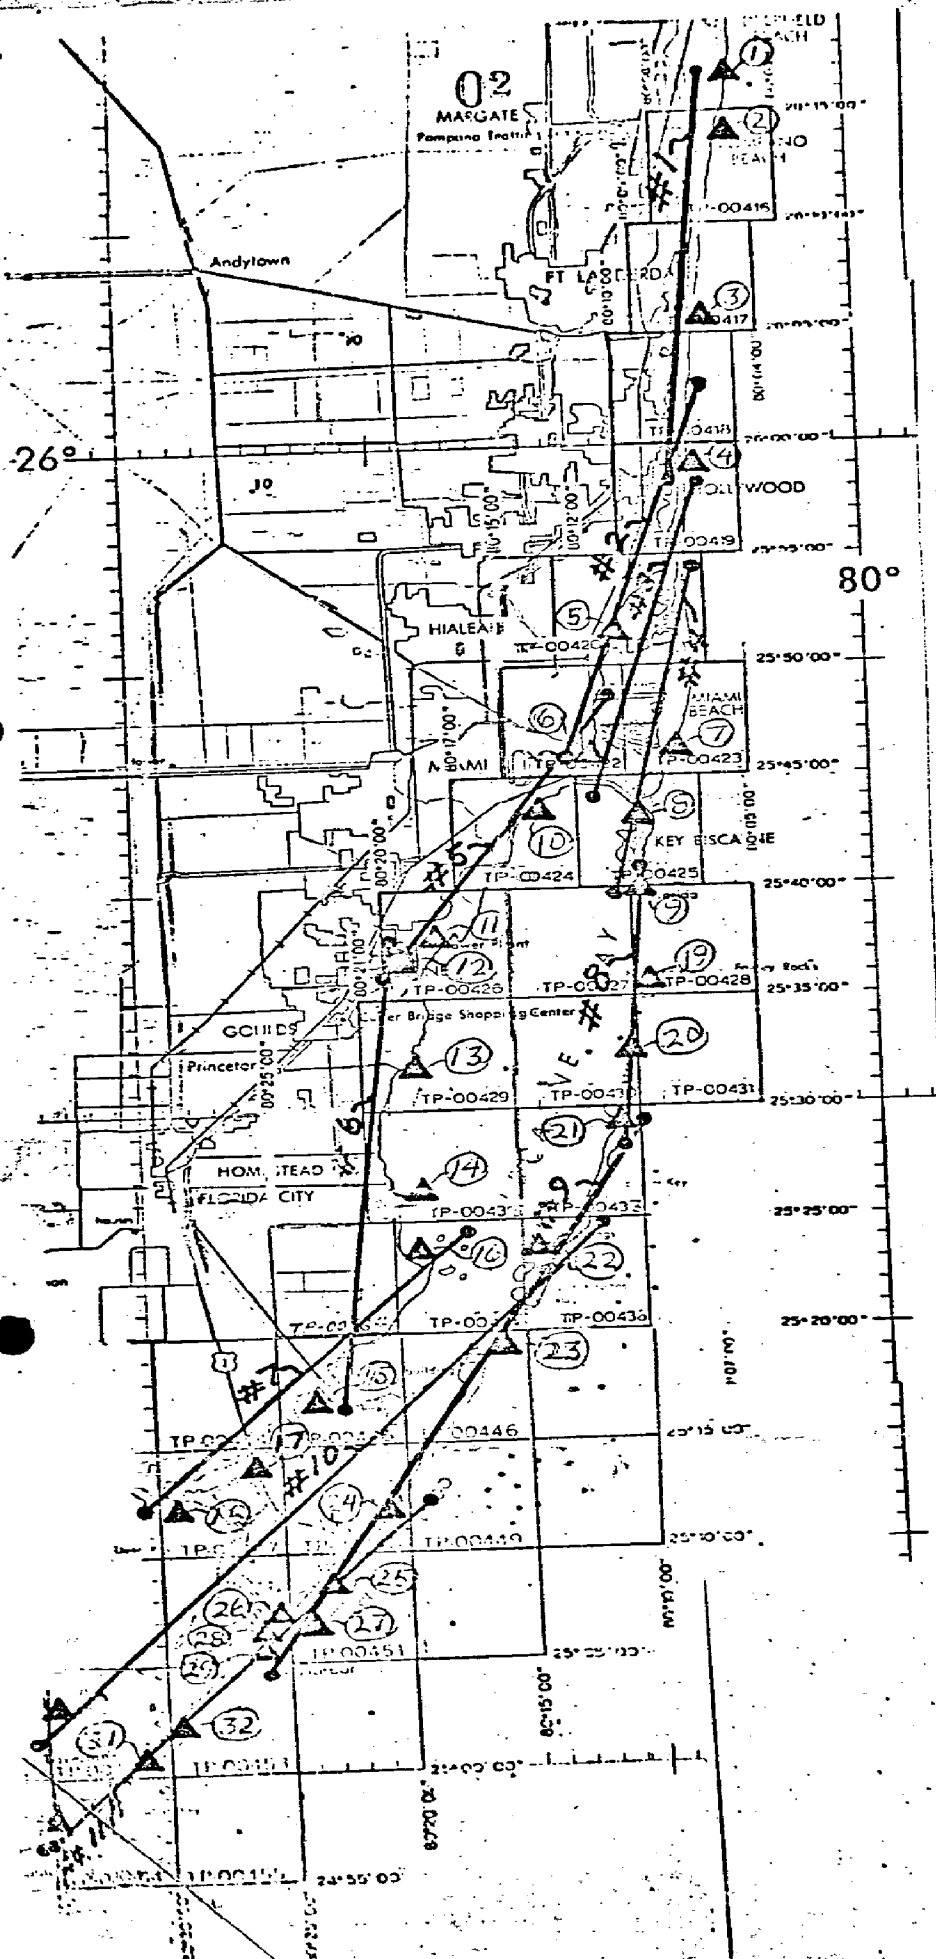
JOB PH-7113  
AND  
JOB PH-7119

HILLSBORO INLET  
TO  
PLANTATION KEY,  
FLORIDA

## INFRA-RED CONTACT PRINTS

1. 71K 5632R - 5660R MLW
2. 71K 5662R - 5672R MLW
3. 71K 5750R - 5766R MHW
4. 71K 5795R - 5806R MHW
5. 71K 5815R - 5829R MHW
6. 71L 8501R - 8509R MLW
7. 71L 8512R - 8520R MLW
8. 71L 8571R - 8580R MHW
9. 71L 8523R - 8530R MLW
10. 71L 8783R - 8791R MHW
11. 71L 8584R - 8593R MHW
12. 71L 8532R - 8537R MLW
13. 71L 9067R - 9080R MLW
14. 71L 8337R - 8341R MHW
15. 72K 6287R - 6298R MHW
16. 72K 6572R - 6584R MLW
17. 72K 6546R - 6563R MLW
18. 72K 6311R - 6330R MHW
19. 71L 8544R - 8559R MLW
20. 71L 8648R - 8662R MLW
21. 72K 6480R - 6499R MHW
22. 71L 8697R - 8705R MHW
23. 72K 6344R - 6350R MLW
24. 72K 6253R - 6255R MLW
25. 72K 6420R - 6423R MHW
26. 72K 6501R - 6515R MHW
27. 72K 6368R - 6382R MLW
28. 71K 5847R - 5856R MHW

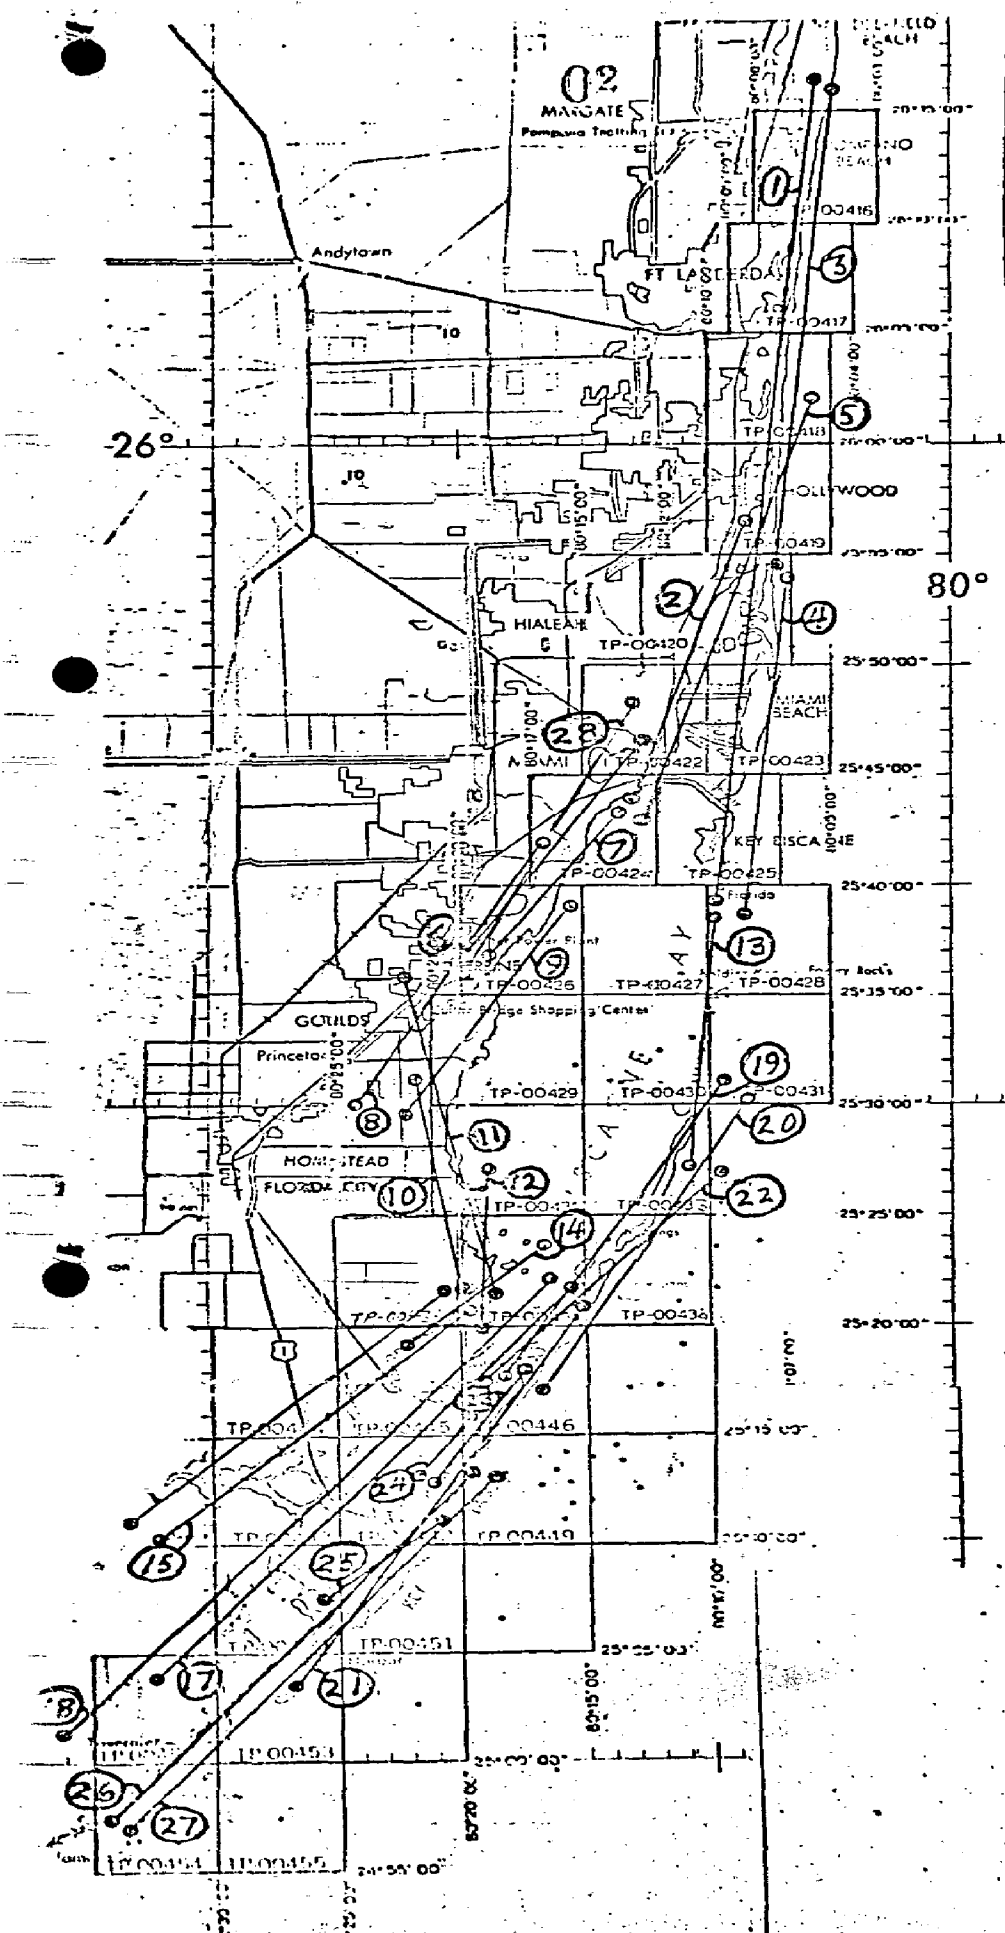
JOB PH-7113  
AND  
JOB PH-7119

HILLSBORO INLET  
TO  
PLANTATION KEY,  
FLORIDA
