DESCRIPTIVE REPORT

Type of Survey Shoreline

Job No. CM-7413 Map No. TP-00895

CM-7413
ICY BAY, ALASKA
Shoreline Mapping

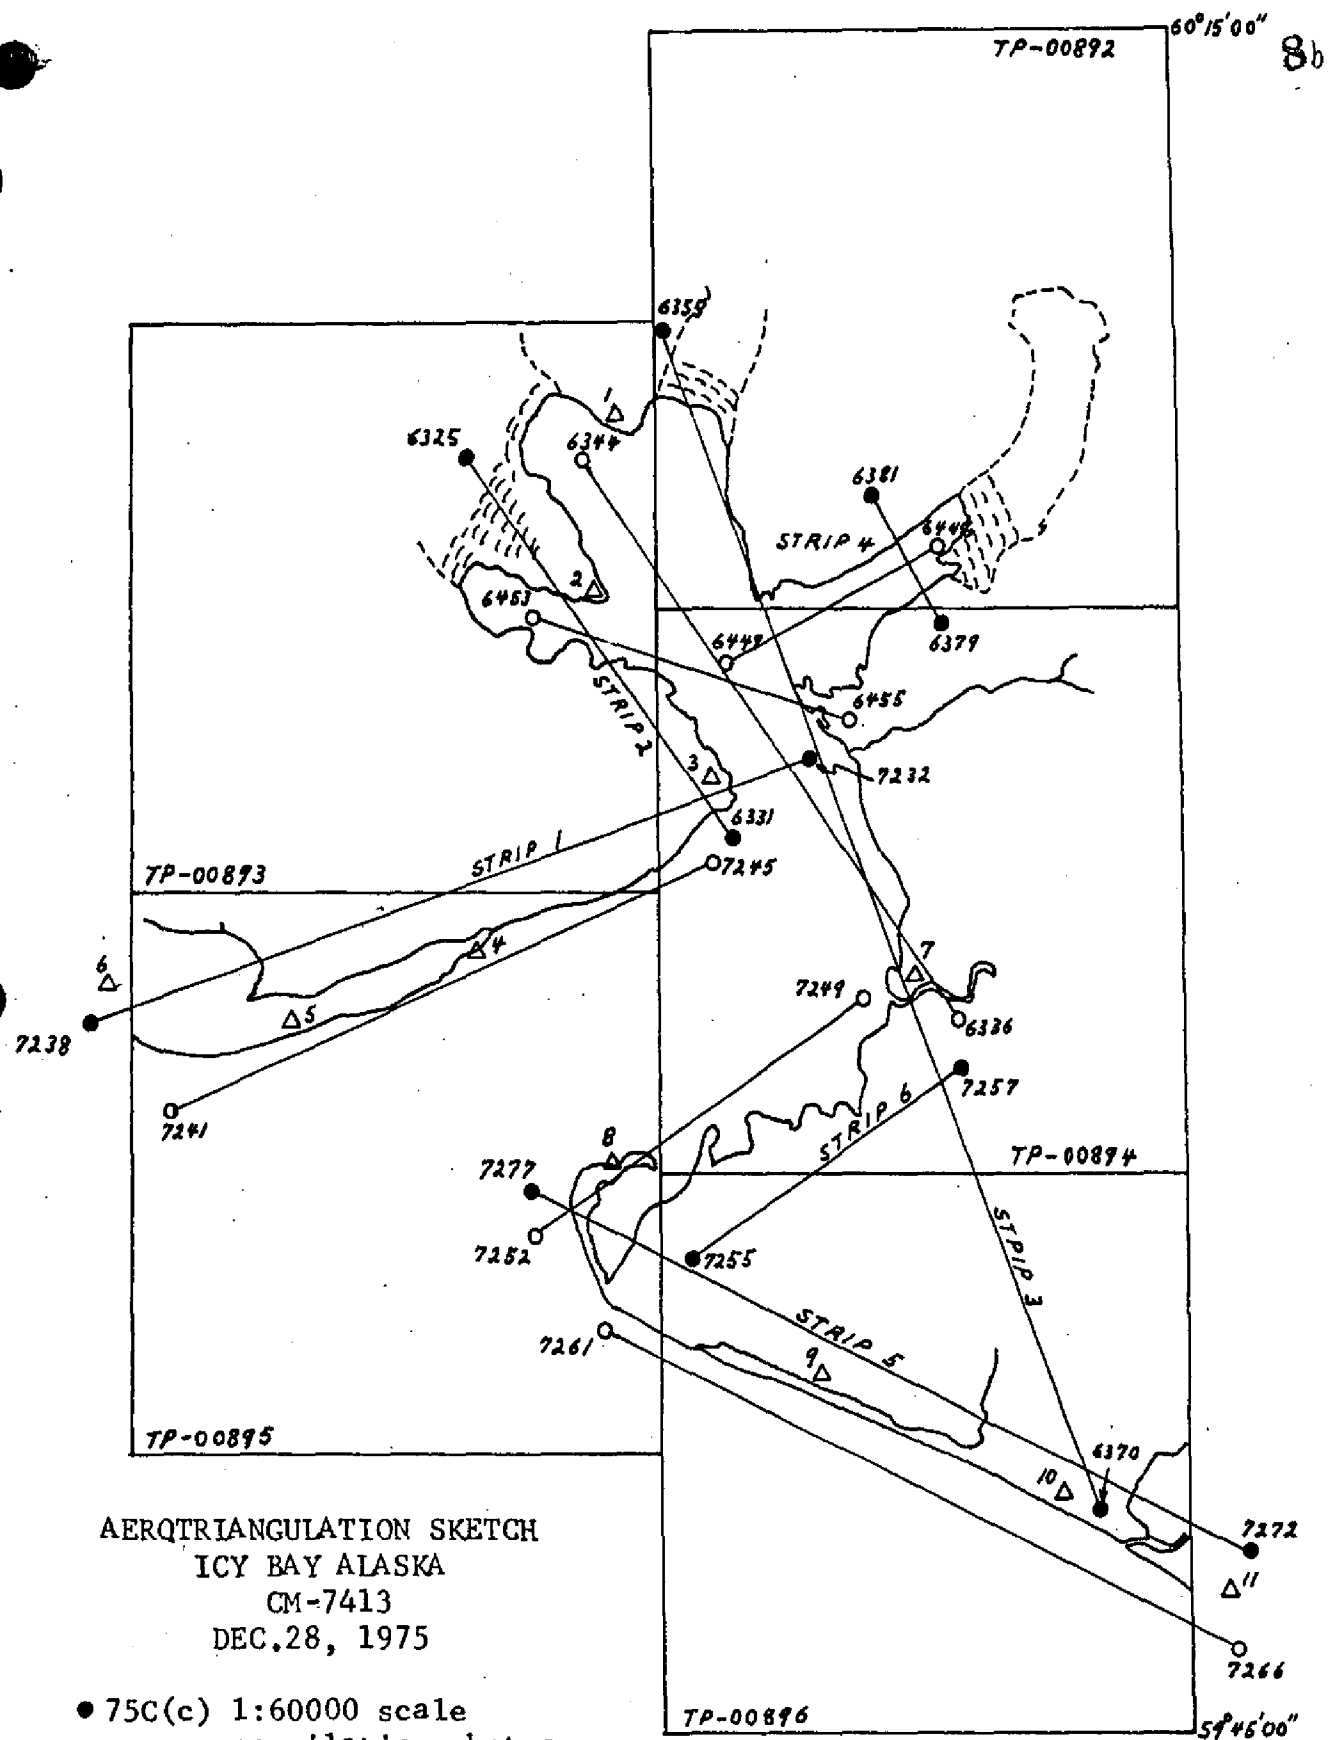
Fit to Control
(in feet)

Strip 1

3 KICHYATT	+0.2, +0.4
4 CARSON	-1.6, -1.2
5 WATSON	+1.2, -1.2
6 STOR	-1.0, 0.2

Strip 2

1 GUYOT	0.0, 0.0
2 TOYUG	0.0, 0.0
3 KICHYATT	0.0, 0.0

Strip 3

1 GUYOT	-0.6, -0.6
2 TOYUG	-0.5, +0.5
3 KICHYATT	+2.7, +1.1
7 CAETANI	-1.9, -1.1
10 YAHTSE	+0.3, 0.0

Strip 5

11 YANA	-1.3, +0.4
10 YAHTSE	+3.0, -1.0
9 JARL	-2.2, +1.0
8 RUNT	+0.5, -0.4

Strip 6

9 JARL	-2.7, +6.7
8 RUNT	-4.0, +2.1
7 CAETANI	-0.4, -0.8
