## DESCRIPTIVE REPORT

Type of Survey ... Shoreline Mapping .....  
Job No. ... CM-7510 ..... Map No. TP-00941 .....  
Classification No. III ..... Edition No. ... 1st .....

State ..... Ohio .....  
General Locality .... Lake Erie .....  
Locality .... Rocky River .....  
.....

# JOB CM-7510 VERMILION TO FAIRPORT HARBOR

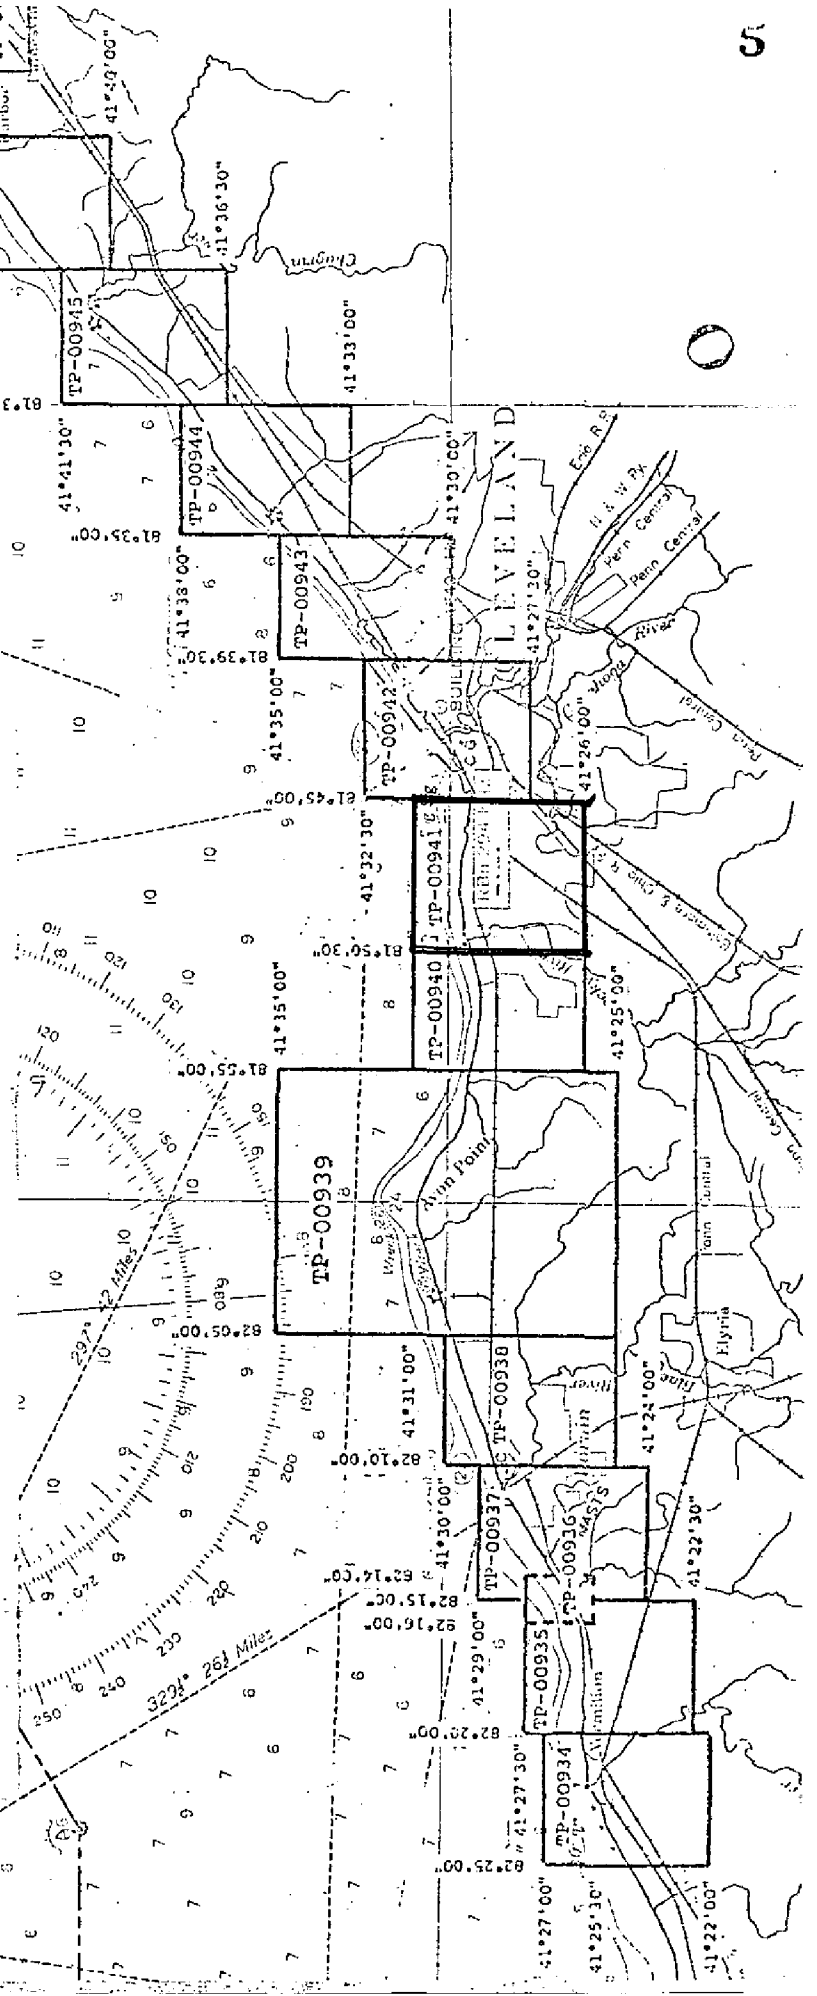
OHIO  
SHORELINE MAPPING  
SCALE 1"=5,000  
1"=10,000  
1"=20,000

SHEET NO.	SQ. MILES	SHEET NO.	SQ. MILES
TP-00934	4	TP-00942	9
TP-00935	5	TP-00943	5
TP-00936	2	TP-00944	6
TP-00937	6	TP-00945	8
TP-00938	6	TP-00946	7
TP-00939	4	TP-00947	3
TP-00940	2	TP-00948	5
TP-00941	9	TP-00949	4
